Profile/Photo Observation Report

Street:	E 38th Ave	Flow Control:	Not Controlled
City:	Hobart, IN	Year Renewed:	
Location:	Other	Tape/Media #:	
Purpose:	Not Known	Dia/Height:	12"
Use:	Sanitary	Material:	VCP
Drain Area:	NA	Lining:	
Category:	NA		
Comment:

Location Details:		Direction of Survey:	Downstream
US MH:	M-203-051	DS MH:	M-203-041
		Total Length Surveyed (ft):	4.2

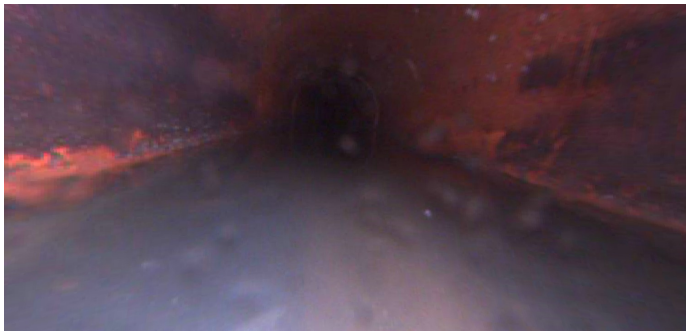
Code: **AMH**
Description: **Manhole**

Distance (ft): **.0**
Structural Grade: **0**
O&M Grade: **0**
Clock Start/From:
Clock To:
1st Value:
2nd Value:
Value Percent:
Continuous Index:
Within 8" of Joint: **NO**
Remarks: **M-203-051**

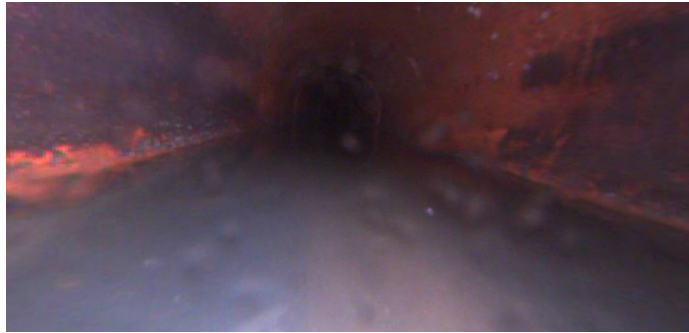
Code: **MWL**
Description: **Water Level**

Distance (ft): **.0**
Structural Grade: **0**
O&M Grade: **0**
Clock Start/From:
Clock To:
1st Value:
2nd Value:
Value Percent: **10.000**
Continuous Index:
Within 8" of Joint: **NO**
Remarks:
