Profile/Photo Observation Report

Street:	W 38TH AVE	Flow Control:	Not Controlled
City:	Hobart, IN	Year Renewed:	
Location:	Other	Tape/Media #:	
Purpose:	Not Known	Dia/Height:	12"
Use:	Sanitary	Material:	VCP
Drain Area:	NA	Lining:	
Category:	NA		
Comment:	pump

Location Details:		Direction of Survey:	Downstream
US MH:	M-203-051	DS MH:	M-203-041
		Total Length Surveyed (ft):	59.4

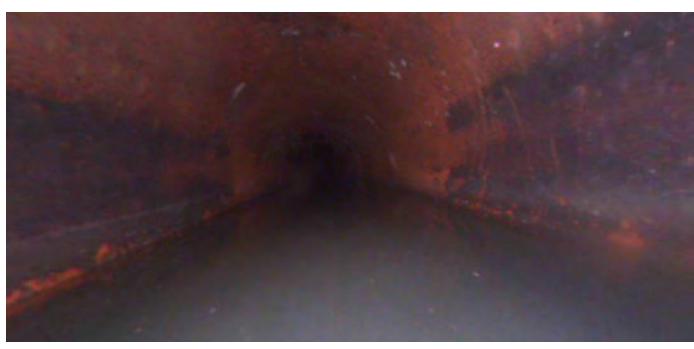
Code: **AMH**
Description: **Manhole**

Distance (ft): **.0**
Structural Grade: **0**
O&M Grade: **0**
Clock Start/From:
Clock To:
1st Value:
2nd Value:
Value Percent:
Continuous Index:
Within 8" of Joint: **NO**
Remarks: **M-203-051**

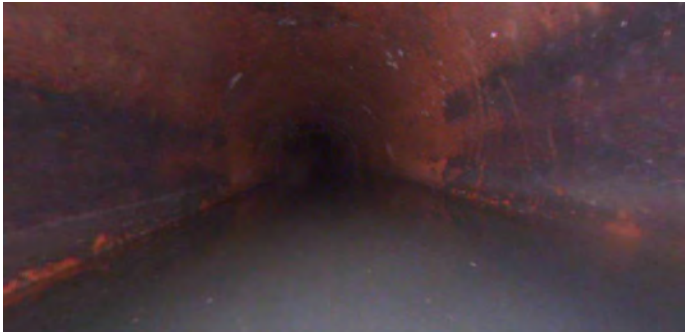
Code:	MWL
Description:	Water Level

Distance (ft):	.0
Structural Grade:	0
O&M Grade:	0
Clock Start/From:	
Clock To:	
1st Value:	
2nd Value:	
Value Percent:	10.000
Continuous Index:	
Within 8" of Joint:	NO
Remarks:

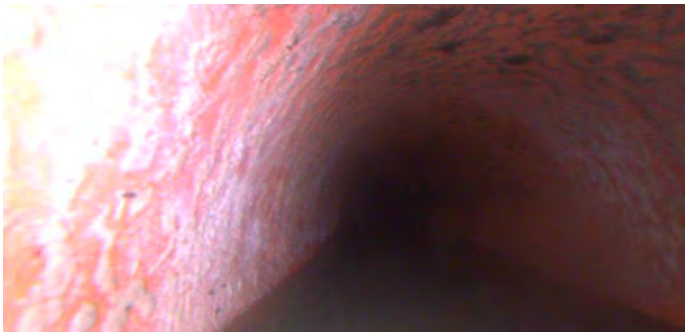
Code:	MSA
Description:	Abandoned Survey

Distance (ft):	59.4
Structural Grade:	0
O&M Grade:	0
Clock Start/From:	
Clock To:	
1st Value:	
2nd Value:	
Value Percent:	
Continuous Index:	
Within 8" of Joint:	NO
Remarks:	stuck on wall
