Profile/Photo Observation Report

Street:	E 38th Ave	Flow Control:	Not Controlled
City:	Hobart, IN	Year Renewed:	
Location:	Other	Tape/Media #:	
Purpose:	Not Known	Dia/Height:	12"
Use:	Sanitary	Material:	VCP
Drain Area:	NA	Lining:	
Category:	NA		
Comment:	pump

Location Details:		Direction of Survey:	Downstream
US MH:	M-203-051	DS MH:	M-203-041
		Total Length Surveyed (ft):	59.4

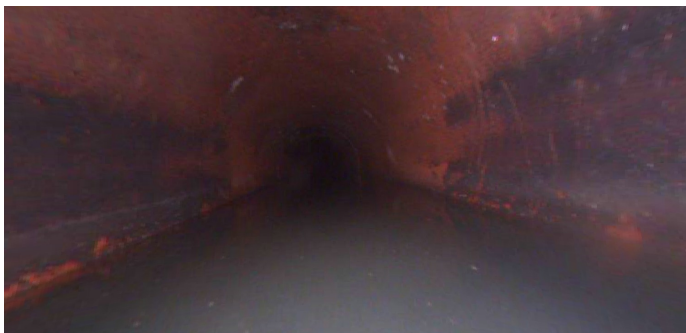
Code: **AMH**
Description: **Manhole**

Distance (ft): **.0**
Structural Grade: **0**
O&M Grade: **0**
Clock Start/From:
Clock To:
1st Value:
2nd Value:
Value Percent:
Continuous Index:
Within 8" of Joint: **NO**
Remarks: **M-203-051**

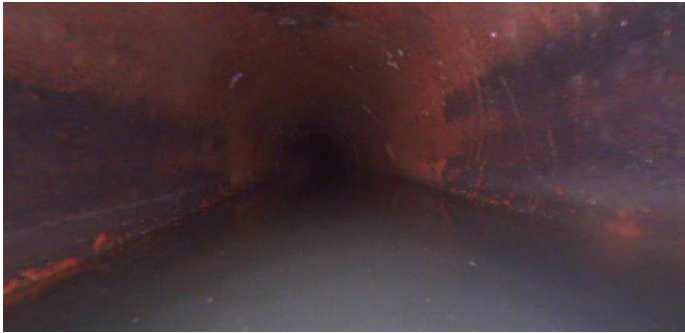
Code:	MWL
Description:	Water Level

Distance (ft):	.0
Structural Grade:	0
O&M Grade:	0
Clock Start/From:	
Clock To:	
1st Value:	
2nd Value:	
Value Percent:	10.000
Continuous Index:	
Within 8" of Joint:	NO
Remarks:

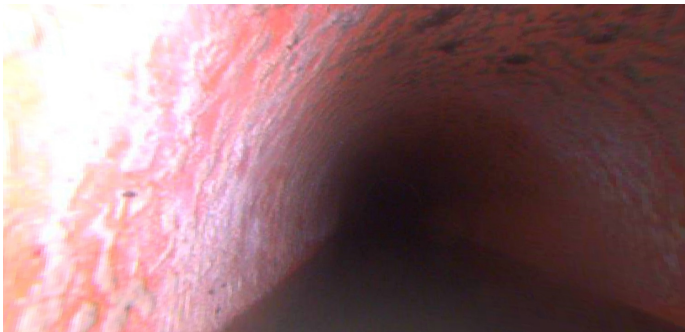
Code:	MSA
Description:	Abandoned Survey

Distance (ft):	59.4
Structural Grade:	0
O&M Grade:	0
Clock Start/From:	
Clock To:	
1st Value:	
2nd Value:	
Value Percent:	
Continuous Index:	
Within 8" of Joint:	NO
Remarks:	stuck on wall
