Profile/Photo Observation Report

Date:	03/24/2018	Weather:		Coding:	PACP 6.0
Pipe Length (ft):	339.2	Owner:	NA	Pre Clean:	Not Known
P.O.#:		Surveyor:	Byrd Fitzgerald	PSR:	P-203-041-051
Customer:		Clean Date:	01/01/1900	Shape:	C

Street:	W 38TH AVE	Flow Control:	Not Controlled
City:	Hobart, IN	Year Renewed:	
Location:	Other	Tape/Media #:	
Purpose:	Not Known	Dia/Height:	12"
Use:	Sanitary	Material:	VCP
Drain Area:	NA	Lining:	
Category:	NA		
Comment:	pump

Location Details:		Direction of Survey:	Upstream
US MH:	M-203-051	DS MH:	M-203-041
		Total Length Surveyed (ft):	49.6

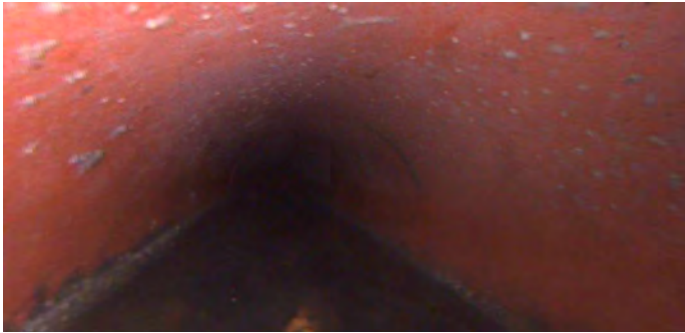
Code:	MWL
Description:	Water Level

Distance (ft):	.0
Structural Grade:	0
O&M Grade:	0
Clock Start/From:	
Clock To:	
1st Value:	
2nd Value:	
Value Percent:	10.000
Continuous Index:	
Within 8" of Joint:	NO
Remarks:

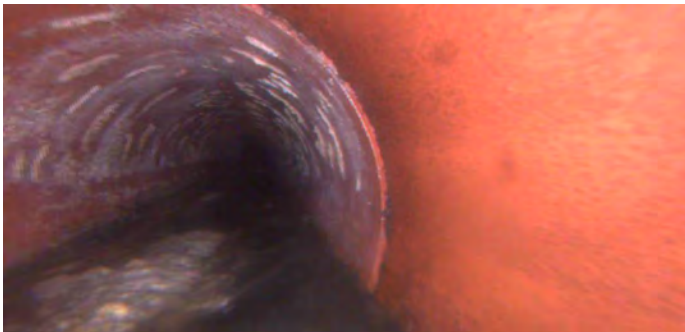
Code:	DSZ
Description:	Deposits Settled Other

Distance (ft):	23.6
Structural Grade:	0
O&M Grade:	2
Clock Start/From:	6
Clock To:	
1st Value:	
2nd Value:	
Value Percent:	5.000
Continuous Index:	S01
Within 8" of Joint:	NO
Remarks:	tissue

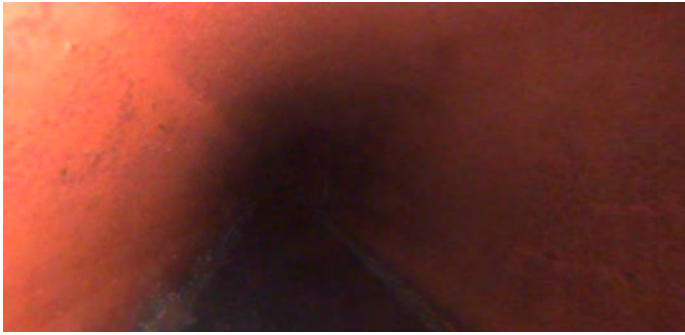
Code: **MSA**
Description: **Abandoned Survey**

Distance (ft): **49.6**
Structural Grade: **0**
O&M Grade: **0**
Clock Start/From:
Clock To:
1st Value:
2nd Value:
Value Percent:
Continuous Index:
Within 8" of Joint: **NO**
Remarks: **debris under water**

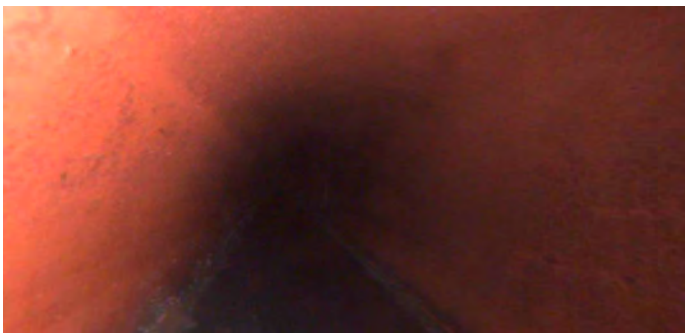
Code: **DSZ**
Description: **Deposits Settled Other**

Distance (ft): **49.6**
Structural Grade: **0**
O&M Grade: **2**
Clock Start/From: **6**
Clock To:
1st Value:
2nd Value:
Value Percent: **5.000**
Continuous Index: **F01**
Within 8" of Joint: **NO**
Remarks: **tissue**
