## Profile/Photo Observation Report

Street:	<b>W 38TH AVE</b>	Flow Control:	<b>Not Controlled</b>
City:	<b>Hobart, IN</b>	Year Renewed:	
Location:	<b>Other</b>	Tape/Media #:	
Purpose:	<b>Not Known</b>	Dia/Height:	<b>12"</b>
Use:	<b>Sanitary</b>	Material:	<b>VCP</b>
Drain Area:	<b>NA</b>	Lining:	
Category:	<b>NA</b>		
Comment:	<b>pump</b>

Location Details:		Direction of Survey:	<b>Upstream</b>
US MH:	<b>M-203-051</b>	DS MH:	<b>M-203-041</b>
		Total Length Surveyed (ft):	<b>33.2</b>

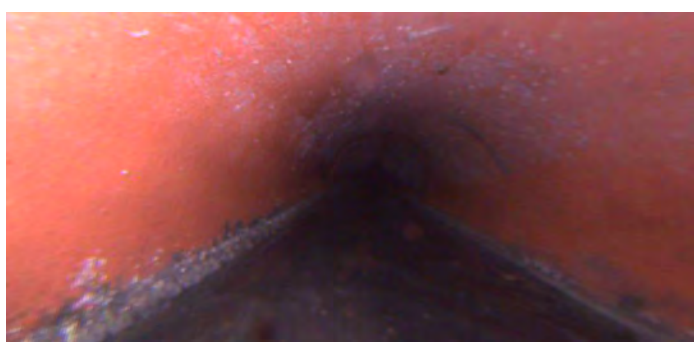
Code: **AMH**  
Description: **Manhole**

Distance (ft): **.0**  
Structural Grade: **0**  
O&M Grade: **0**  
Clock Start/From:  
Clock To:  
1st Value:  
2nd Value:  
Value Percent:  
Continuous Index:  
Within 8" of Joint: **NO**  
Remarks: **M-203-041**

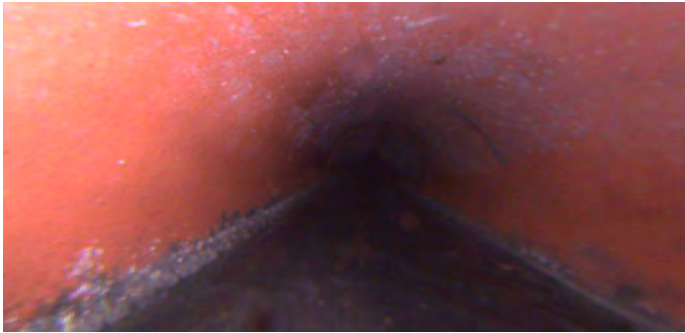
Code:	<b>MWL</b>
Description:	<b>Water Level</b>

Distance (ft):	<b>.0</b>
Structural Grade:	<b>0</b>
O&M Grade:	<b>0</b>
Clock Start/From:	
Clock To:	
1st Value:	
2nd Value:	
Value Percent:	<b>5.000</b>
Continuous Index:	
Within 8" of Joint:	<b>NO</b>
Remarks:

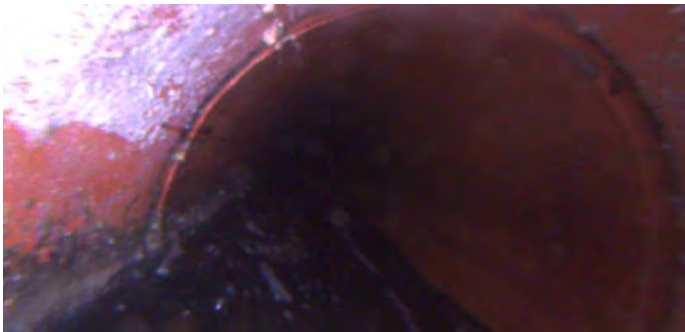
Code:	<b>MSA</b>
Description:	<b>Abandoned Survey</b>

Distance (ft):	<b>33.2</b>
Structural Grade:	<b>0</b>
O&M Grade:	<b>0</b>
Clock Start/From:	
Clock To:	
1st Value:	
2nd Value:	
Value Percent:	
Continuous Index:	
Within 8" of Joint:	<b>NO</b>
Remarks:	<b>stuck on wall</b>
