Profile/Photo Observation Report

Date:	03/24/2018	Weather:		Coding:	PACP 6.0
Pipe Length (ft):	262.1	Owner:	NA	Pre Clean:	Not Known
P.O.#:		Surveyor:	Byrd Fitzgerald	PSR:	P-203-052-051
Customer:		Clean Date:	01/01/1900	Shape:	C

Street:	ALLEY BETWEEN SANDUSKY ST & EV	Flow Control:	Not Controlled
City:	Hobart, IN	Year Renewed:	
Location:	Other	Tape/Media #:	
Purpose:	Not Known	Dia/Height:	12"
Use:	Sanitary	Material:	VCP
Drain Area:	NA	Lining:	
Category:	NA		
Comment:

Location Details:		Direction of Survey:	Downstream
US MH:	M-203-051	DS MH:	M-203-052
		Total Length Surveyed (ft):	15.5

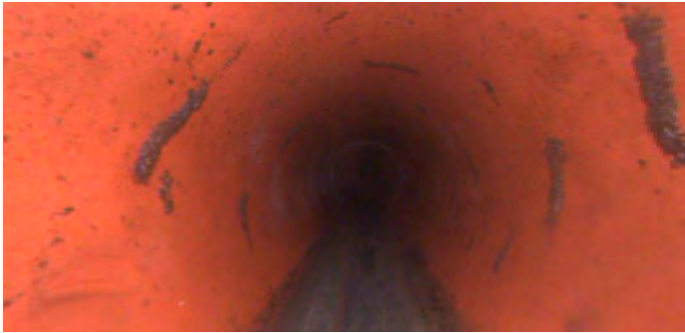
Code:	MWL
Description:	Water Level

Distance (ft):	.0
Structural Grade:	0
O&M Grade:	0
Clock Start/From:	
Clock To:	
1st Value:	
2nd Value:	
Value Percent:	5.000
Continuous Index:	
Within 8" of Joint:	NO
Remarks:

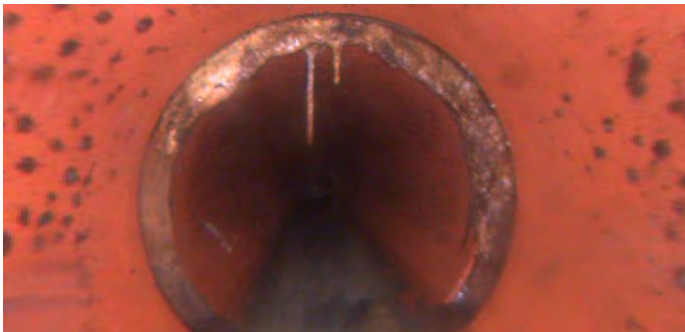
Code:	DAE
Description:	Deposits Attached Encrustation

Distance (ft):	8.7
Structural Grade:	0
O&M Grade:	2
Clock Start/From:	10
Clock To:	4
1st Value:	
2nd Value:	
Value Percent:	5.000
Continuous Index:	
Within 8" of Joint:	YES
Remarks:

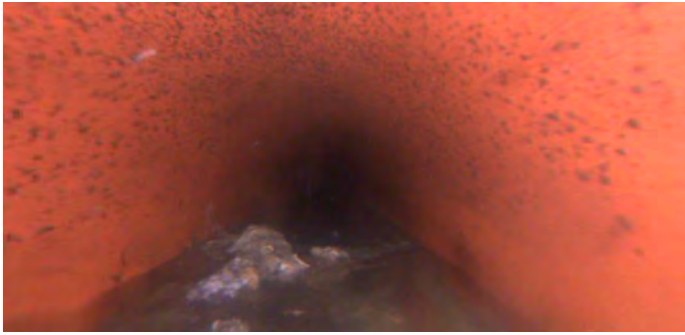
Code: **DSZ**
Description: **Deposits Settled Other**

Distance (ft): **14.5**
Structural Grade: **0**
O&M Grade: **2**
Clock Start/From: **6**
Clock To:
1st Value:
2nd Value:
Value Percent: **5.000**
Continuous Index:
Within 8" of Joint: **NO**
Remarks: **debris**

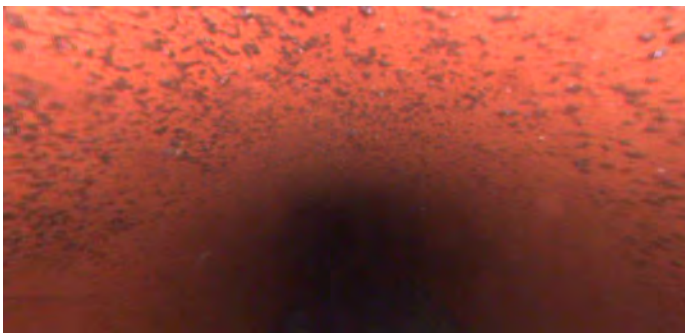
Code: **MSA**
Description: **Abandoned Survey**

Distance (ft): **15.5**
Structural Grade: **0**
O&M Grade: **0**
Clock Start/From:
Clock To:
1st Value:
2nd Value:
Value Percent:
Continuous Index:
Within 8" of Joint: **NO**
Remarks: **stuck in debris**
