Profile/Photo Observation Report

Date:	03/24/2018	Weather:		Coding:	PACP 6.0
Pipe Length (ft):	262.1	Owner:	NA	Pre Clean:	Not Known
P.O.#:		Surveyor:	Byrd Fitzgerald	PSR:	P-203-052-051
Customer:		Clean Date:	01/01/1900	Shape:	C

Street:	E 38th Ave	Flow Control:	Not Controlled
City:	Hobart, IN	Year Renewed:	
Location:	Other	Tape/Media #:	
Purpose:	Not Known	Dia/Height:	12"
Use:	Sanitary	Material:	VCP
Drain Area:	NA	Lining:	
Category:	NA		
Comment:

Location Details:		Direction of Survey:	Downstream
US MH:	M-203-051	DS MH:	M-203-052
		Total Length Surveyed (ft):	15.5

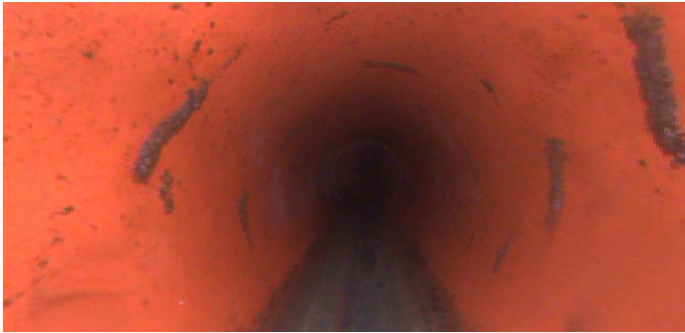
Code:	MWL
Description:	Water Level

Distance (ft):	.0
Structural Grade:	0
O&M Grade:	0
Clock Start/From:	
Clock To:	
1st Value:	
2nd Value:	
Value Percent:	5.000
Continuous Index:	
Within 8" of Joint:	NO
Remarks:

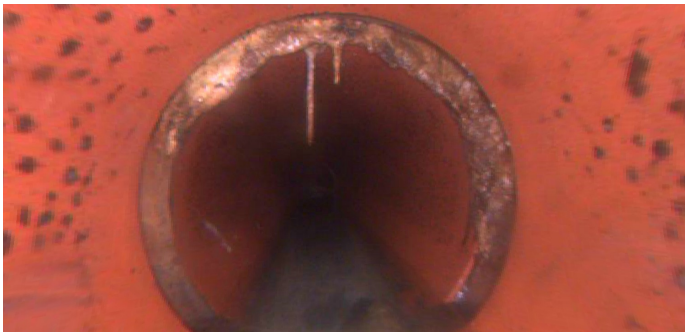
Code:	DAE
Description:	Deposits Attached Encrustation

Distance (ft):	8.7
Structural Grade:	0
O&M Grade:	2
Clock Start/From:	10
Clock To:	4
1st Value:	
2nd Value:	
Value Percent:	5.000
Continuous Index:	
Within 8" of Joint:	YES
Remarks:

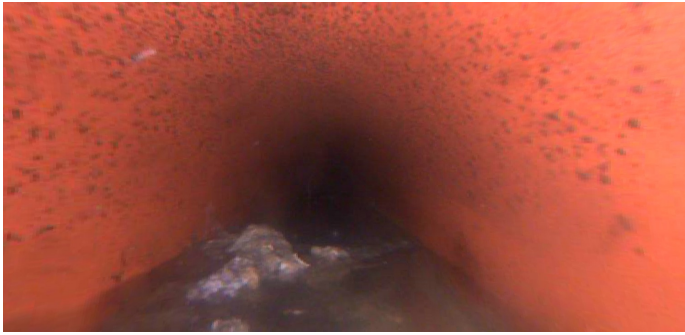
Code: **DSZ**
Description: **Deposits Settled Other**

Distance (ft): **14.5**
Structural Grade: **0**
O&M Grade: **2**
Clock Start/From: **6**
Clock To:
1st Value:
2nd Value:
Value Percent: **5.000**
Continuous Index:
Within 8" of Joint: **NO**
Remarks: **debris**

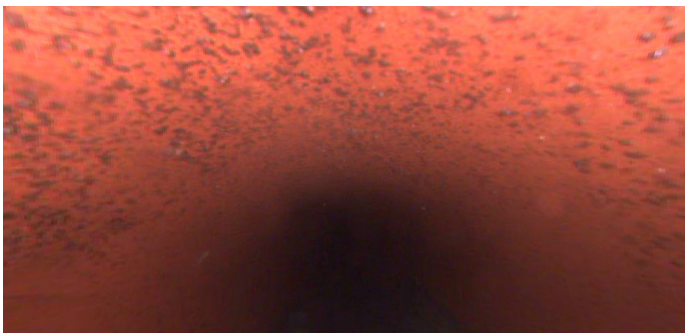
Code: **MSA**
Description: **Abandoned Survey**

Distance (ft): **15.5**
Structural Grade: **0**
O&M Grade: **0**
Clock Start/From:
Clock To:
1st Value:
2nd Value:
Value Percent:
Continuous Index:
Within 8" of Joint: **NO**
Remarks: **stuck in debris**
