## Profile/Photo Observation Report

Date:	<b>03/24/2018</b>	Weather:		Coding:	<b>PACP 6.0</b>
Pipe Length (ft):	<b>262.1</b>	Owner:	<b>NA</b>	Pre Clean:	<b>Not Known</b>
P.O.#:		Surveyor:	<b>Byrd Fitzgerald</b>	PSR:	<b>P-203-052-051</b>
Customer:		Clean Date:	<b>01/01/1900</b>	Shape:	<b>C</b>

Street:	<b>ALLEY BETWEEN SANDUSKY ST &amp; EV</b>	Flow Control:	<b>Not Controlled</b>
City:	<b>Hobart, IN</b>	Year Renewed:	
Location:	<b>Other</b>	Tape/Media #:	
Purpose:	<b>Not Known</b>	Dia/Height:	<b>10"</b>
Use:	<b>Sanitary</b>	Material:	<b>VCP</b>
Drain Area:	<b>NA</b>	Lining:	
Category:	<b>NA</b>		
Comment:	<b>cnl</b>

Location Details:		Direction of Survey:	<b>Upstream</b>
US MH:	<b>M-203-051</b>	DS MH:	<b>M-203-052</b>
		Total Length Surveyed (ft):	<b>10.4</b>

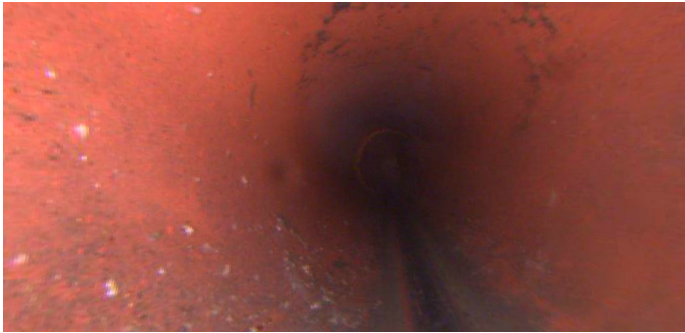
Code:	<b>MWL</b>
Description:	<b>Water Level</b>

Distance (ft):	<b>.0</b>
Structural Grade:	<b>0</b>
O&M Grade:	<b>0</b>
Clock Start/From:	
Clock To:	
1st Value:	
2nd Value:	
Value Percent:	<b>5.000</b>
Continuous Index:	
Within 8" of Joint:	<b>NO</b>
Remarks:

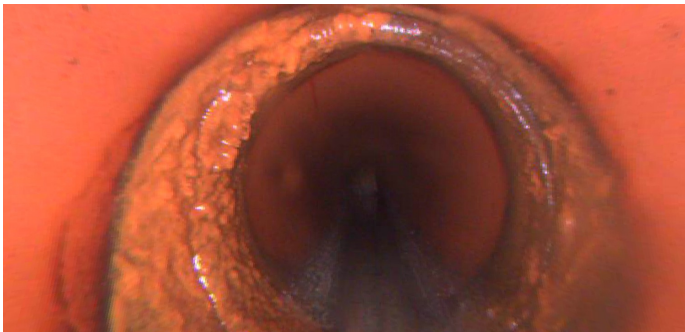
Code:	<b>DAE</b>
Description:	<b>Deposits Attached Encrustation</b>

Distance (ft):	<b>3.3</b>
Structural Grade:	<b>0</b>
O&M Grade:	<b>2</b>
Clock Start/From:	<b>7</b>
Clock To:	<b>5</b>
1st Value:	
2nd Value:	
Value Percent:	<b>5.000</b>
Continuous Index:	
Within 8" of Joint:	<b>YES</b>
Remarks:

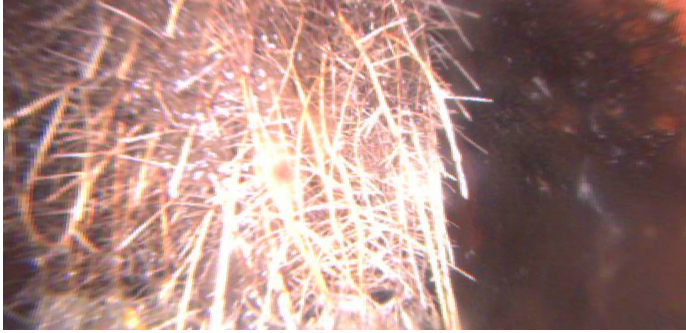
Code: **RBB**  
Description: **Roots Ball Barrel**

Distance (ft): **9.1**  
Structural Grade: **0**  
O&M Grade: **5**  
Clock Start/From: **7**  
Clock To: **12**  
1st Value:  
2nd Value:  
Value Percent: **55.000**  
Continuous Index:  
Within 8" of Joint: **NO**  
Remarks:
