## Profile/Photo Observation Report

Street:	<b>ALLEY BETWEEN SANDUSKY ST &amp; EV</b>	Flow Control:	<b>Not Controlled</b>
City:	<b>Hobart, IN</b>	Year Renewed:	
Location:	<b>Other</b>	Tape/Media #:	
Purpose:	<b>Not Known</b>	Dia/Height:	<b>10"</b>
Use:	<b>Sanitary</b>	Material:	<b>VCP</b>
Drain Area:	<b>NA</b>	Lining:	
Category:	<b>NA</b>		
Comment:	<b>6 inch</b>

Location Details:		Direction of Survey:	<b>Downstream</b>
US MH:	<b>M-203-054</b>	DS MH:	<b>M-203-053</b>
		Total Length Surveyed (ft):	<b>70.2</b>

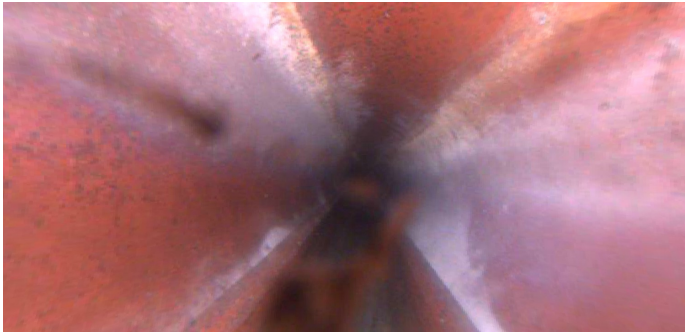
Code:	<b>MWL</b>
Description:	<b>Water Level</b>

Distance (ft):	<b>.0</b>
Structural Grade:	<b>0</b>
O&M Grade:	<b>0</b>
Clock Start/From:	
Clock To:	
1st Value:	
2nd Value:	
Value Percent:	<b>5.000</b>
Continuous Index:	
Within 8" of Joint:	<b>NO</b>
Remarks:

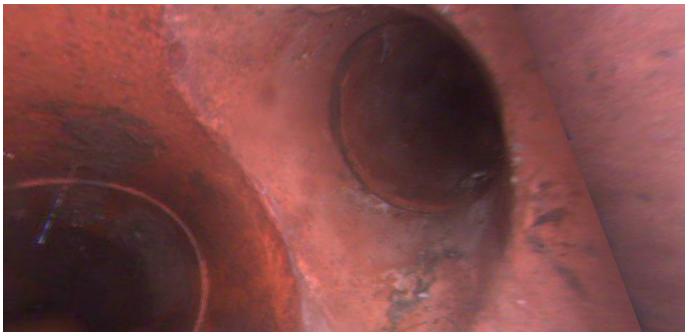
Code:	<b>TF</b>
Description:	<b>Tap Factory</b>

Distance (ft):	<b>20.7</b>
Structural Grade:	<b>0</b>
O&M Grade:	<b>0</b>
Clock Start/From:	<b>2</b>
Clock To:	
1st Value:	<b>4.000</b>
2nd Value:	
Value Percent:	
Continuous Index:	
Within 8" of Joint:	<b>YES</b>
Remarks:

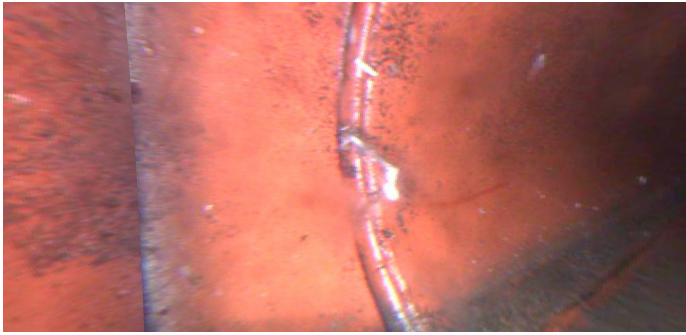
Code: **RFJ**  
Description: **Roots Fine Joint**

Distance (ft): **47.1**  
Structural Grade: **0**  
O&M Grade: **1**  
Clock Start/From: **3**  
Clock To:  
1st Value:  
2nd Value:  
Value Percent:  
Continuous Index:  
Within 8" of Joint: **YES**  
Remarks:

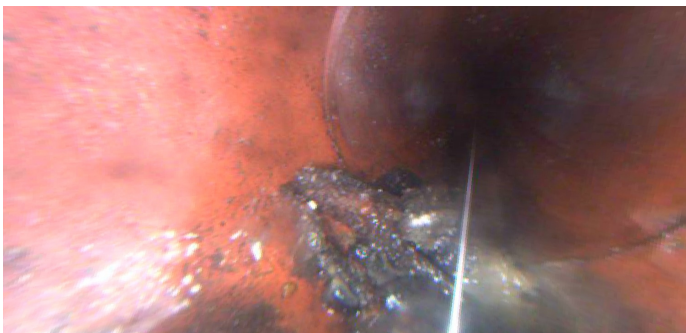
Code: **DAZ**  
Description: **Deposits Attached Other**

Distance (ft): **62.5**  
Structural Grade: **0**  
O&M Grade: **2**  
Clock Start/From: **4**  
Clock To: **5**  
1st Value:  
2nd Value:  
Value Percent: **5.000**  
Continuous Index:  
Within 8" of Joint: **YES**  
Remarks:

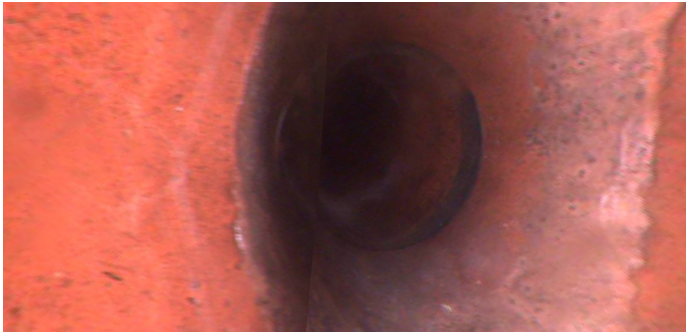
Code: **TF**  
Description: **Tap Factory**

Distance (ft): **68.3**  
Structural Grade: **0**  
O&M Grade: **0**  
Clock Start/From: **2**  
Clock To:  
1st Value: **4.000**  
2nd Value:  
Value Percent:  
Continuous Index:  
Within 8" of Joint: **YES**  
Remarks:

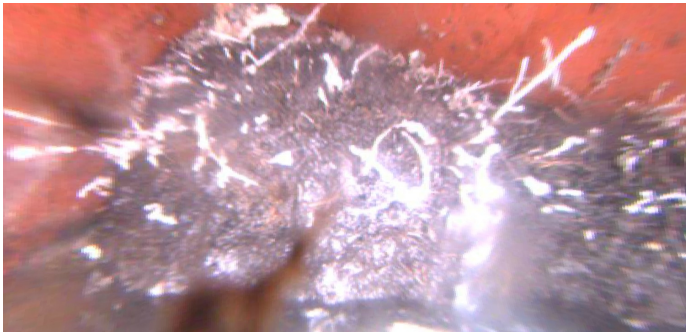
Code: **RBB**  
Description: **Roots Ball Barrel**

Distance (ft): **69.8**  
Structural Grade: **0**  
O&M Grade: **5**  
Clock Start/From: **12**  
Clock To: **12**  
1st Value:  
2nd Value:  
Value Percent: **100.000**  
Continuous Index:  
Within 8" of Joint: **NO**  
Remarks:

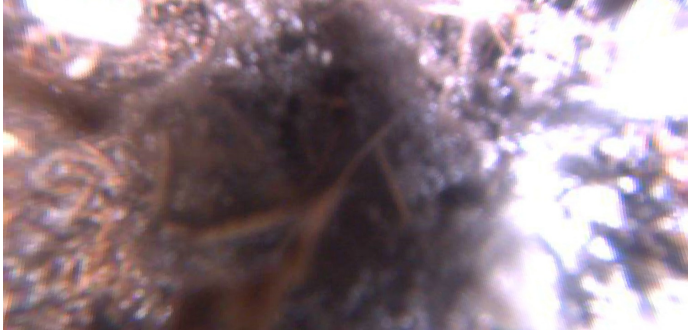
Code:	<b>MSA</b>
Description:	<b>Abandoned Survey</b>
Distance (ft):	<b>70.2</b>
Structural Grade:	<b>0</b>
O&M Grade:	<b>0</b>
Clock Start/From:	
Clock To:	
1st Value:	
2nd Value:	
Value Percent:	
Continuous Index:	
Within 8" of Joint:	<b>NO</b>
Remarks:	<b>rbb</b>
