Profile/Photo Observation Report

Date:	03/24/2018	Weather:		Coding:	PACP 6.0
Pipe Length (ft):	130.9	Owner:	NA	Pre Clean:	Not Known
P.O.#:		Surveyor:	Byrd Fitzgerald	PSR:	P-203-053-054
Customer:		Clean Date:	01/01/1900	Shape:	C

Street:	ALLEY BETWEEN SANDUSKY ST & EV	Flow Control:	Not Controlled
City:	Hobart, IN	Year Renewed:	
Location:	Other	Tape/Media #:	
Purpose:	Not Known	Dia/Height:	10"
Use:	Sanitary	Material:	PVC
Drain Area:	NA	Lining:	
Category:	NA		
Comment:	6 inch

Location Details:		Direction of Survey:	Upstream
US MH:	M-203-054	DS MH:	M-203-053
		Total Length Surveyed (ft):	36.9

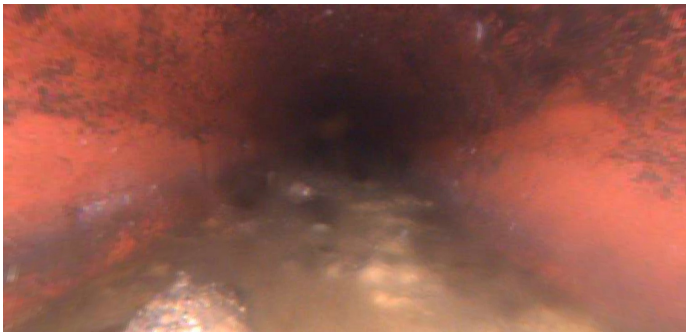
Code:	DSZ
Description:	Deposits Settled Other

Distance (ft):	.0
Structural Grade:	0
O&M Grade:	2
Clock Start/From:	6
Clock To:	
1st Value:	
2nd Value:	
Value Percent:	10.000
Continuous Index:	S01
Within 8" of Joint:	NO
Remarks:	debris

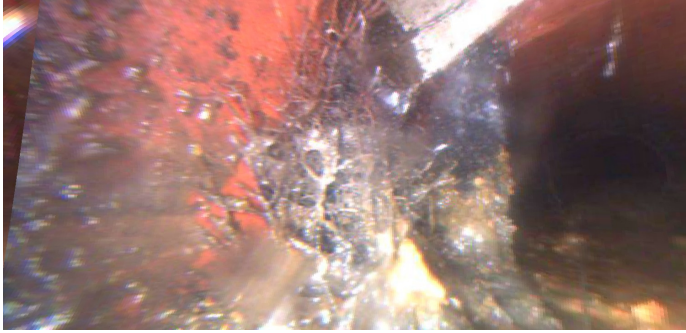
Code: **RML**
Description: **Roots Medium Lateral**

Distance (ft): **19.7**
Structural Grade: **0**
O&M Grade: **3**
Clock Start/From: **3**
Clock To: **5**
1st Value:
2nd Value:
Value Percent: **10.000**
Continuous Index:
Within 8" of Joint: **NO**
Remarks:

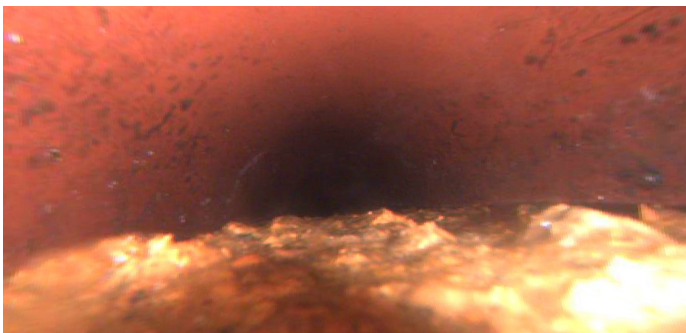
Code: **MWL**
Description: **Water Level**

Distance (ft): **19.7**
Structural Grade: **0**
O&M Grade: **0**
Clock Start/From:
Clock To:
1st Value:
2nd Value:
Value Percent: **25.000**
Continuous Index:
Within 8" of Joint: **NO**
Remarks: **heavy debris**

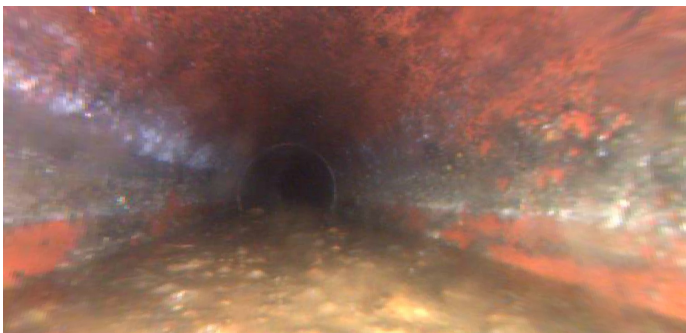
Code: **MGO**
Description: **General Observation**

Distance (ft): **23.8**
Structural Grade: **0**
O&M Grade: **0**
Clock Start/From:
Clock To:
1st Value:
2nd Value:
Value Percent:
Continuous Index:
Within 8" of Joint: **NO**
Remarks: **rear camera/lense covered**
