## Profile/Photo Observation Report

Street:	<b>E 38th Ave</b>	Flow Control:	<b>Not Controlled</b>
City:	<b>Hobart, IN</b>	Year Renewed:	
Location:	<b>Other</b>	Tape/Media #:	
Purpose:	<b>Not Known</b>	Dia/Height:	<b>10"</b>
Use:	<b>Sanitary</b>	Material:	<b>PVC</b>
Drain Area:	<b>NA</b>	Lining:	
Category:	<b>NA</b>		
Comment:	<b>6 inch</b>

Location Details:		Direction of Survey:	<b>Upstream</b>
US MH:	<b>M-203-054</b>	DS MH:	<b>M-203-053</b>
		Total Length Surveyed (ft):	<b>36.9</b>

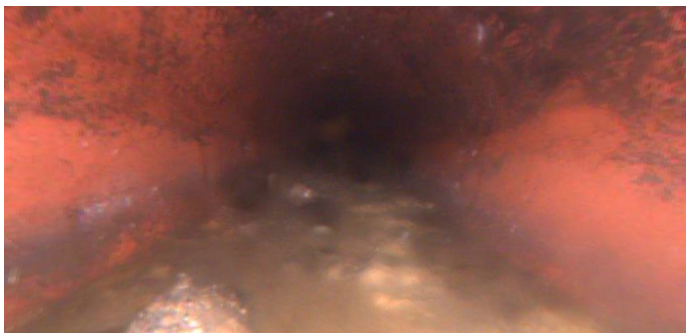
Code: **AMH**  
Description: **Manhole**

Distance (ft): **.0**  
Structural Grade: **0**  
O&M Grade: **0**  
Clock Start/From:  
Clock To:  
1st Value:  
2nd Value:  
Value Percent:  
Continuous Index:  
Within 8" of Joint: **NO**  
Remarks: **M-203-053**

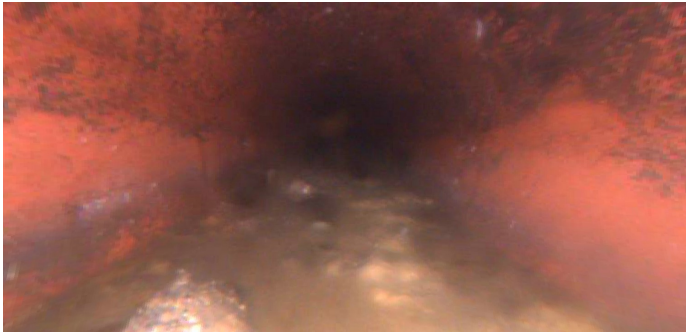
Code:	<b>MWL</b>
Description:	<b>Water Level</b>

Distance (ft):	<b>.0</b>
Structural Grade:	<b>0</b>
O&M Grade:	<b>0</b>
Clock Start/From:	
Clock To:	
1st Value:	
2nd Value:	
Value Percent:	<b>5.000</b>
Continuous Index:	
Within 8" of Joint:	<b>NO</b>
Remarks:

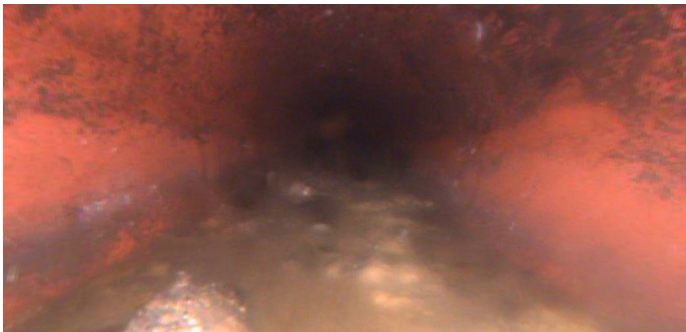
Code:	<b>DSZ</b>
Description:	<b>Deposits Settled Other</b>

Distance (ft):	<b>.0</b>
Structural Grade:	<b>0</b>
O&M Grade:	<b>2</b>
Clock Start/From:	<b>6</b>
Clock To:	
1st Value:	
2nd Value:	
Value Percent:	<b>10.000</b>
Continuous Index:	<b>S01</b>
Within 8" of Joint:	<b>NO</b>
Remarks:	<b>debris</b>

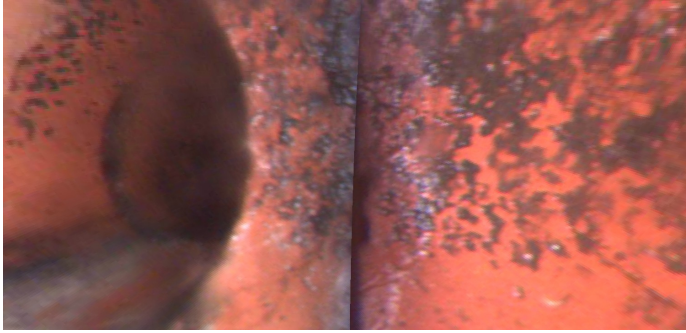
Code: **TF**  
Description: **Tap Factory**

Distance (ft): **5.9**  
Structural Grade: **0**  
O&M Grade: **0**  
Clock Start/From: **10**  
Clock To:  
1st Value: **4.000**  
2nd Value:  
Value Percent:  
Continuous Index:  
Within 8" of Joint: **YES**  
Remarks:

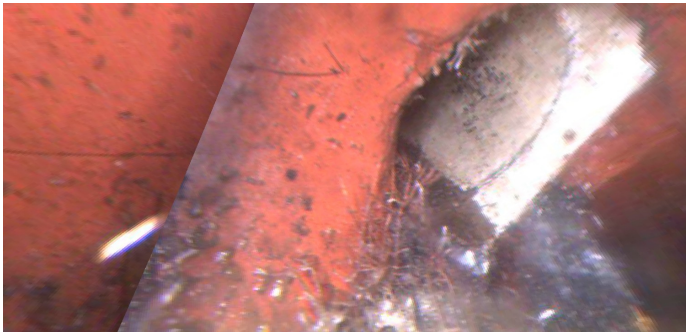
Code: **TF**  
Description: **Tap Factory**

Distance (ft): **19.7**  
Structural Grade: **0**  
O&M Grade: **0**  
Clock Start/From: **2**  
Clock To:  
1st Value: **4.000**  
2nd Value:  
Value Percent:  
Continuous Index:  
Within 8" of Joint: **YES**  
Remarks:

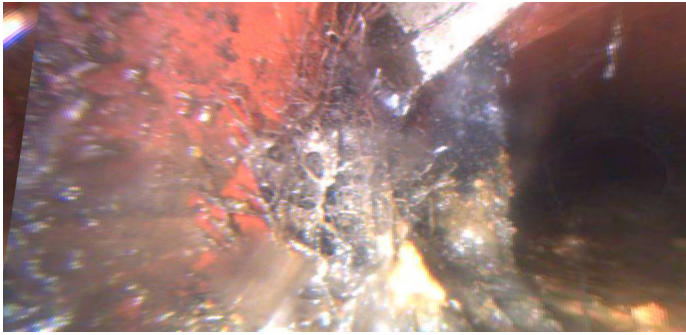
Code: **RML**  
Description: **Roots Medium Lateral**

Distance (ft): **19.7**  
Structural Grade: **0**  
O&M Grade: **3**  
Clock Start/From: **3**  
Clock To: **5**  
1st Value:  
2nd Value:  
Value Percent: **10.000**  
Continuous Index:  
Within 8" of Joint: **NO**  
Remarks:

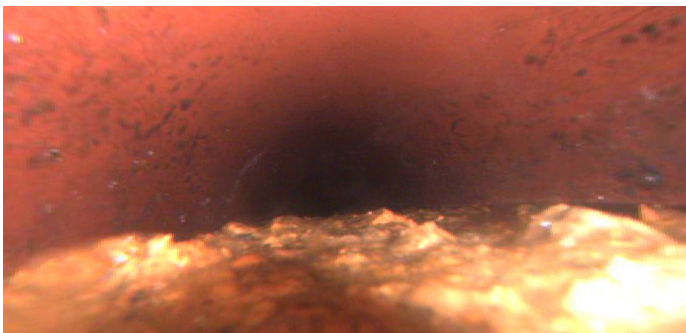
Code: **MWL**  
Description: **Water Level**

Distance (ft): **19.7**  
Structural Grade: **0**  
O&M Grade: **0**  
Clock Start/From:  
Clock To:  
1st Value:  
2nd Value:  
Value Percent: **25.000**  
Continuous Index:  
Within 8" of Joint: **NO**  
Remarks: **heavy debris**

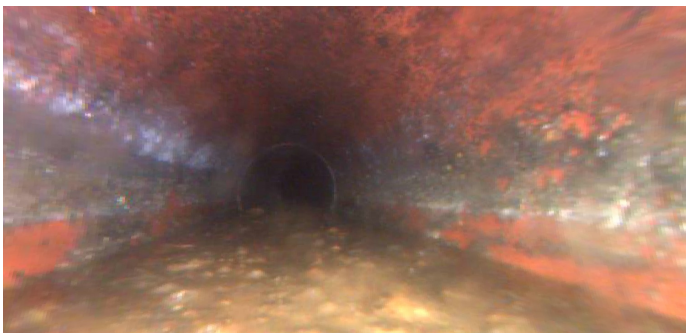
Code: **MGO**  
Description: **General Observation**

Distance (ft): **23.8**  
Structural Grade: **0**  
O&M Grade: **0**  
Clock Start/From:  
Clock To:  
1st Value:  
2nd Value:  
Value Percent:  
Continuous Index:  
Within 8" of Joint: **NO**  
Remarks: **rear camera/lense covered**

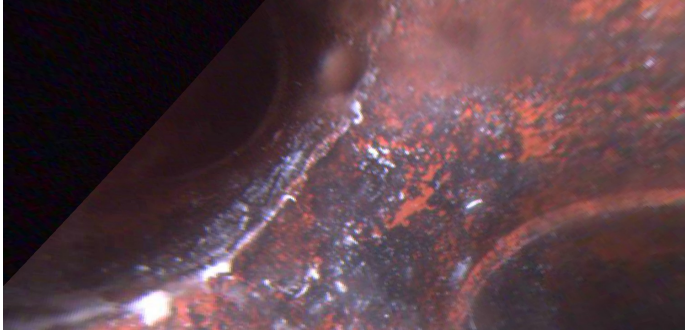
Code: **TF**  
Description: **Tap Factory**

Distance (ft): **27.2**  
Structural Grade: **0**  
O&M Grade: **0**  
Clock Start/From: **2**  
Clock To:  
1st Value: **4.000**  
2nd Value:  
Value Percent:  
Continuous Index:  
Within 8" of Joint:  
Remarks:
