## Profile/Photo Observation Report

Date:	<b>03/24/2018</b>	Weather:		Coding:	<b>PACP 6.0</b>
Pipe Length (ft):	<b>232.8</b>	Owner:	<b>NA</b>	Pre Clean:	<b>Not Known</b>
P.O.#:		Surveyor:	<b>Byrd Fitzgerald</b>	PSR:	<b>P-203-058-056</b>
Customer:		Clean Date:	<b>01/01/1900</b>	Shape:	<b>C</b>

Street:	<b>ALLEY BETWEEN SANDUSKY ST &amp; EV</b>	Flow Control:	<b>Not Controlled</b>
City:	<b>Hobart, IN</b>	Year Renewed:	
Location:	<b>Other</b>	Tape/Media #:	
Purpose:	<b>Not Known</b>	Dia/Height:	<b>10"</b>
Use:	<b>Sanitary</b>	Material:	<b>VCP</b>
Drain Area:	<b>NA</b>	Lining:	
Category:	<b>NA</b>		
Comment:	<b>Graveled over</b>

Location Details:		Direction of Survey:	<b>Upstream</b>
US MH:	<b>M-203-056</b>	DS MH:	<b>M-203-058</b>
		Total Length Surveyed (ft):	<b>61.9</b>

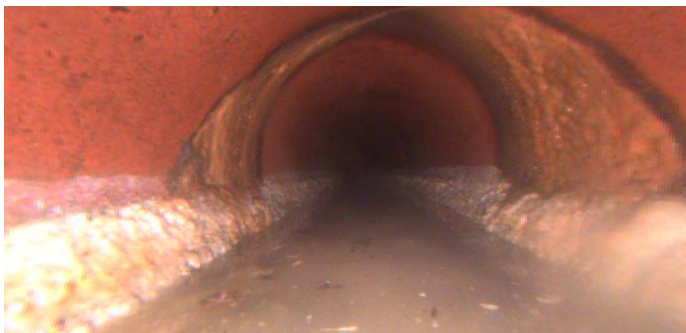
Code: **AMH**  
Description: **Manhole**

Distance (ft): **.0**  
Structural Grade: **0**  
O&M Grade: **0**  
Clock Start/From:  
Clock To:  
1st Value:  
2nd Value:  
Value Percent:  
Continuous Index:  
Within 8" of Joint: **NO**  
Remarks: **M-203-058**

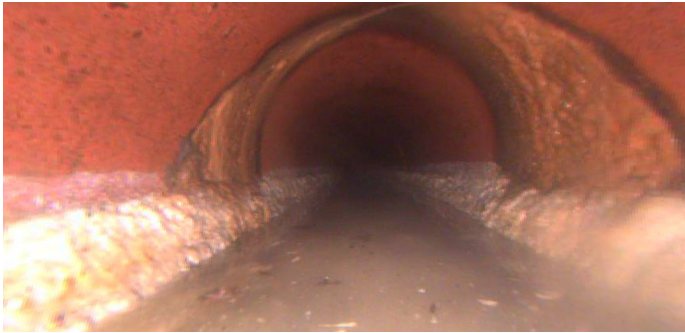
Code:	<b>MWL</b>
Description:	<b>Water Level</b>

Distance (ft):	<b>.0</b>
Structural Grade:	<b>0</b>
O&M Grade:	<b>0</b>
Clock Start/From:	
Clock To:	
1st Value:	
2nd Value:	
Value Percent:	<b>5.000</b>
Continuous Index:	
Within 8" of Joint:	<b>NO</b>
Remarks:

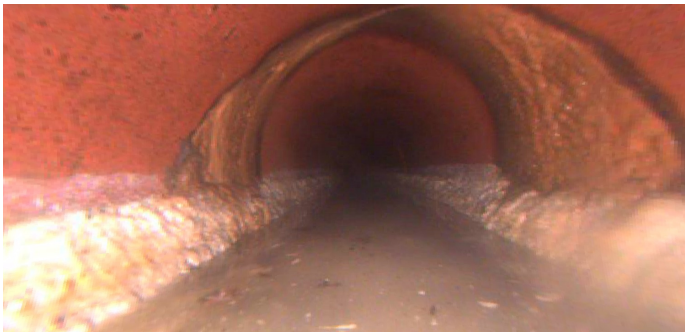
Code:	<b>DAGS</b>
Description:	<b>Deposits Attached Grease</b>

Distance (ft):	<b>.0</b>
Structural Grade:	<b>0</b>
O&M Grade:	<b>2</b>
Clock Start/From:	<b>7</b>
Clock To:	<b>5</b>
1st Value:	
2nd Value:	
Value Percent:	<b>5.000</b>
Continuous Index:	<b>S01</b>
Within 8" of Joint:	<b>NO</b>
Remarks:	<b>8 and 4 oclock</b>

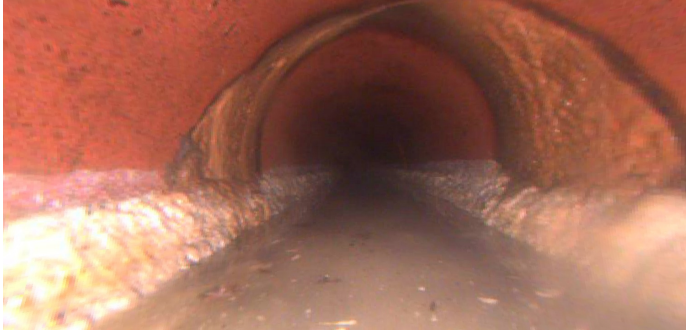
Code: **DAE**  
Description: **Deposits Attached Encrustation**

Distance (ft): **.0**  
Structural Grade: **0**  
O&M Grade: **2**  
Clock Start/From: **8**  
Clock To: **4**  
1st Value:  
2nd Value:  
Value Percent: **5.000**  
Continuous Index:  
Within 8" of Joint: **YES**  
Remarks:

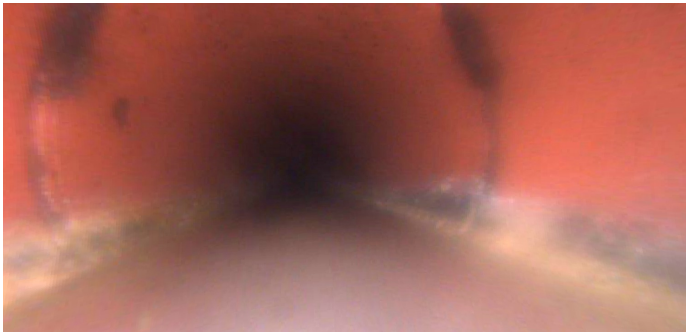
Code: **MGO**  
Description: **General Observation**

Distance (ft): **13.2**  
Structural Grade: **0**  
O&M Grade: **0**  
Clock Start/From:  
Clock To:  
1st Value:  
2nd Value:  
Value Percent:  
Continuous Index:  
Within 8" of Joint: **NO**  
Remarks: **steam**

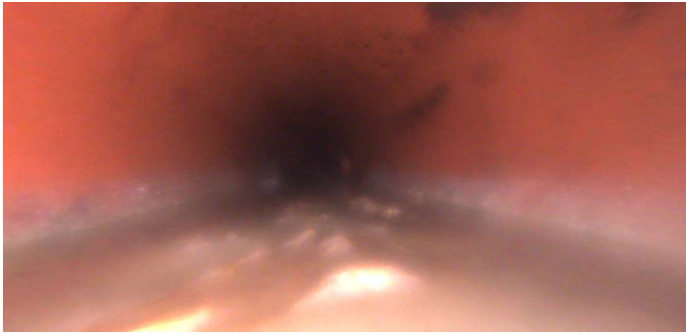
Code: **DSZ**  
Description: **Deposits Settled Other**

Distance (ft): **21.4**  
Structural Grade: **0**  
O&M Grade: **2**  
Clock Start/From: **6**  
Clock To:  
1st Value:  
2nd Value:  
Value Percent: **5.000**  
Continuous Index: **S02**  
Within 8" of Joint: **NO**  
Remarks: **tissue/debris**

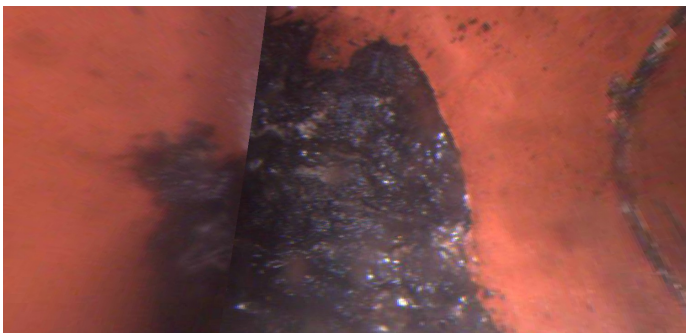
Code: **TFD**  
Description: **Tap Factory Defective**

Distance (ft): **24.7**  
Structural Grade: **0**  
O&M Grade: **2**  
Clock Start/From: **2**  
Clock To:  
1st Value: **4.000**  
2nd Value:  
Value Percent:  
Continuous Index:  
Within 8" of Joint: **YES**  
Remarks: **total blockage**

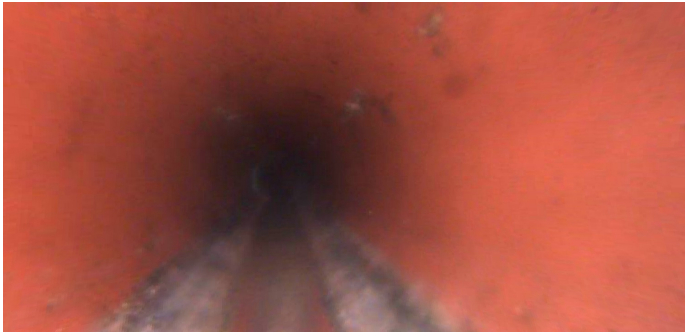
Code: **DAGS**  
Description: **Deposits Attached Grease**

Distance (ft): **28.2**  
Structural Grade: **0**  
O&M Grade: **2**  
Clock Start/From: **7**  
Clock To: **5**  
1st Value:  
2nd Value:  
Value Percent: **5.000**  
Continuous Index: **F01**  
Within 8" of Joint: **NO**  
Remarks: **8 and 4 oclock**

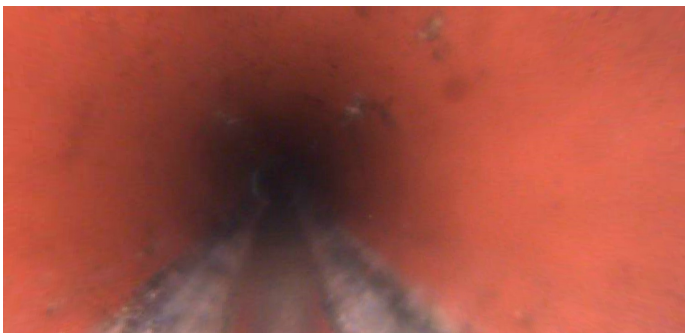
Code: **DSZ**  
Description: **Deposits Settled Other**

Distance (ft): **28.2**  
Structural Grade: **0**  
O&M Grade: **2**  
Clock Start/From: **6**  
Clock To:  
1st Value:  
2nd Value:  
Value Percent: **5.000**  
Continuous Index: **F02**  
Within 8" of Joint: **NO**  
Remarks: **tissue/debris**

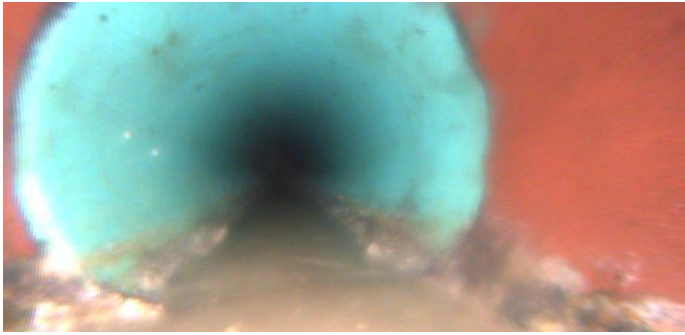
Code: **MMC**  
Description: **Material Change**

Distance (ft): **32.3**  
Structural Grade: **0**  
O&M Grade: **0**  
Clock Start/From:  
Clock To:  
1st Value:  
2nd Value:  
Value Percent:  
Continuous Index:  
Within 8" of Joint: **NO**  
Remarks: **pvc**

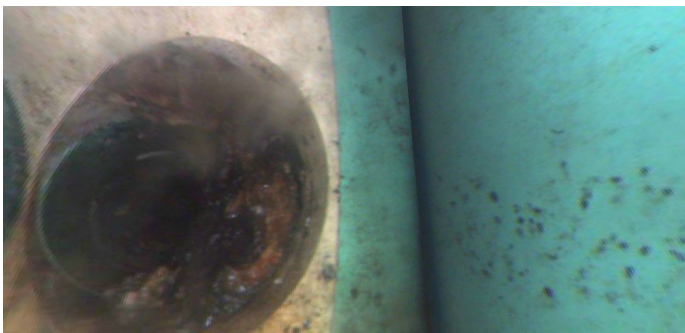
Code: **TF**  
Description: **Tap Factory**

Distance (ft): **42.7**  
Structural Grade: **0**  
O&M Grade: **0**  
Clock Start/From: **10**  
Clock To:  
1st Value: **4.000**  
2nd Value:  
Value Percent:  
Continuous Index:  
Within 8" of Joint: **YES**  
Remarks:

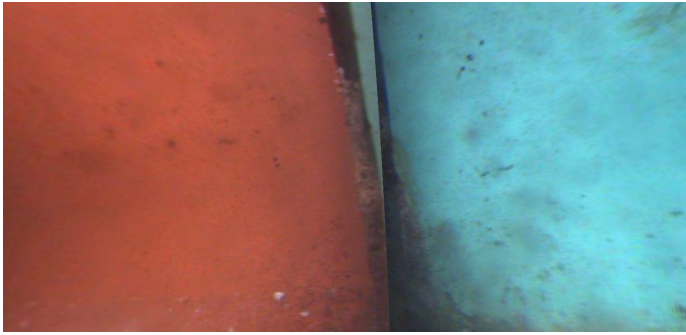
Code: **MMC**  
Description: **Material Change**

Distance (ft): **45.5**  
Structural Grade: **0**  
O&M Grade: **0**  
Clock Start/From:  
Clock To:  
1st Value:  
2nd Value:  
Value Percent:  
Continuous Index:  
Within 8" of Joint: **NO**  
Remarks: **vcp**

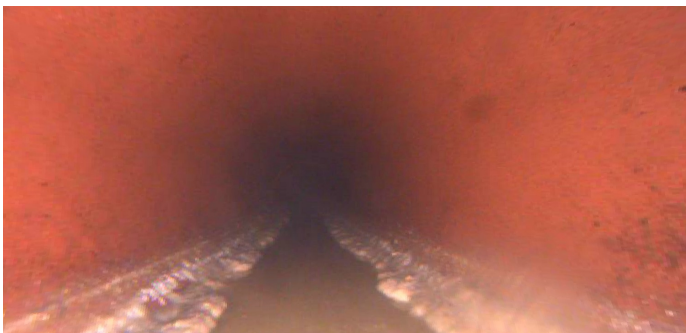
Code: **MSA**  
Description: **Abandoned Survey**

Distance (ft): **61.9**  
Structural Grade: **0**  
O&M Grade: **0**  
Clock Start/From:  
Clock To:  
1st Value:  
2nd Value:  
Value Percent:  
Continuous Index:  
Within 8" of Joint: **NO**  
Remarks: **no blockage**
