Profile/Photo Observation Report

Street:	E 38th Ave	Flow Control:	Not Controlled
City:	Hobart, IN	Year Renewed:	
Location:	Other	Tape/Media #:	
Purpose:	Not Known	Dia/Height:	10"
Use:	Sanitary	Material:	VCP
Drain Area:	NA	Lining:	
Category:	NA		
Comment:	Graveled over

Location Details:		Direction of Survey:	Upstream
US MH:	M-203-056	DS MH:	M-203-058
		Total Length Surveyed (ft):	61.9

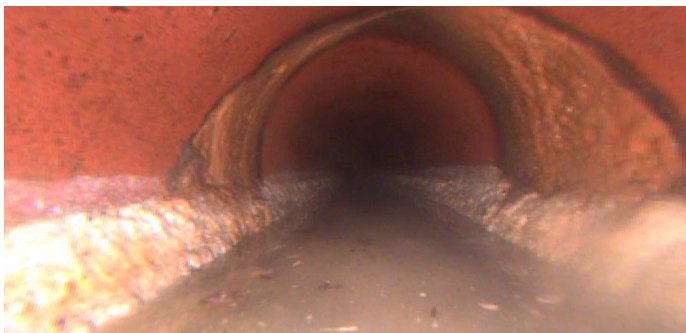
Code: **AMH**
Description: **Manhole**

Distance (ft): **.0**
Structural Grade: **0**
O&M Grade: **0**
Clock Start/From:
Clock To:
1st Value:
2nd Value:
Value Percent:
Continuous Index:
Within 8" of Joint: **NO**
Remarks: **M-203-058**

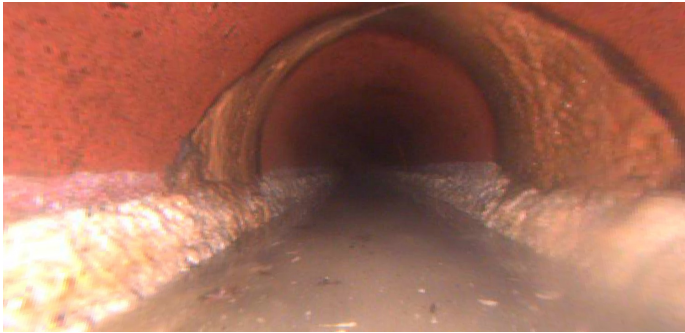
Code:	MWL
Description:	Water Level

Distance (ft):	.0
Structural Grade:	0
O&M Grade:	0
Clock Start/From:	
Clock To:	
1st Value:	
2nd Value:	
Value Percent:	5.000
Continuous Index:	
Within 8" of Joint:	NO
Remarks:

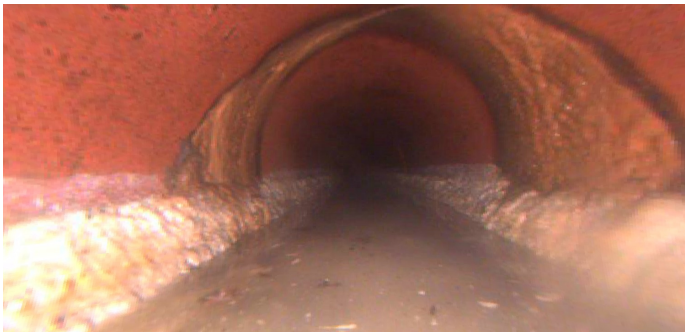
Code:	DAGS
Description:	Deposits Attached Grease

Distance (ft):	.0
Structural Grade:	0
O&M Grade:	2
Clock Start/From:	7
Clock To:	5
1st Value:	
2nd Value:	
Value Percent:	5.000
Continuous Index:	S01
Within 8" of Joint:	NO
Remarks:	8 and 4 oclock

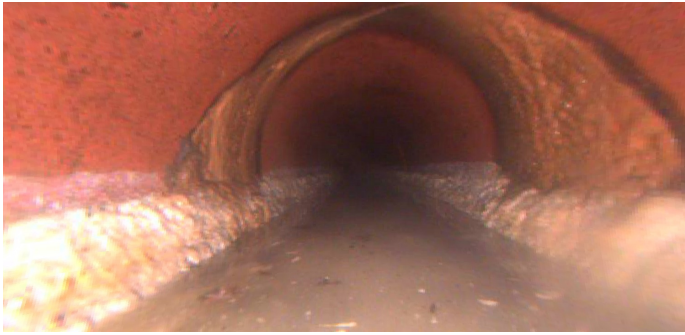
Code: **DAE**
Description: **Deposits Attached Encrustation**

Distance (ft): **.0**
Structural Grade: **0**
O&M Grade: **2**
Clock Start/From: **8**
Clock To: **4**
1st Value:
2nd Value:
Value Percent: **5.000**
Continuous Index:
Within 8" of Joint: **YES**
Remarks:

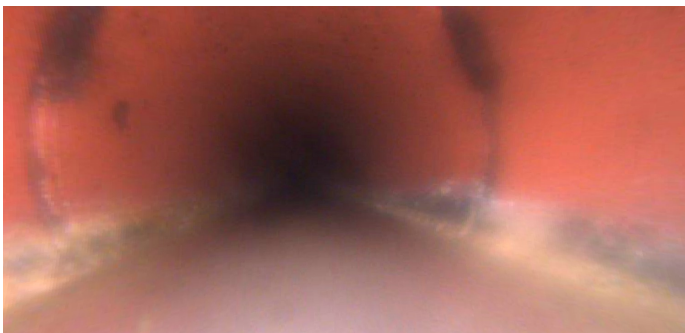
Code: **MGO**
Description: **General Observation**

Distance (ft): **13.2**
Structural Grade: **0**
O&M Grade: **0**
Clock Start/From:
Clock To:
1st Value:
2nd Value:
Value Percent:
Continuous Index:
Within 8" of Joint: **NO**
Remarks: **steam**

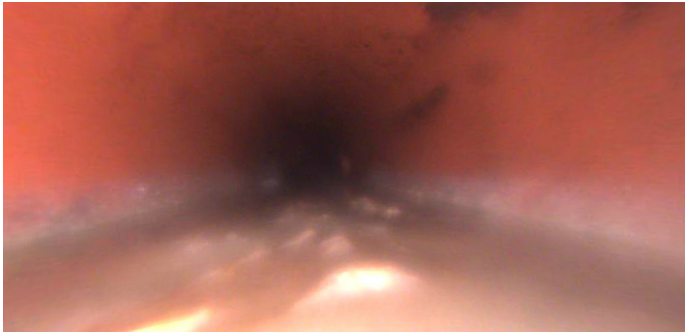
Code: **DSZ**
Description: **Deposits Settled Other**

Distance (ft): **21.4**
Structural Grade: **0**
O&M Grade: **2**
Clock Start/From: **6**
Clock To:
1st Value:
2nd Value:
Value Percent: **5.000**
Continuous Index: **S02**
Within 8" of Joint: **NO**
Remarks: **tissue/debris**

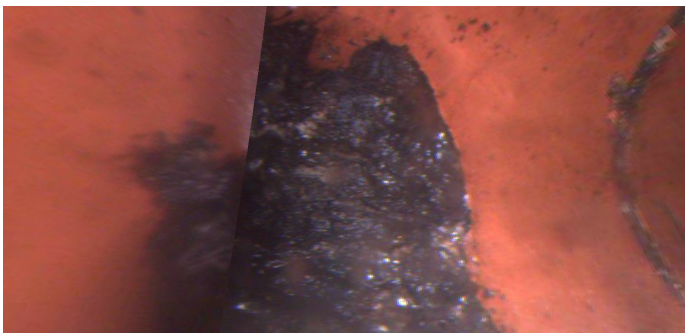
Code: **TFD**
Description: **Tap Factory Defective**

Distance (ft): **24.7**
Structural Grade: **0**
O&M Grade: **2**
Clock Start/From: **2**
Clock To:
1st Value: **4.000**
2nd Value:
Value Percent:
Continuous Index:
Within 8" of Joint: **YES**
Remarks: **total blockage**

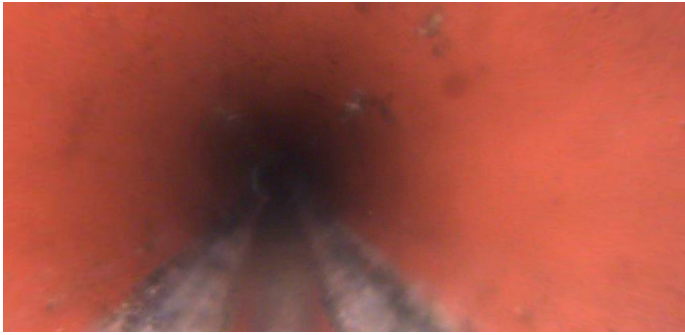
Code: **DAGS**
Description: **Deposits Attached Grease**

Distance (ft): **28.2**
Structural Grade: **0**
O&M Grade: **2**
Clock Start/From: **7**
Clock To: **5**
1st Value:
2nd Value:
Value Percent: **5.000**
Continuous Index: **F01**
Within 8" of Joint: **NO**
Remarks: **8 and 4 oclock**

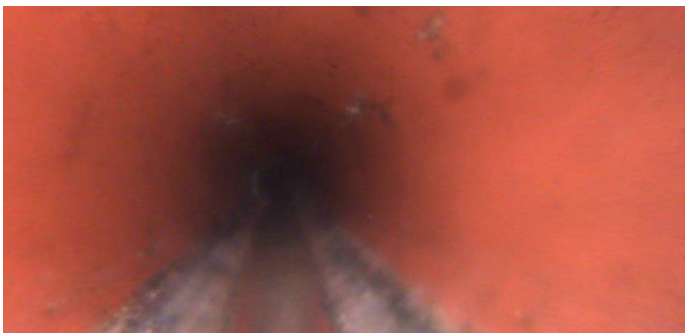
Code: **DSZ**
Description: **Deposits Settled Other**

Distance (ft): **28.2**
Structural Grade: **0**
O&M Grade: **2**
Clock Start/From: **6**
Clock To:
1st Value:
2nd Value:
Value Percent: **5.000**
Continuous Index: **F02**
Within 8" of Joint: **NO**
Remarks: **tissue/debris**

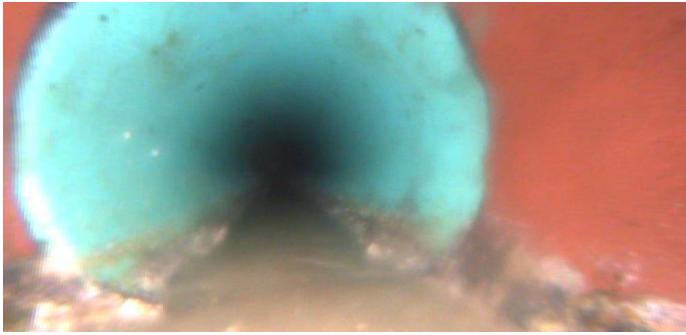
Code: **MMC**
Description: **Material Change**

Distance (ft): **32.3**
Structural Grade: **0**
O&M Grade: **0**
Clock Start/From:
Clock To:
1st Value:
2nd Value:
Value Percent:
Continuous Index:
Within 8" of Joint: **NO**
Remarks: **pvc**

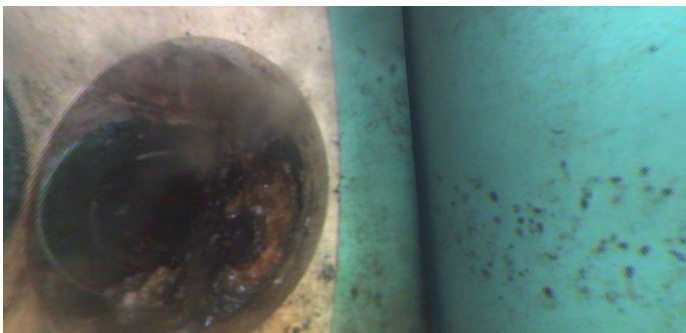
Code: **TF**
Description: **Tap Factory**

Distance (ft): **42.7**
Structural Grade: **0**
O&M Grade: **0**
Clock Start/From: **10**
Clock To:
1st Value: **4.000**
2nd Value:
Value Percent:
Continuous Index:
Within 8" of Joint: **YES**
Remarks:

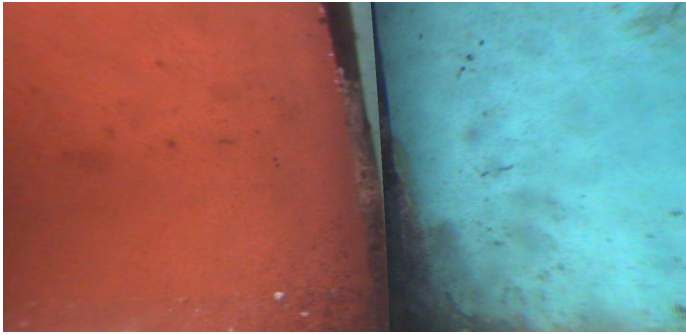
Code: **MMC**
Description: **Material Change**

Distance (ft): **45.5**
Structural Grade: **0**
O&M Grade: **0**
Clock Start/From:
Clock To:
1st Value:
2nd Value:
Value Percent:
Continuous Index:
Within 8" of Joint: **NO**
Remarks: **vcp**

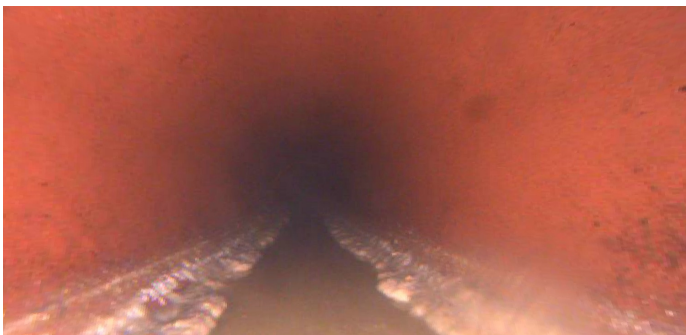
Code: **MSA**
Description: **Abandoned Survey**

Distance (ft): **61.9**
Structural Grade: **0**
O&M Grade: **0**
Clock Start/From:
Clock To:
1st Value:
2nd Value:
Value Percent:
Continuous Index:
Within 8" of Joint: **NO**
Remarks: **no blockage**
