Profile/Photo Observation Report

Date:	03/24/2018	Weather:		Coding:	PACP 6.0
Pipe Length (ft):	232.8	Owner:	NA	Pre Clean:	Not Known
P.O.#:		Surveyor:	Justin Gonzales	PSR:	P-203-058-056
Customer:		Clean Date:	01/01/1900	Shape:	C

Street:	ALLEY BETWEEN SANDUSKY ST & EV	Flow Control:	Not Controlled
City:	Hobart, IN	Year Renewed:	
Location:	Other	Tape/Media #:	
Purpose:	Not Known	Dia/Height:	10"
Use:	Sanitary	Material:	PVC
Drain Area:	NA	Lining:	
Category:	NA		
Comment:	Graveled over

Location Details:		Direction of Survey:	Downstream
US MH:	M-203-056	DS MH:	M-203-058
		Total Length Surveyed (ft):	126.1

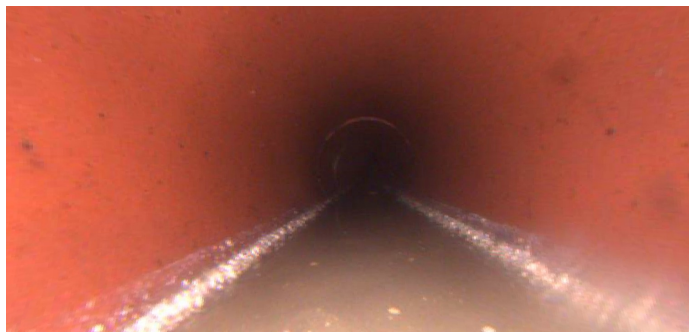
Code: **AMH**
 Description: **Manhole**

Distance (ft): **.0**
 Structural Grade: **0**
 O&M Grade: **0**
 Clock Start/From:
 Clock To:
 1st Value:
 2nd Value:
 Value Percent:
 Continuous Index:
 Within 8" of Joint: **NO**
 Remarks: **M-203-056**

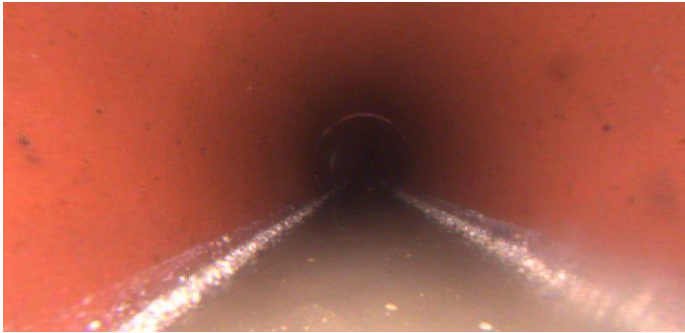
Code:	MWL
Description:	Water Level

Distance (ft):	.0
Structural Grade:	0
O&M Grade:	0
Clock Start/From:	
Clock To:	
1st Value:	
2nd Value:	
Value Percent:	10.000
Continuous Index:	
Within 8" of Joint:	NO
Remarks:

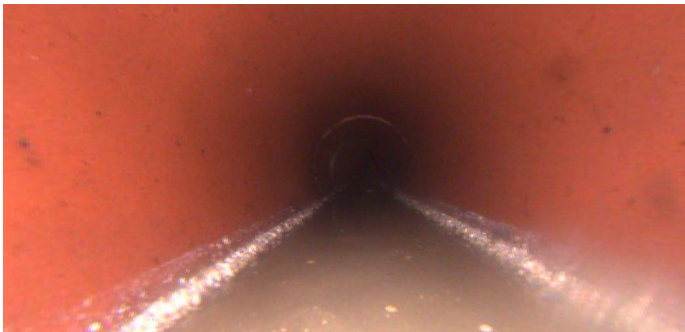
Code:	DAGS
Description:	Deposits Attached Grease

Distance (ft):	.0
Structural Grade:	0
O&M Grade:	2
Clock Start/From:	7
Clock To:	5
1st Value:	
2nd Value:	
Value Percent:	5.000
Continuous Index:	S01
Within 8" of Joint:	YES
Remarks:	WANDER

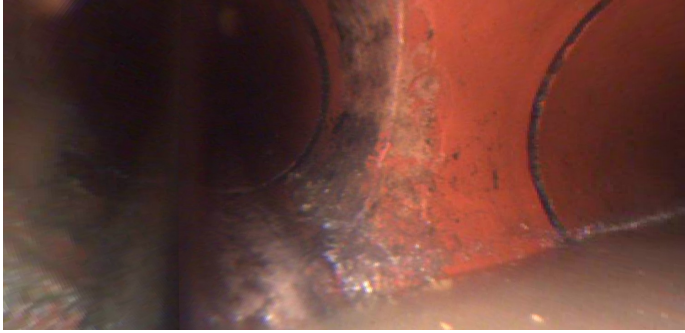
Code: **TF**
Description: **Tap Factory**

Distance (ft): **4.1**
Structural Grade: **0**
O&M Grade: **0**
Clock Start/From: **9**
Clock To:
1st Value: **4.000**
2nd Value:
Value Percent:
Continuous Index:
Within 8" of Joint:
Remarks:

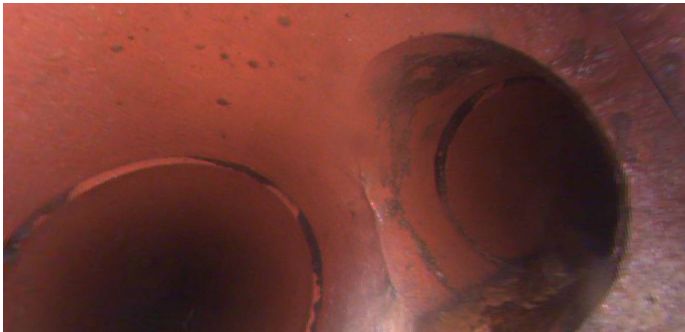
Code: **TF**
Description: **Tap Factory**

Distance (ft): **26.3**
Structural Grade: **0**
O&M Grade: **0**
Clock Start/From: **2**
Clock To:
1st Value: **4.000**
2nd Value:
Value Percent:
Continuous Index:
Within 8" of Joint:
Remarks:

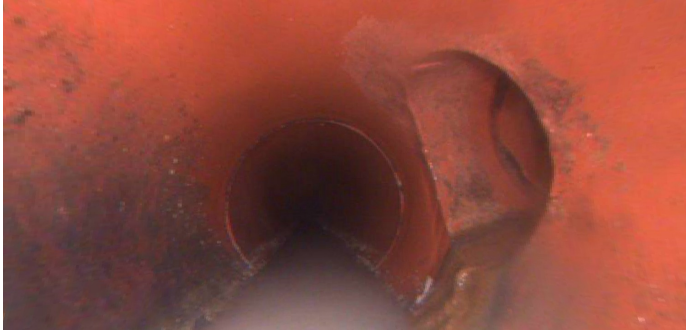
Code: **TF**
Description: **Tap Factory**

Distance (ft): **68.5**
Structural Grade: **0**
O&M Grade: **0**
Clock Start/From: **3**
Clock To:
1st Value: **4.000**
2nd Value:
Value Percent:
Continuous Index:
Within 8" of Joint:
Remarks:

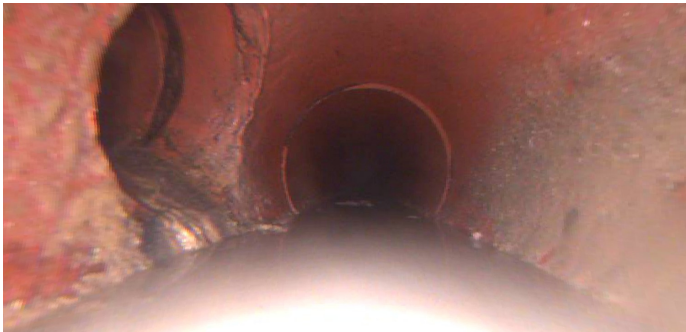
Code: **TF**
Description: **Tap Factory**

Distance (ft): **90.5**
Structural Grade: **0**
O&M Grade: **0**
Clock Start/From: **9**
Clock To:
1st Value: **4.000**
2nd Value:
Value Percent:
Continuous Index:
Within 8" of Joint:
Remarks:

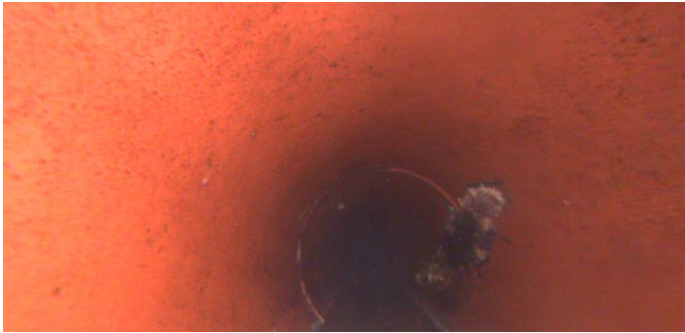
Code: **MSA**
Description: **Abandoned Survey**

Distance (ft): **126.1**
Structural Grade: **0**
O&M Grade: **0**
Clock Start/From:
Clock To:
1st Value:
2nd Value:
Value Percent:
Continuous Index:
Within 8" of Joint: **NO**
Remarks: **ROBOT HAS STOPPED**

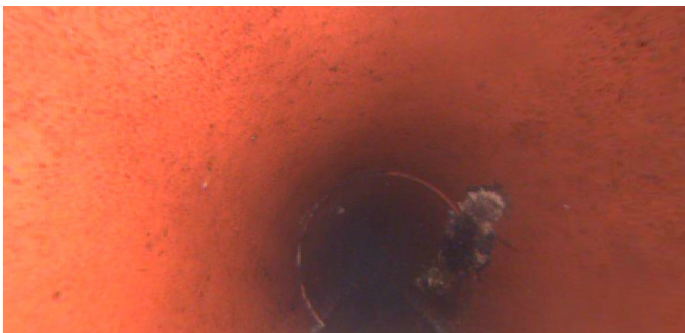
Code: **DAGS**
Description: **Deposits Attached Grease**

Distance (ft): **126.1**
Structural Grade: **0**
O&M Grade: **2**
Clock Start/From: **7**
Clock To: **5**
1st Value:
2nd Value:
Value Percent: **5.000**
Continuous Index: **F01**
Within 8" of Joint: **YES**
Remarks: **WANDER**
