Profile/Photo Observation Report

Date:	04/24/2018	Weather:		Coding:	PACP 6.0
Pipe Length (ft):		Owner:	City of Hobart	Pre Clean:	No Pre-Cleaning
P.O.#:	69	Surveyor:	M. Pielacha	PSR:	P-203-059-058
Customer:	City of Hobart	Clean Date:		Shape:	C

Street:	Off 37th	Flow Control:	Not Controlled
City:	Hobart, IN	Year Renewed:	
Location:	Alley	Tape/Media #:	DEP 69
Purpose:	Routine Assessment	Dia/Height:	6"
Use:	Sanitary	Material:	VCP
Drain Area:		Lining:	
Category:	NA		
Comment:	YES501824 Submittal 2		
Location Details:		Direction of Survey:	Upstream
US MH:	M-203-059	DS MH:	M-203-058
		Total Length Surveyed (ft):	33.7

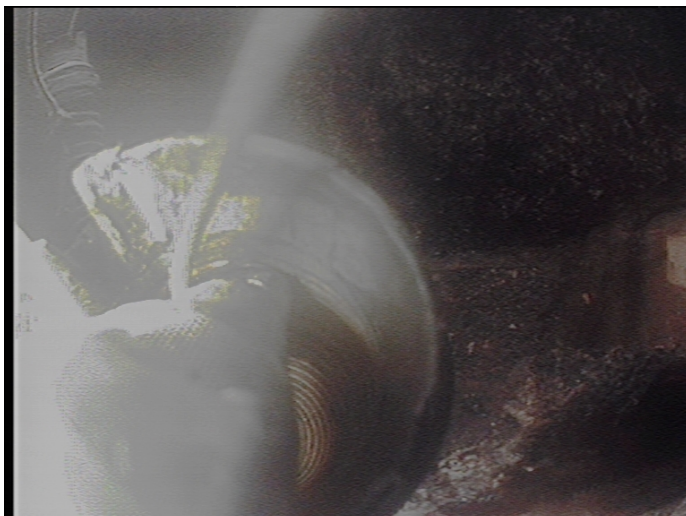
Code: **AMH**
 Description: **Manhole**

Distance (ft): **.0**
 Structural Grade: **0**
 O&M Grade: **0**
 Clock Start/From:
 Clock To:
 1st Value:
 2nd Value:
 Value Percent:
 Continuous Index:
 Within 8" of Joint: **NO**
 Remarks: **M-203-058**

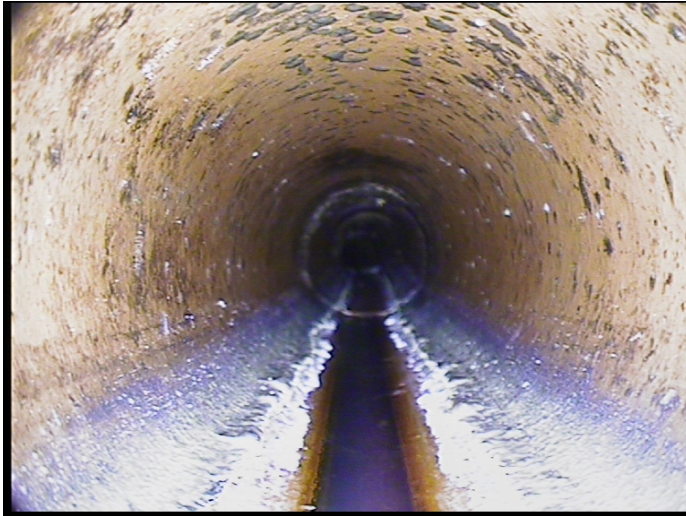
Code: **MWL**
Description: **Water Level**

Distance (ft): **.0**
Structural Grade: **0**
O&M Grade: **0**
Clock Start/From:
Clock To:
1st Value:
2nd Value:
Value Percent: **5.000**
Continuous Index:
Within 8" of Joint: **NO**
Remarks:

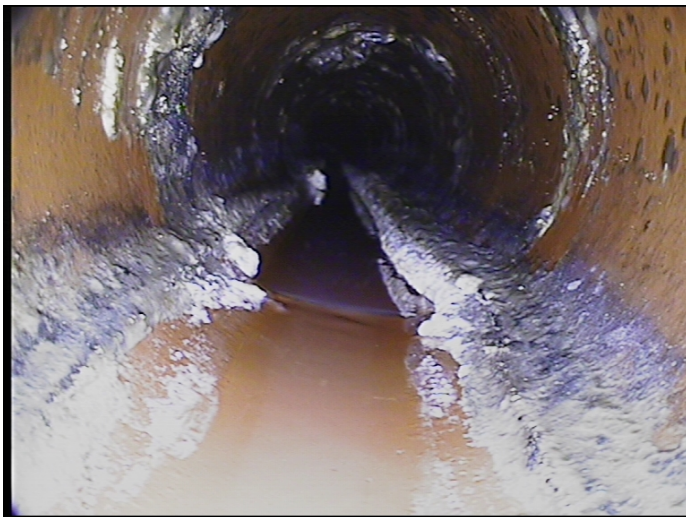
Code: **DAGS**
Description: **Deposits Attached Grease**

Distance (ft): **9.5**
Structural Grade: **0**
O&M Grade: **2**
Clock Start/From: **5**
Clock To: **7**
1st Value:
2nd Value:
Value Percent: **5.000**
Continuous Index: **S01**
Within 8" of Joint: **YES**
Remarks:

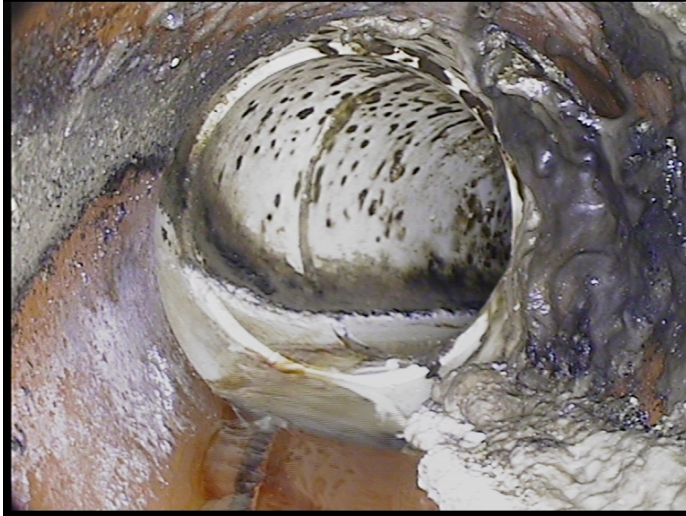
Code: **DAGS**
Description: **Deposits Attached Grease**

Distance (ft): **32.8**
Structural Grade: **0**
O&M Grade: **2**
Clock Start/From: **5**
Clock To: **7**
1st Value:
2nd Value:
Value Percent: **5.000**
Continuous Index: **F01**
Within 8" of Joint: **NO**
Remarks:

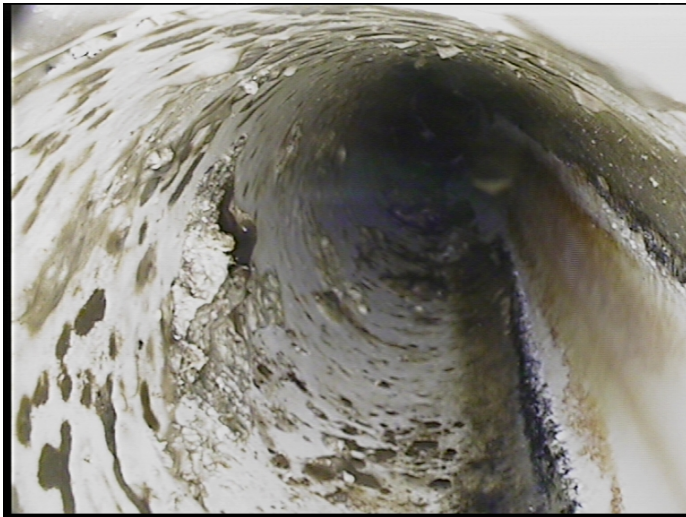
Code: **MMC**
Description: **Material Change**

Distance (ft): **33.1**
Structural Grade: **0**
O&M Grade: **0**
Clock Start/From:
Clock To:
1st Value:
2nd Value:
Value Percent:
Continuous Index:
Within 8" of Joint: **NO**
Remarks: **pvc**

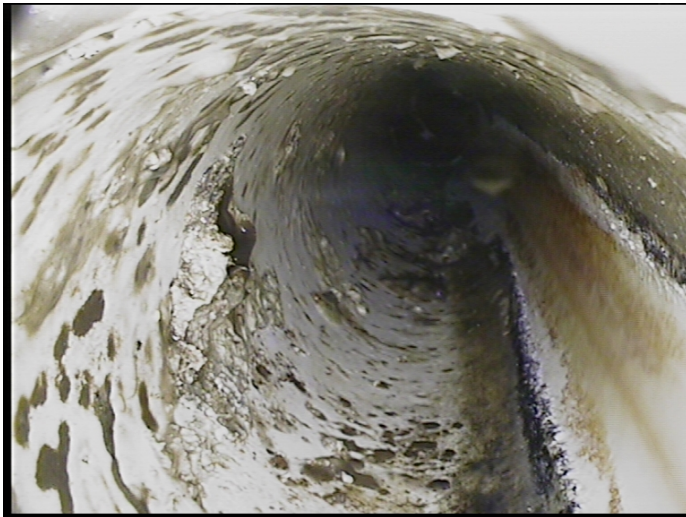
Code: **LR**
Description: **Alignment Right**

Distance (ft): **33.1**
Structural Grade: **0**
O&M Grade: **2**
Clock Start/From:
Clock To:
1st Value:
2nd Value:
Value Percent: **15.000**
Continuous Index:
Within 8" of Joint: **NO**
Remarks:

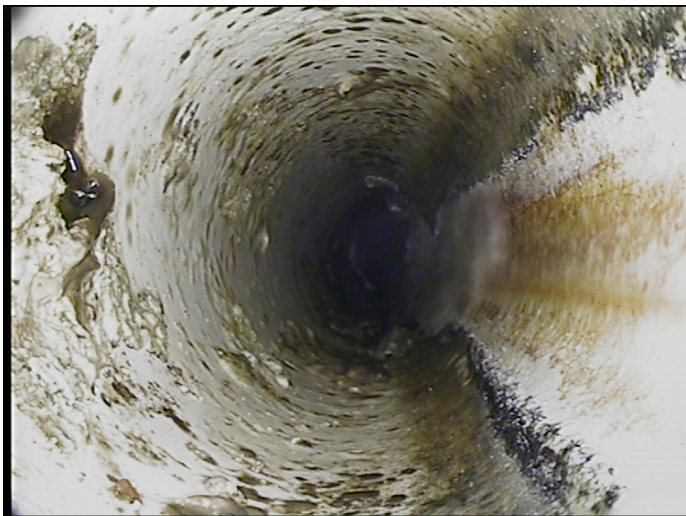
Code: **MSA**
Description: **Abandoned Survey**

Distance (ft): **33.7**
Structural Grade: **0**
O&M Grade: **0**
Clock Start/From:
Clock To:
1st Value:
2nd Value:
Value Percent:
Continuous Index:
Within 8" of Joint: **NO**
Remarks: **can not make bend**
