## Profile/Photo Observation Report

Street:	<b>E 38th Ave</b>	Flow Control:	<b>Not Controlled</b>
City:	<b>Hobart, IN</b>	Year Renewed:	
Location:	<b>Other</b>	Tape/Media #:	
Purpose:	<b>Not Known</b>	Dia/Height:	<b>12"</b>
Use:	<b>Sanitary</b>	Material:	<b>VCP</b>
Drain Area:	<b>NA</b>	Lining:	
Category:	<b>NA</b>		
Comment:

Location Details:		Direction of Survey:	<b>Downstream</b>
US MH:	<b>M-203-060</b>	DS MH:	<b>M-203-051</b>
		Total Length Surveyed (ft):	<b>10.5</b>

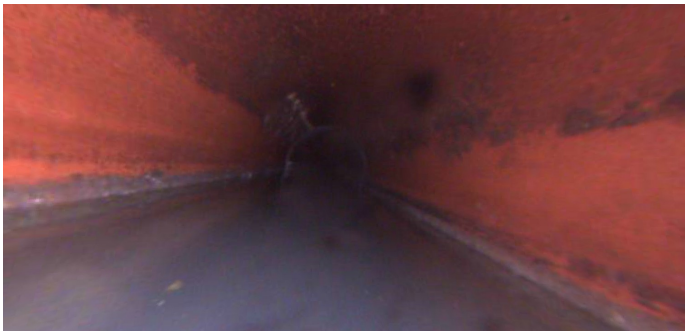
Code: **AMH**  
Description: **Manhole**

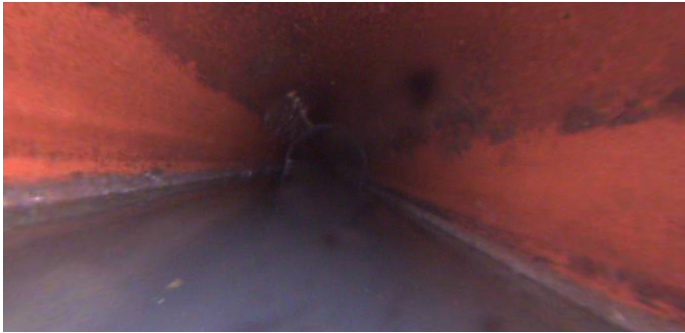
Code:	<b>MWL</b>
Description:	<b>Water Level</b>

Distance (ft):	<b>.0</b>
Structural Grade:	<b>0</b>
O&M Grade:	<b>0</b>
Clock Start/From:	
Clock To:	
1st Value:	
2nd Value:	
Value Percent:	<b>30.000</b>
Continuous Index:	
Within 8" of Joint:	<b>NO</b>
Remarks:

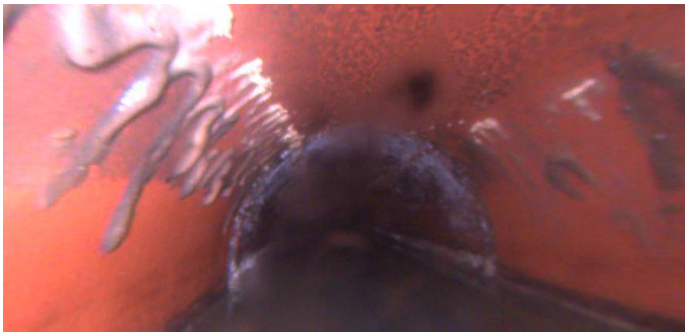
Code:	<b>DAGS</b>
Description:	<b>Deposits Attached Grease</b>

Distance (ft):	<b>3.5</b>
Structural Grade:	<b>0</b>
O&M Grade:	<b>2</b>
Clock Start/From:	<b>8</b>
Clock To:	<b>4</b>
1st Value:	
2nd Value:	
Value Percent:	<b>5.000</b>
Continuous Index:	
Within 8" of Joint:	<b>NO</b>
Remarks:

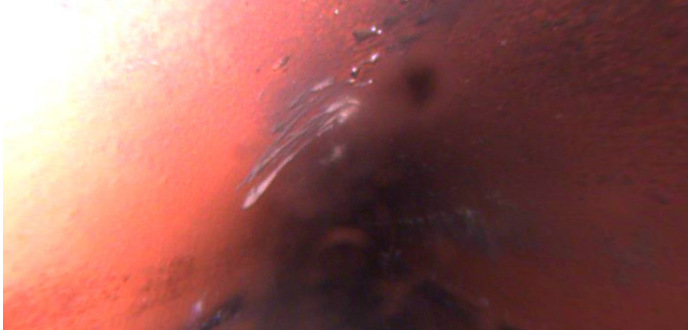
Code:	<b>MSA</b>
Description:	<b>Abandoned Survey</b>
Distance (ft):	<b>10.5</b>
Structural Grade:	<b>0</b>
O&M Grade:	<b>0</b>
Clock Start/From:	
Clock To:	
1st Value:	
2nd Value:	
Value Percent:	
Continuous Index:	
Within 8" of Joint:	<b>NO</b>
Remarks:	<b>UNKNOWN</b>
