## Profile/Photo Observation Report

Street:	<b>W 38TH AVE</b>	Flow Control:	<b>Not Controlled</b>
City:	<b>Hobart, IN</b>	Year Renewed:	
Location:	<b>Other</b>	Tape/Media #:	
Purpose:	<b>Not Known</b>	Dia/Height:	<b>12"</b>
Use:	<b>Sanitary</b>	Material:	<b>PVC</b>
Drain Area:	<b>NA</b>	Lining:	
Category:	<b>NA</b>		
Comment:

Location Details:		Direction of Survey:	<b>Downstream</b>
US MH:	<b>M-203-060</b>	DS MH:	<b>M-203-051</b>
		Total Length Surveyed (ft):	<b>261.7</b>

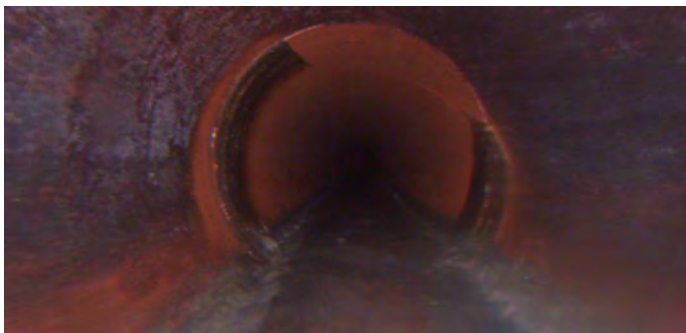
Code: **AMH**  
Description: **Manhole**

Distance (ft): **.0**  
Structural Grade: **0**  
O&M Grade: **0**  
Clock Start/From:  
Clock To:  
1st Value:  
2nd Value:  
Value Percent:  
Continuous Index:  
Within 8" of Joint: **NO**  
Remarks: **M-203-060**

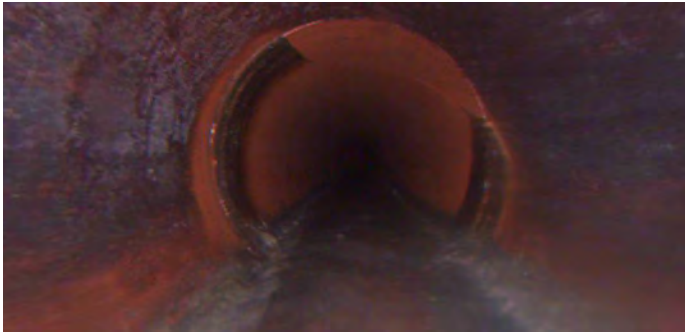
Code:	<b>MWL</b>
Description:	<b>Water Level</b>

Distance (ft):	<b>.0</b>
Structural Grade:	<b>0</b>
O&M Grade:	<b>0</b>
Clock Start/From:	
Clock To:	
1st Value:	
2nd Value:	
Value Percent:	<b>10.000</b>
Continuous Index:	
Within 8" of Joint:	<b>NO</b>
Remarks:

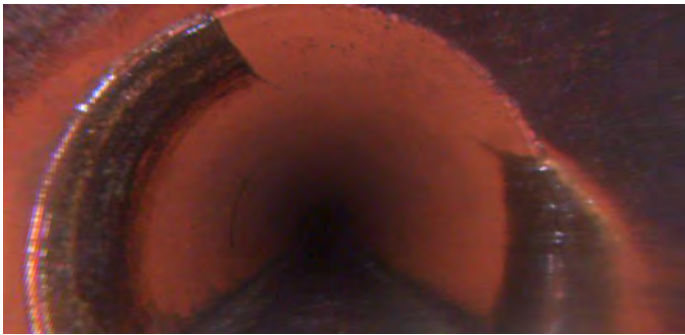
Code:	<b>CS</b>
Description:	<b>Crack Spiral</b>

Distance (ft):	<b>1.0</b>
Structural Grade:	<b>2</b>
O&M Grade:	<b>0</b>
Clock Start/From:	<b>11</b>
Clock To:	<b>3</b>
1st Value:	
2nd Value:	
Value Percent:	
Continuous Index:	
Within 8" of Joint:	<b>YES</b>
Remarks:

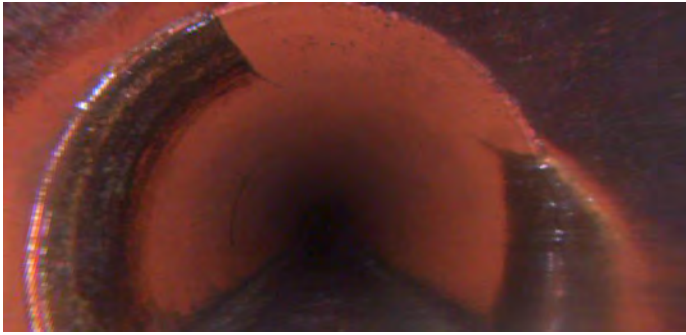
Code: **IS**  
Description: **Infil Stain**

Distance (ft): **1.0**  
Structural Grade: **0**  
O&M Grade: **0**  
Clock Start/From: **7**  
Clock To: **5**  
1st Value:  
2nd Value:  
Value Percent:  
Continuous Index:  
Within 8" of Joint: **YES**  
Remarks:

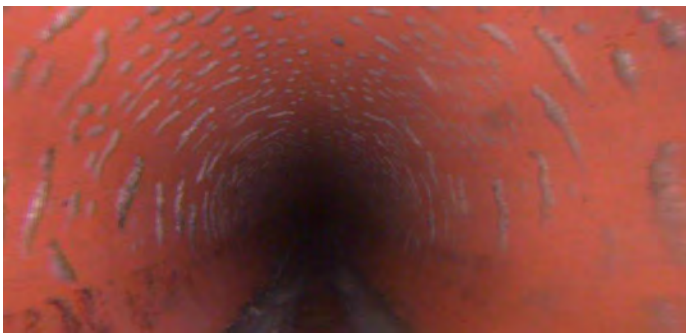
Code: **DAZ**  
Description: **Deposits Attached Other**

Distance (ft): **22.1**  
Structural Grade: **0**  
O&M Grade: **2**  
Clock Start/From: **7**  
Clock To: **5**  
1st Value:  
2nd Value:  
Value Percent: **5.000**  
Continuous Index: **S01**  
Within 8" of Joint: **YES**  
Remarks: **WANDER**

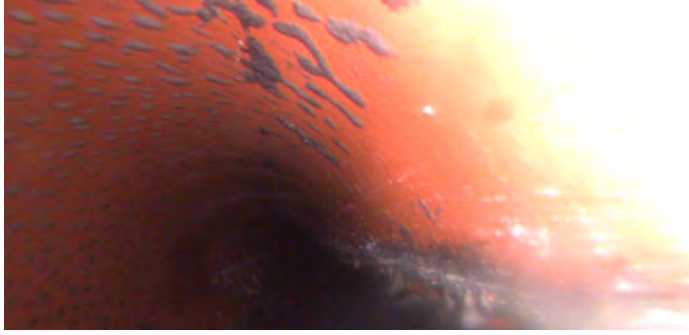
Code:	<b>MSA</b>
Description:	<b>Abandoned Survey</b>
Distance (ft):	<b>261.7</b>
Structural Grade:	<b>0</b>
O&M Grade:	<b>0</b>
Clock Start/From:	
Clock To:	
1st Value:	
2nd Value:	
Value Percent:	
Continuous Index:	
Within 8" of Joint:	<b>NO</b>
Remarks:	<b>ROBOT TURNED OVER</b>

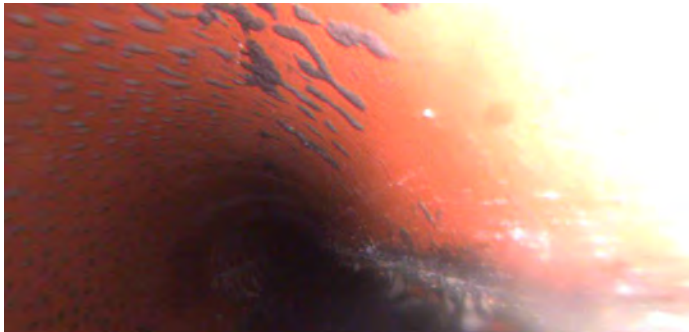
Code:	<b>DAZ</b>
Description:	<b>Deposits Attached Other</b>
Distance (ft):	<b>261.7</b>
Structural Grade:	<b>0</b>
O&M Grade:	<b>2</b>
Clock Start/From:	<b>7</b>
Clock To:	<b>5</b>
1st Value:	
2nd Value:	
Value Percent:	<b>5.000</b>
Continuous Index:	<b>F01</b>
Within 8" of Joint:	<b>YES</b>
Remarks:	<b>WANDER</b>
