Profile/Photo Observation Report

Date:	03/23/2018	Weather:		Coding:	PACP 6.0
Pipe Length (ft):	328.8	Owner:	NA	Pre Clean:	Not Known
P.O.#:		Surveyor:	Justin Gonzales	PSR:	P-203-051-060
Customer:		Clean Date:	01/01/1900	Shape:	C

Street:	E 38th Ave	Flow Control:	Not Controlled
City:	Hobart, IN	Year Renewed:	
Location:	Other	Tape/Media #:	
Purpose:	Not Known	Dia/Height:	12"
Use:	Sanitary	Material:	PVC
Drain Area:	NA	Lining:	
Category:	NA		
Comment:

Location Details:		Direction of Survey:	Downstream
US MH:	M-203-060	DS MH:	M-203-051
		Total Length Surveyed (ft):	261.7

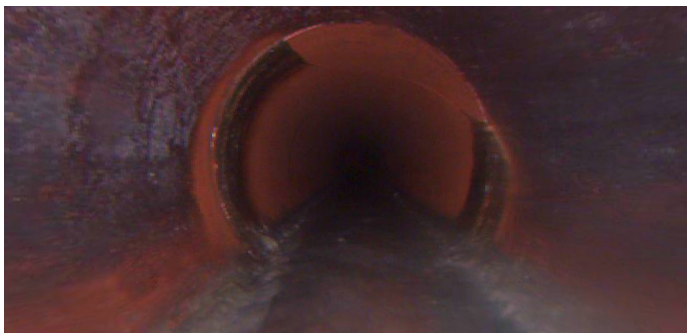
Code: **AMH**
Description: **Manhole**

Distance (ft): **.0**
Structural Grade: **0**
O&M Grade: **0**
Clock Start/From:
Clock To:
1st Value:
2nd Value:
Value Percent:
Continuous Index:
Within 8" of Joint: **NO**
Remarks: **M-203-060**

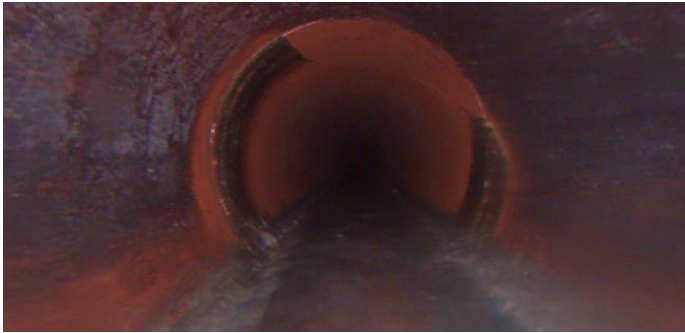
Code:	MWL
Description:	Water Level

Distance (ft):	.0
Structural Grade:	0
O&M Grade:	0
Clock Start/From:	
Clock To:	
1st Value:	
2nd Value:	
Value Percent:	10.000
Continuous Index:	
Within 8" of Joint:	NO
Remarks:

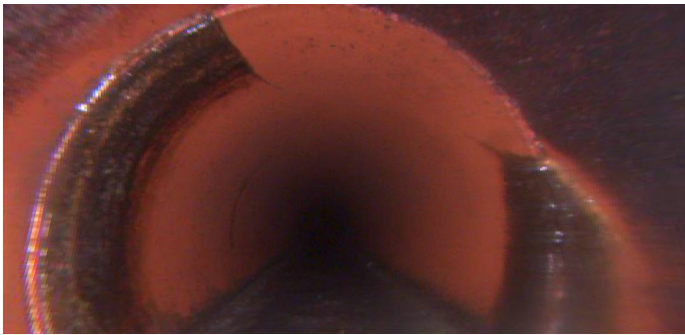
Code:	CS
Description:	Crack Spiral

Distance (ft):	1.0
Structural Grade:	2
O&M Grade:	0
Clock Start/From:	11
Clock To:	3
1st Value:	
2nd Value:	
Value Percent:	
Continuous Index:	
Within 8" of Joint:	YES
Remarks:

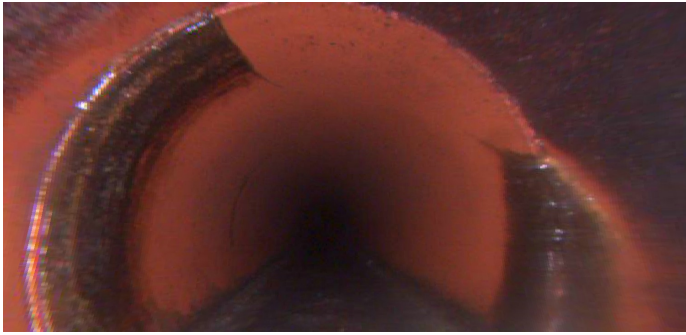
Code: **IS**
Description: **Infil Stain**

Distance (ft): **1.0**
Structural Grade: **0**
O&M Grade: **0**
Clock Start/From: **7**
Clock To: **5**
1st Value:
2nd Value:
Value Percent:
Continuous Index:
Within 8" of Joint: **YES**
Remarks:

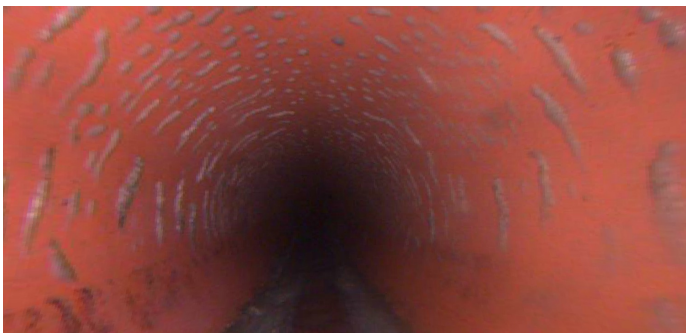
Code: **DAZ**
Description: **Deposits Attached Other**

Distance (ft): **22.1**
Structural Grade: **0**
O&M Grade: **2**
Clock Start/From: **7**
Clock To: **5**
1st Value:
2nd Value:
Value Percent: **5.000**
Continuous Index: **S01**
Within 8" of Joint: **YES**
Remarks: **WANDER**

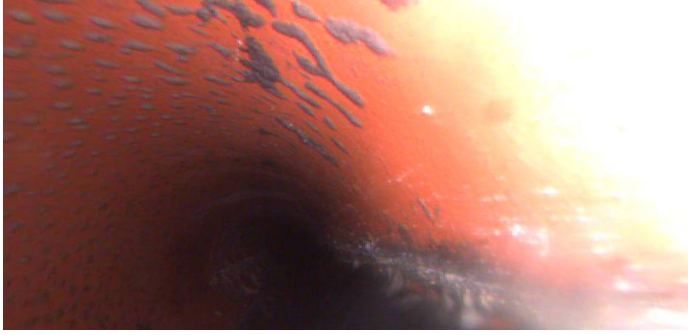
Code:	MSA
Description:	Abandoned Survey
Distance (ft):	261.7
Structural Grade:	0
O&M Grade:	0
Clock Start/From:	
Clock To:	
1st Value:	
2nd Value:	
Value Percent:	
Continuous Index:	
Within 8" of Joint:	NO
Remarks:	ROBOT TURNED OVER

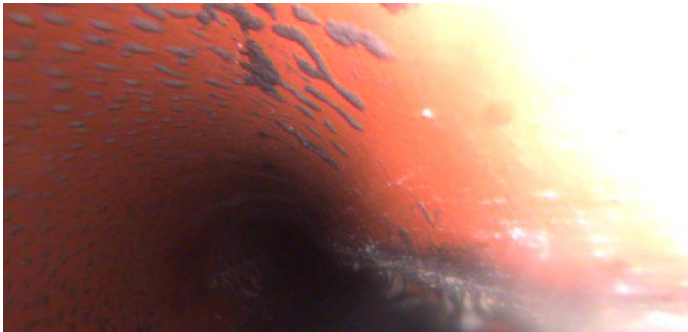
Code:	DAZ
Description:	Deposits Attached Other
Distance (ft):	261.7
Structural Grade:	0
O&M Grade:	2
Clock Start/From:	7
Clock To:	5
1st Value:	
2nd Value:	
Value Percent:	5.000
Continuous Index:	F01
Within 8" of Joint:	YES
Remarks:	WANDER
