Profile/Photo Observation Report

Date:	03/23/2018	Weather:		Coding:	PACP 6.0
Pipe Length (ft):	328.8	Owner:	NA	Pre Clean:	Not Known
P.O.#:		Surveyor:	Justin Gonzales	PSR:	P-203-051-060
Customer:		Clean Date:	01/01/1900	Shape:	C

Street:	W 38TH AVE	Flow Control:	Not Controlled
City:	Hobart, IN	Year Renewed:	
Location:	Other	Tape/Media #:	
Purpose:	Not Known	Dia/Height:	12"
Use:	Sanitary	Material:	PVC
Drain Area:	NA	Lining:	
Category:	NA		
Comment:

Location Details:		Direction of Survey:	Upstream
US MH:	M-203-060	DS MH:	M-203-051
		Total Length Surveyed (ft):	207.5

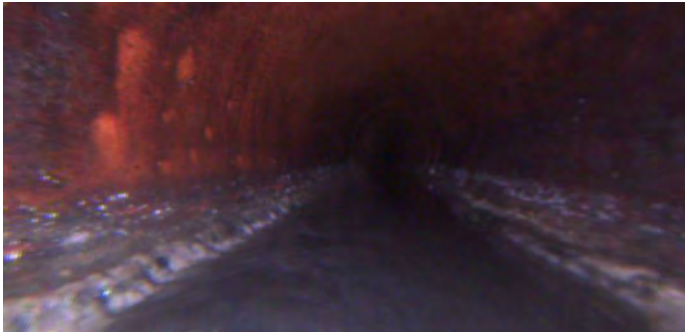
Code:	MWL
Description:	Water Level

Distance (ft):	.0
Structural Grade:	0
O&M Grade:	0
Clock Start/From:	
Clock To:	
1st Value:	
2nd Value:	
Value Percent:	10.000
Continuous Index:	
Within 8" of Joint:	NO
Remarks:

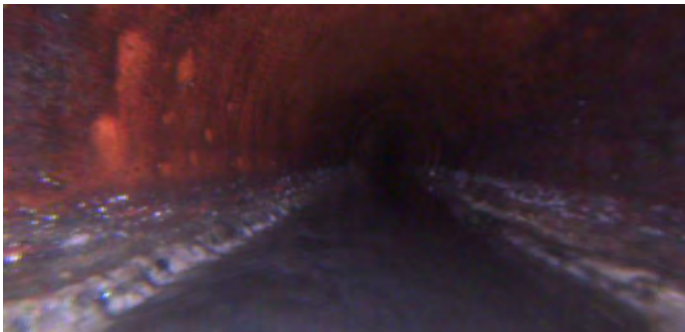
Code:	DAZ
Description:	Deposits Attached Other

Distance (ft):	.0
Structural Grade:	0
O&M Grade:	2
Clock Start/From:	7
Clock To:	5
1st Value:	
2nd Value:	
Value Percent:	5.000
Continuous Index:	S01
Within 8" of Joint:	YES
Remarks:	WANDER

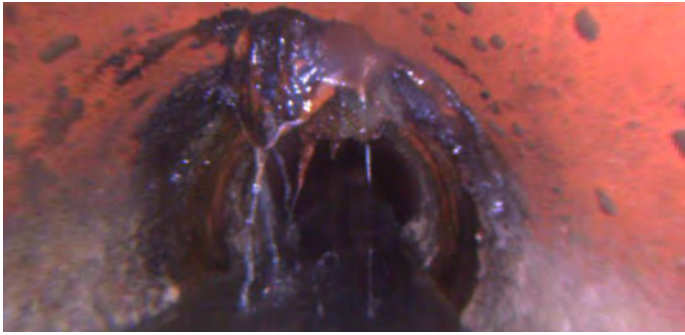
Code: **TBI**
Description: **Tap Break-in Intruding**

Distance (ft): **59.0**
Structural Grade: **0**
O&M Grade: **2**
Clock Start/From: **12**
Clock To:
1st Value: **4.000**
2nd Value: **1.500**
Value Percent:
Continuous Index:
Within 8" of Joint:
Remarks:

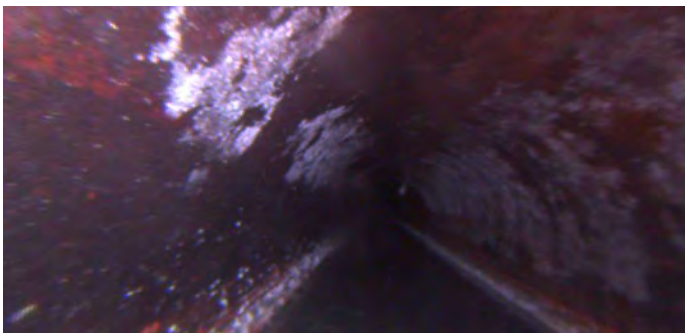
Code: **DAGS**
Description: **Deposits Attached Grease**

Distance (ft): **104.9**
Structural Grade: **0**
O&M Grade: **2**
Clock Start/From: **7**
Clock To: **5**
1st Value:
2nd Value:
Value Percent: **5.000**
Continuous Index: **S02**
Within 8" of Joint: **YES**
Remarks: **WANDER**

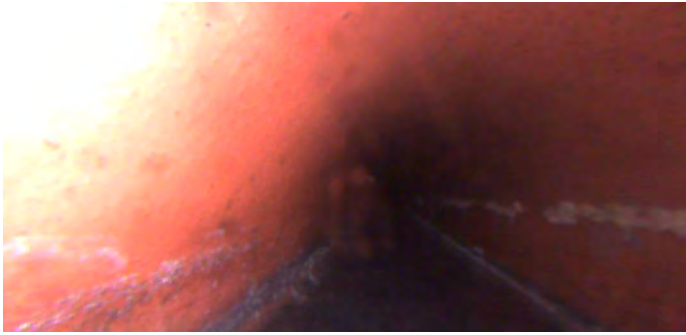
Code:	MSA
Description:	Abandoned Survey
Distance (ft):	207.5
Structural Grade:	0
O&M Grade:	0
Clock Start/From:	
Clock To:	
1st Value:	
2nd Value:	
Value Percent:	
Continuous Index:	
Within 8" of Joint:	NO
Remarks:	ROBOT HAS STOPPED

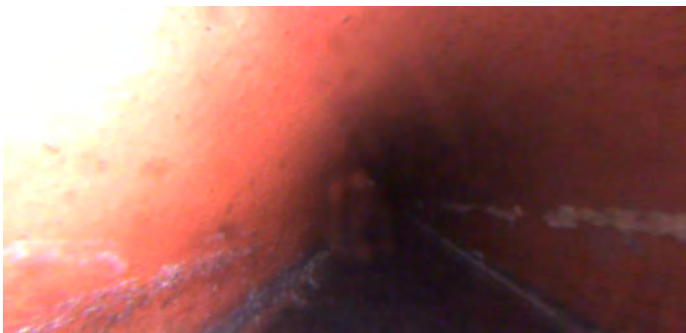
Code:	DAZ
Description:	Deposits Attached Other
Distance (ft):	207.5
Structural Grade:	0
O&M Grade:	2
Clock Start/From:	7
Clock To:	5
1st Value:	
2nd Value:	
Value Percent:	5.000
Continuous Index:	F01
Within 8" of Joint:	YES
Remarks:	WANDER

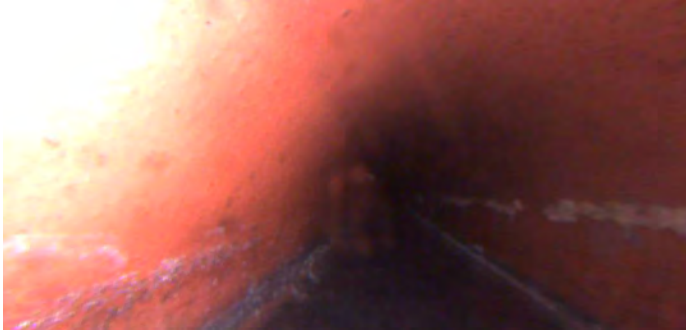
Code:	DAGS
Description:	Deposits Attached Grease
Distance (ft):	207.5
Structural Grade:	0
O&M Grade:	2
Clock Start/From:	7
Clock To:	5
1st Value:	
2nd Value:	
Value Percent:	5.000
Continuous Index:	F02
Within 8" of Joint:	YES
Remarks:	WANDER
