## Profile/Photo Observation Report

Street:	<b>E 38th Ave</b>	Flow Control:	<b>Not Controlled</b>
City:	<b>Hobart, IN</b>	Year Renewed:	
Location:	<b>Other</b>	Tape/Media #:	
Purpose:	<b>Not Known</b>	Dia/Height:	<b>12"</b>
Use:	<b>Sanitary</b>	Material:	<b>PVC</b>
Drain Area:	<b>NA</b>	Lining:	
Category:	<b>NA</b>		
Comment:

Location Details:		Direction of Survey:	<b>Upstream</b>
US MH:	<b>M-203-060</b>	DS MH:	<b>M-203-051</b>
		Total Length Surveyed (ft):	<b>207.5</b>

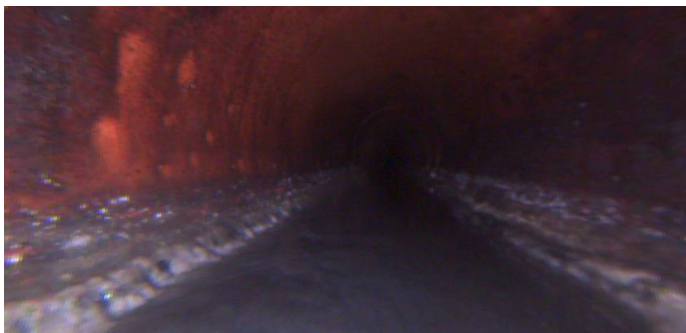
Code: **AMH**  
Description: **Manhole**

Distance (ft): **.0**  
Structural Grade: **0**  
O&M Grade: **0**  
Clock Start/From:  
Clock To:  
1st Value:  
2nd Value:  
Value Percent:  
Continuous Index:  
Within 8" of Joint: **NO**  
Remarks: **M-203-051**

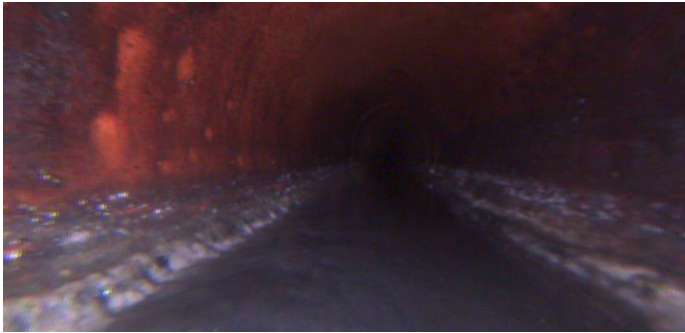
Code:	<b>MWL</b>
Description:	<b>Water Level</b>

Distance (ft):	<b>.0</b>
Structural Grade:	<b>0</b>
O&M Grade:	<b>0</b>
Clock Start/From:	
Clock To:	
1st Value:	
2nd Value:	
Value Percent:	<b>10.000</b>
Continuous Index:	
Within 8" of Joint:	<b>NO</b>
Remarks:

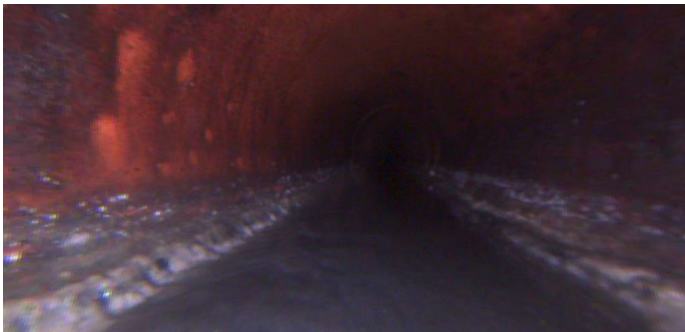
Code:	<b>DAZ</b>
Description:	<b>Deposits Attached Other</b>

Distance (ft):	<b>.0</b>
Structural Grade:	<b>0</b>
O&M Grade:	<b>2</b>
Clock Start/From:	<b>7</b>
Clock To:	<b>5</b>
1st Value:	
2nd Value:	
Value Percent:	<b>5.000</b>
Continuous Index:	<b>S01</b>
Within 8" of Joint:	<b>YES</b>
Remarks:	<b>WANDER</b>

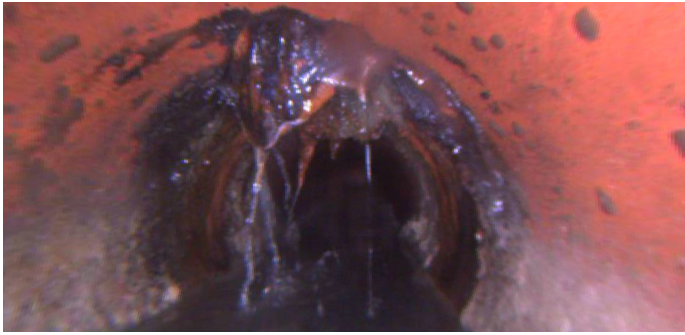
Code: **TBI**  
Description: **Tap Break-in Intruding**

Distance (ft): **59.0**  
Structural Grade: **0**  
O&M Grade: **2**  
Clock Start/From: **12**  
Clock To:  
1st Value: **4.000**  
2nd Value: **1.500**  
Value Percent:  
Continuous Index:  
Within 8" of Joint:  
Remarks:

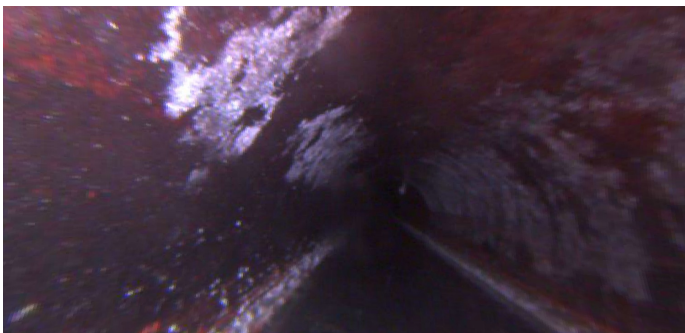
Code: **DAGS**  
Description: **Deposits Attached Grease**

Distance (ft): **104.9**  
Structural Grade: **0**  
O&M Grade: **2**  
Clock Start/From: **7**  
Clock To: **5**  
1st Value:  
2nd Value:  
Value Percent: **5.000**  
Continuous Index: **S02**  
Within 8" of Joint: **YES**  
Remarks: **WANDER**

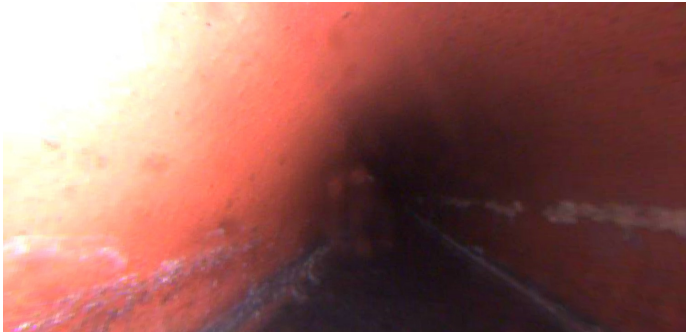
Code: **MSA**  
Description: **Abandoned Survey**

Distance (ft): **207.5**  
Structural Grade: **0**  
O&M Grade: **0**  
Clock Start/From:  
Clock To:  
1st Value:  
2nd Value:  
Value Percent:  
Continuous Index:  
Within 8" of Joint: **NO**  
Remarks: **ROBOT HAS STOPPED**

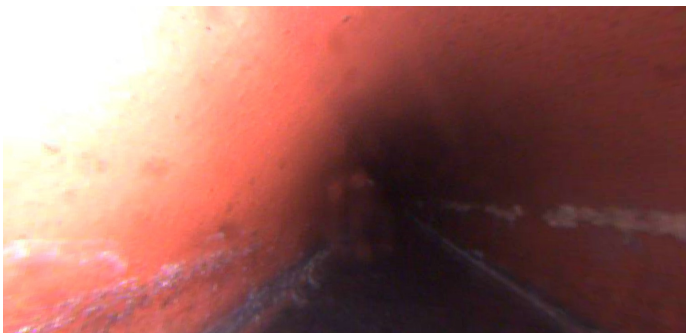
Code: **DAZ**  
Description: **Deposits Attached Other**

Distance (ft): **207.5**  
Structural Grade: **0**  
O&M Grade: **2**  
Clock Start/From: **7**  
Clock To: **5**  
1st Value:  
2nd Value:  
Value Percent: **5.000**  
Continuous Index: **F01**  
Within 8" of Joint: **YES**  
Remarks: **WANDER**

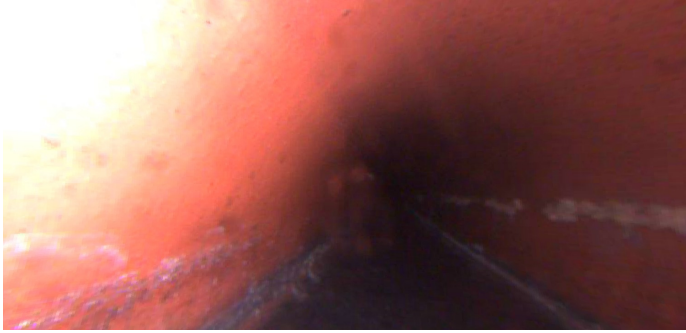
Code:	<b>DAGS</b>
Description:	<b>Deposits Attached Grease</b>
Distance (ft):	<b>207.5</b>
Structural Grade:	<b>0</b>
O&M Grade:	<b>2</b>
Clock Start/From:	<b>7</b>
Clock To:	<b>5</b>
1st Value:	
2nd Value:	
Value Percent:	<b>5.000</b>
Continuous Index:	<b>F02</b>
Within 8" of Joint:	<b>YES</b>
Remarks:	<b>WANDER</b>
