## Profile/Photo Observation Report

Street:	<b>E 38th Ave</b>	Flow Control:	<b>Not Controlled</b>
City:	<b>Hobart, IN</b>	Year Renewed:	
Location:	<b>Other</b>	Tape/Media #:	
Purpose:	<b>Not Known</b>	Dia/Height:	<b>12"</b>
Use:	<b>Sanitary</b>	Material:	<b>VCP</b>
Drain Area:	<b>NA</b>	Lining:	
Category:	<b>NA</b>		
Comment:

Location Details:		Direction of Survey:	<b>Upstream</b>
US MH:	<b>M-203-060</b>	DS MH:	<b>M-203-051</b>
		Total Length Surveyed (ft):	<b>39.3</b>

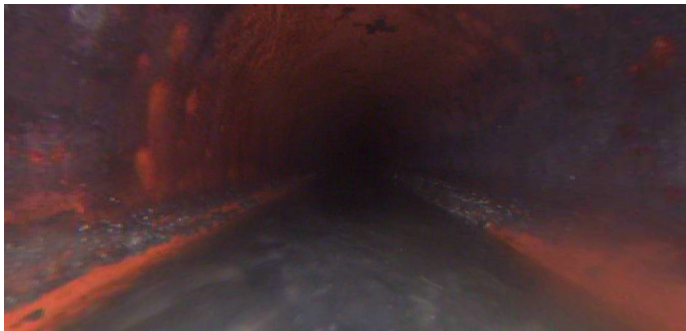
Code: **AMH**  
Description: **Manhole**

Distance (ft): **.0**  
Structural Grade: **0**  
O&M Grade: **0**  
Clock Start/From:  
Clock To:  
1st Value:  
2nd Value:  
Value Percent:  
Continuous Index:  
Within 8" of Joint: **NO**  
Remarks: **M-203-051**

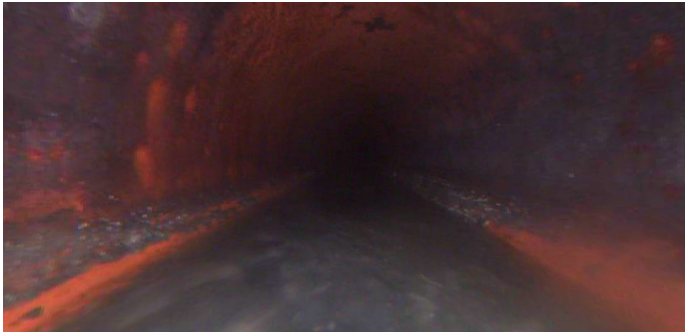
Code:	<b>MWL</b>
Description:	<b>Water Level</b>

Distance (ft):	<b>.0</b>
Structural Grade:	<b>0</b>
O&M Grade:	<b>0</b>
Clock Start/From:	
Clock To:	
1st Value:	
2nd Value:	
Value Percent:	<b>5.000</b>
Continuous Index:	
Within 8" of Joint:	<b>NO</b>
Remarks:

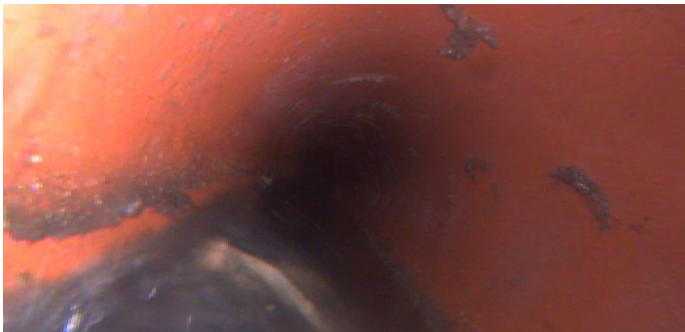
Code:	<b>MSA</b>
Description:	<b>Abandoned Survey</b>

Distance (ft):	<b>39.3</b>
Structural Grade:	<b>0</b>
O&M Grade:	<b>0</b>
Clock Start/From:	
Clock To:	
1st Value:	
2nd Value:	
Value Percent:	
Continuous Index:	
Within 8" of Joint:	<b>NO</b>
Remarks:	<b>camera flipped</b>
