Profile/Photo Observation Report

Date:	10/18/2021	Weather:		Coding:	PACP 6.0
Pipe Length (ft):		Owner:	Hobart, IN	Pre Clean:	Not Known
P.O.#:	877_1	Surveyor:	M. Pielacha	PSR:	P-203-061-060
Customer:	Hobart, IN	Clean Date:		Shape:	C

Street:	West 38th Avenue	Flow Control:	
City:	Hobart, IN	Year Renewed:	
Location:	Light Highway	Tape/Media #:	877
Purpose:	Routine Assessment	Dia/Height:	10"
Use:	Sanitary	Material:	VCP
Drain Area:		Lining:	
Category:	NA		
Comment:

Location Details:		Direction of Survey:	Upstream
US MH:	M-203-60	DS MH:	M-203-61
		Total Length Surveyed (ft):	155.8

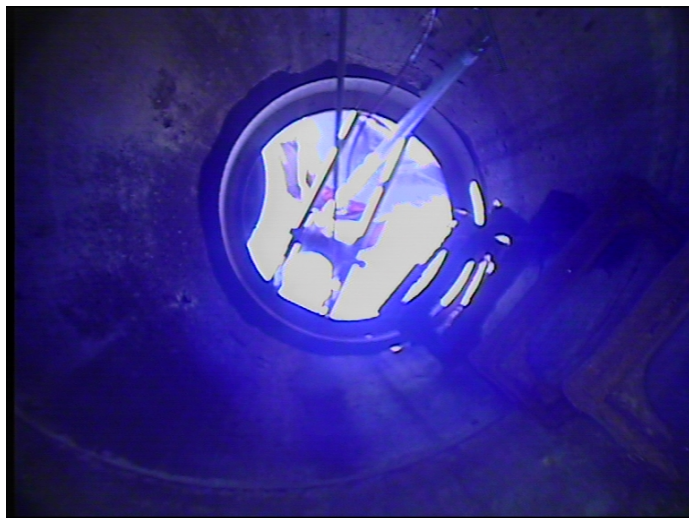
Code: **AMH**
Description: **Manhole**

Distance (ft): **.0**
Structural Grade: **0**
O&M Grade: **0**
Clock Start/From:
Clock To:
1st Value:
2nd Value:
Value Percent:
Continuous Index:
Within 8" of Joint: **NO**
Remarks: **M-203-61**

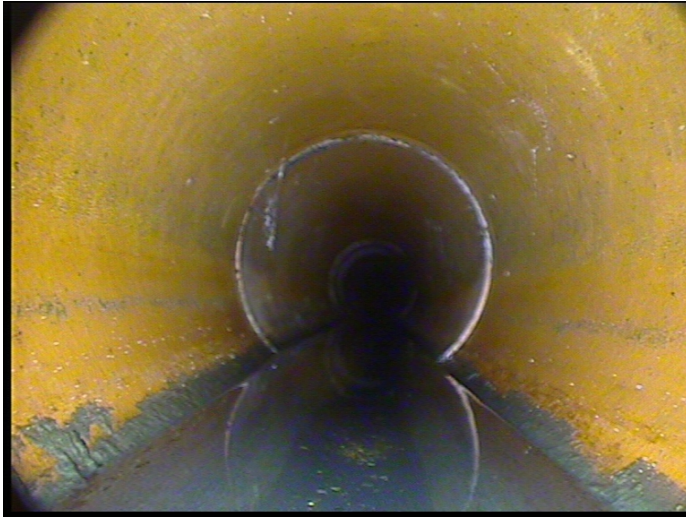
Code: **MWL**
Description: **Water Level**

Distance (ft): **.0**
Structural Grade: **0**
O&M Grade: **0**
Clock Start/From:
Clock To:
1st Value:
2nd Value:
Value Percent: **5.000**
Continuous Index:
Within 8" of Joint: **NO**
Remarks:

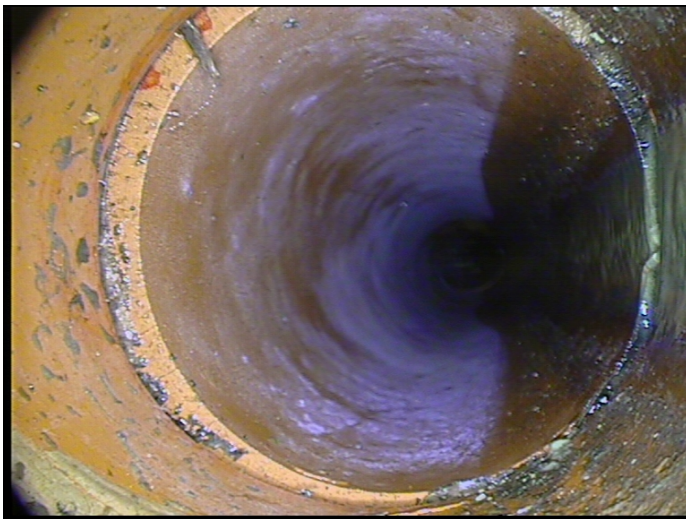
Code: **TF**
Description: **Tap Factory**

Distance (ft): **54.0**
Structural Grade: **0**
O&M Grade: **0**
Clock Start/From: **3**
Clock To:
1st Value: **4.000**
2nd Value:
Value Percent:
Continuous Index:
Within 8" of Joint: **NO**
Remarks:

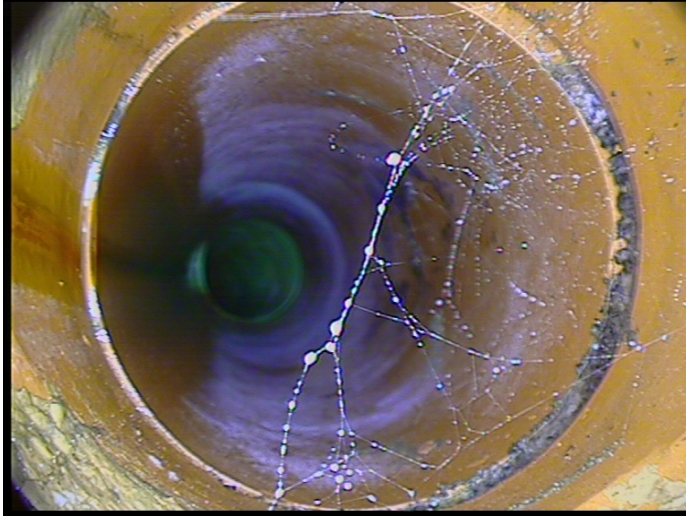
Code: **TF**
Description: **Tap Factory**

Distance (ft): **55.9**
Structural Grade: **0**
O&M Grade: **0**
Clock Start/From: **9**
Clock To:
1st Value: **4.000**
2nd Value:
Value Percent:
Continuous Index:
Within 8" of Joint: **NO**
Remarks:

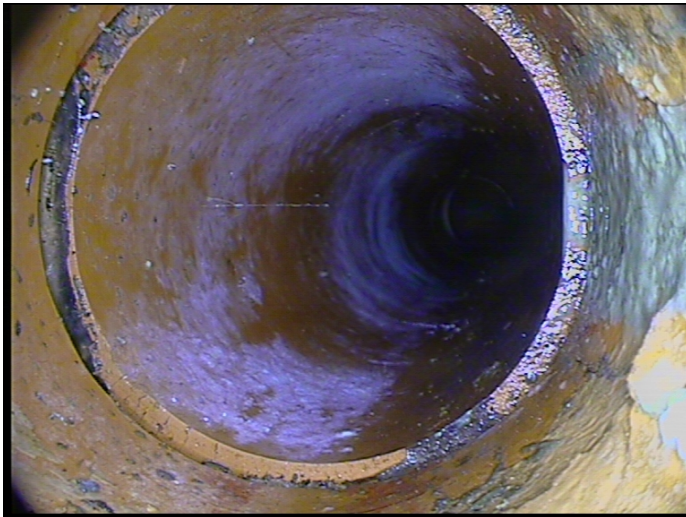
Code: **TF**
Description: **Tap Factory**

Distance (ft): **108.0**
Structural Grade: **0**
O&M Grade: **0**
Clock Start/From: **2**
Clock To:
1st Value: **4.000**
2nd Value:
Value Percent:
Continuous Index:
Within 8" of Joint: **NO**
Remarks:

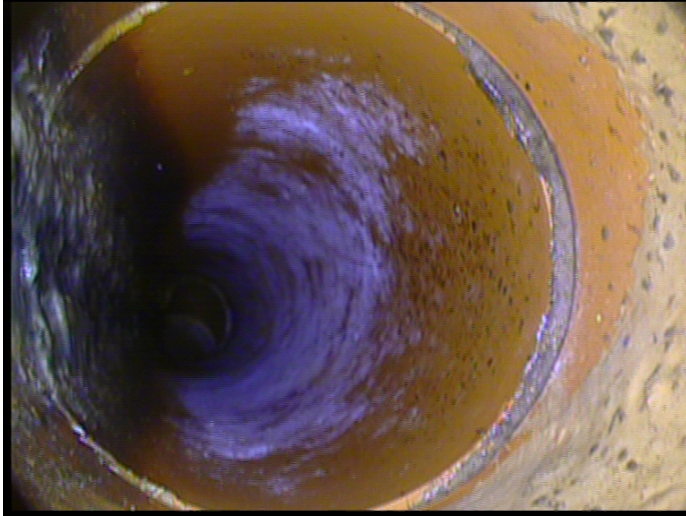
Code: **TF**
Description: **Tap Factory**

Distance (ft): **109.9**
Structural Grade: **0**
O&M Grade: **0**
Clock Start/From: **9**
Clock To:
1st Value: **4.000**
2nd Value:
Value Percent:
Continuous Index:
Within 8" of Joint: **NO**
Remarks:

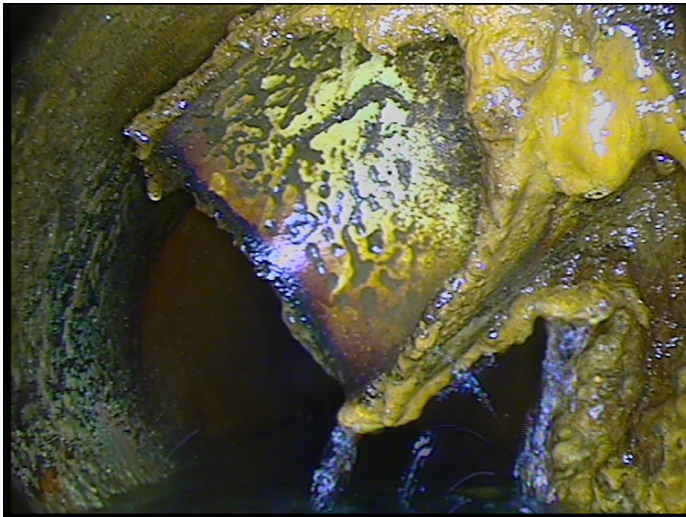
Code: **TBI**
Description: **Tap Break-in Intruding**

Distance (ft): **155.7**
Structural Grade: **0**
O&M Grade: **2**
Clock Start/From: **2**
Clock To:
1st Value: **4.000**
2nd Value: **3.000**
Value Percent:
Continuous Index:
Within 8" of Joint: **NO**
Remarks:

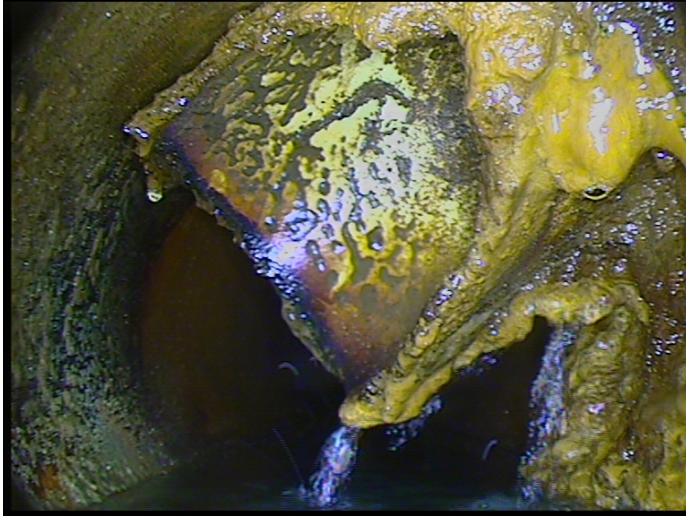
Code:	MSA
Description:	Abandoned Survey
Distance (ft):	155.7
Structural Grade:	0
O&M Grade:	0
Clock Start/From:	
Clock To:	
1st Value:	
2nd Value:	
Value Percent:	
Continuous Index:	
Within 8" of Joint:	NO
Remarks:	Intruding tap
