Profile/Photo Observation Report

Street:	ALLEY BETWEEN SANDUSKY ST & CO	Flow Control:	Not Controlled
City:	Hobart, IN	Year Renewed:	
Location:	Other	Tape/Media #:	
Purpose:	Not Known	Dia/Height:	10"
Use:	Sanitary	Material:	VCP
Drain Area:	NA	Lining:	
Category:	NA		
Comment:

Location Details:		Direction of Survey:	Upstream
US MH:	M-203-061	DS MH:	M-203-063
		Total Length Surveyed (ft):	82.2

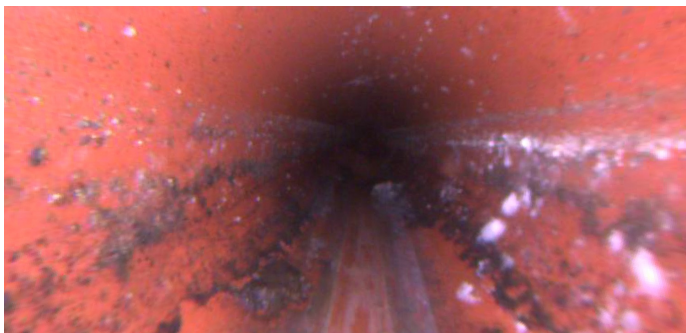
Code: **AMH**
Description: **Manhole**

Distance (ft): **.0**
Structural Grade: **0**
O&M Grade: **0**
Clock Start/From:
Clock To:
1st Value:
2nd Value:
Value Percent:
Continuous Index:
Within 8" of Joint: **NO**
Remarks: **M-203-063**

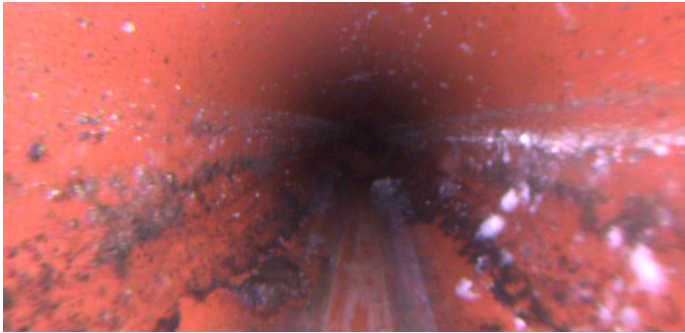
Code:	MWL
Description:	Water Level

Distance (ft):	.0
Structural Grade:	0
O&M Grade:	0
Clock Start/From:	
Clock To:	
1st Value:	
2nd Value:	
Value Percent:	5.000
Continuous Index:	
Within 8" of Joint:	NO
Remarks:

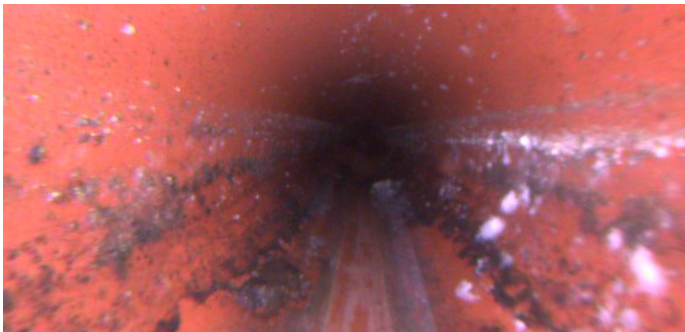
Code:	DAGS
Description:	Deposits Attached Grease

Distance (ft):	.0
Structural Grade:	0
O&M Grade:	2
Clock Start/From:	7
Clock To:	5
1st Value:	
2nd Value:	
Value Percent:	5.000
Continuous Index:	S01
Within 8" of Joint:	NO
Remarks:

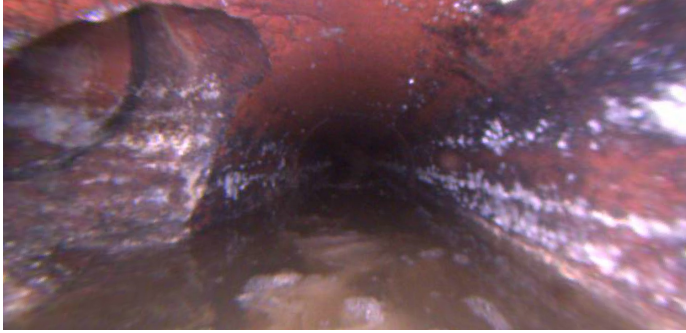
Code: **TF**
Description: **Tap Factory**

Distance (ft): **40.3**
Structural Grade: **0**
O&M Grade: **0**
Clock Start/From: **9**
Clock To:
1st Value: **4.000**
2nd Value:
Value Percent:
Continuous Index:
Within 8" of Joint:
Remarks:

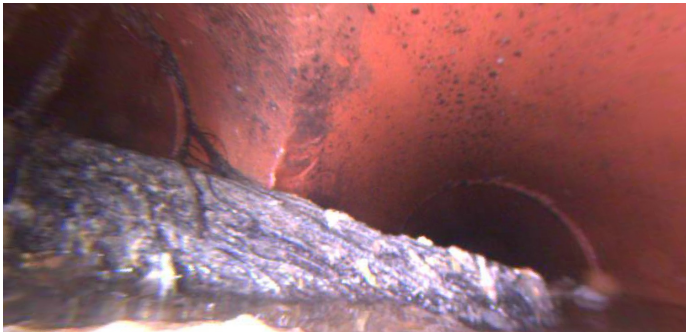
Code: **TFD**
Description: **Tap Factory Defective**

Distance (ft): **72.5**
Structural Grade: **0**
O&M Grade: **2**
Clock Start/From: **9**
Clock To:
1st Value: **4.000**
2nd Value:
Value Percent:
Continuous Index:
Within 8" of Joint:
Remarks: **ROOTS**

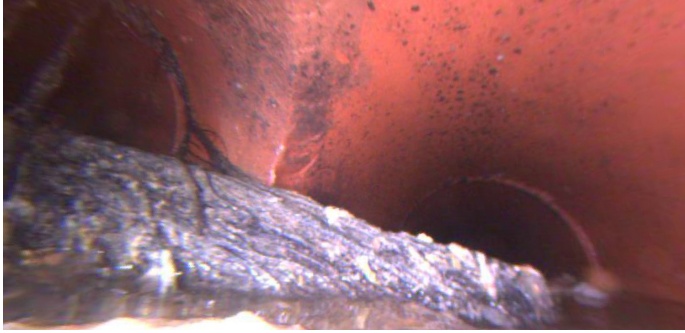
Code: **RML**
Description: **Roots Medium Lateral**

Distance (ft): **72.5**
Structural Grade: **0**
O&M Grade: **3**
Clock Start/From: **9**
Clock To: **10**
1st Value:
2nd Value:
Value Percent: **20.000**
Continuous Index:
Within 8" of Joint: **NO**
Remarks:

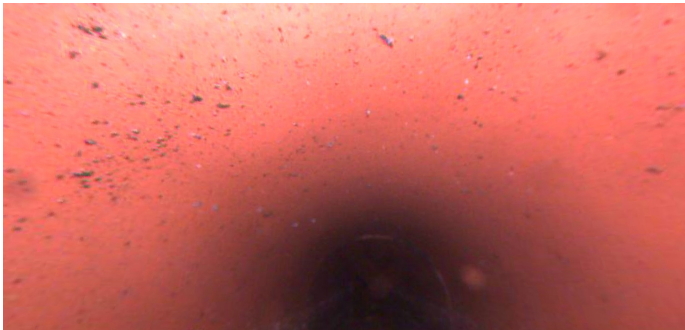
Code: **MSA**
Description: **Abandoned Survey**

Distance (ft): **82.2**
Structural Grade: **0**
O&M Grade: **0**
Clock Start/From:
Clock To:
1st Value:
2nd Value:
Value Percent:
Continuous Index:
Within 8" of Joint: **NO**
Remarks: **ROOTS**

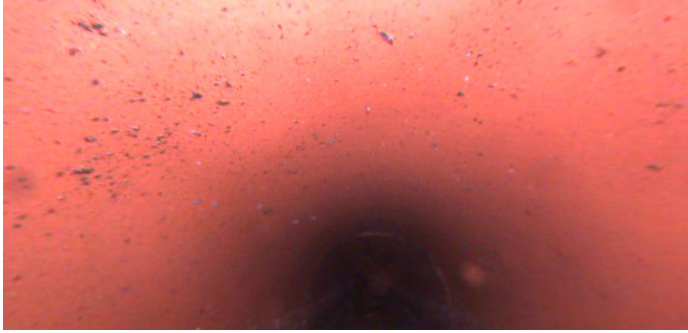
Code:	DAGS
Description:	Deposits Attached Grease
Distance (ft):	82.2
Structural Grade:	0
O&M Grade:	2
Clock Start/From:	7
Clock To:	5
1st Value:	
2nd Value:	
Value Percent:	5.000
Continuous Index:	F01
Within 8" of Joint:	NO
Remarks:
