# Profile/Photo Observation Report

Street:	<b>E 38th Ave</b>	Flow Control:	<b>Not Controlled</b>
City:	<b>Hobart, IN</b>	Year Renewed:	
Location:	<b>Other</b>	Tape/Media #:	
Purpose:	<b>Not Known</b>	Dia/Height:	<b>10"</b>
Use:	<b>Sanitary</b>	Material:	<b>VCP</b>
Drain Area:	<b>NA</b>	Lining:	
Category:	<b>NA</b>		
Comment:			
Location Details:		Direction of Survey:	<b>Upstream</b>
US MH:	<b>M-203-061</b>	DS MH:	<b>M-203-063</b>
		Total Length Surveyed (ft):	<b>82.2</b>

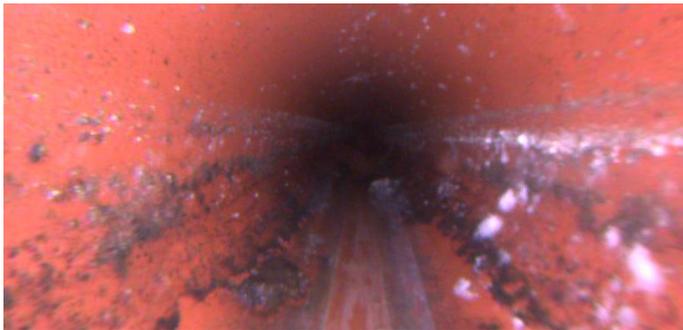
Code: **AMH**  
Description: **Manhole**

Distance (ft): **.0**  
Structural Grade: **0**  
O&M Grade: **0**  
Clock Start/From:  
Clock To:  
1st Value:  
2nd Value:  
Value Percent:  
Continuous Index:  
Within 8" of Joint: **NO**  
Remarks: **M-203-063**

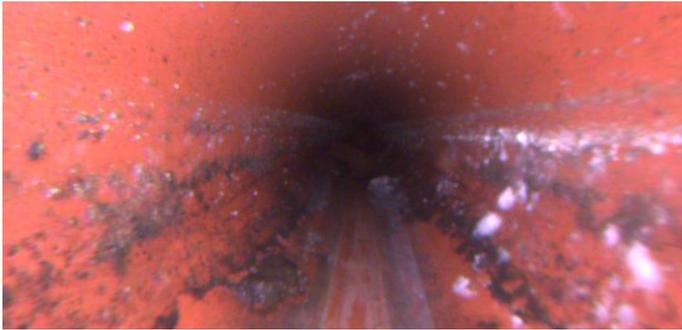
Code: **MWL**  
Description: **Water Level**

Distance (ft): **.0**  
Structural Grade: **0**  
O&M Grade: **0**  
Clock Start/From:  
Clock To:  
1st Value:  
2nd Value:  
Value Percent: **5.000**  
Continuous Index:  
Within 8" of Joint: **NO**  
Remarks:

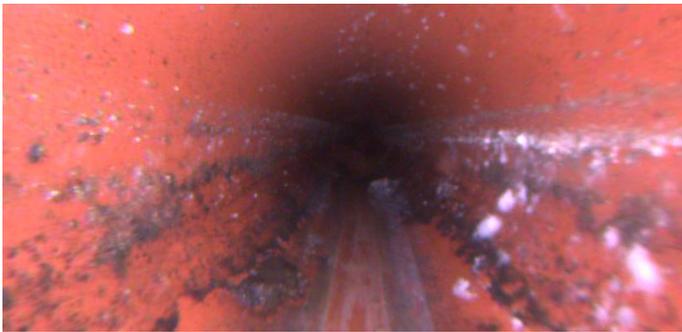
Code: **DAGS**  
Description: **Deposits Attached Grease**

Distance (ft): **.0**  
Structural Grade: **0**  
O&M Grade: **2**  
Clock Start/From: **7**  
Clock To: **5**  
1st Value:  
2nd Value:  
Value Percent: **5.000**  
Continuous Index: **S01**  
Within 8" of Joint: **NO**  
Remarks:

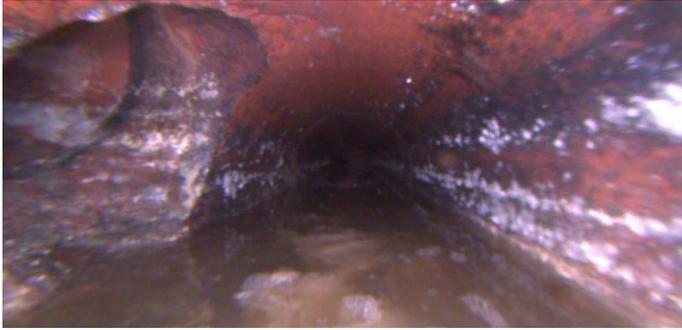
Code: **TF**  
Description: **Tap Factory**

Distance (ft): **40.3**  
Structural Grade: **0**  
O&M Grade: **0**  
Clock Start/From: **9**  
Clock To:  
1st Value: **4.000**  
2nd Value:  
Value Percent:  
Continuous Index:  
Within 8" of Joint:  
Remarks:

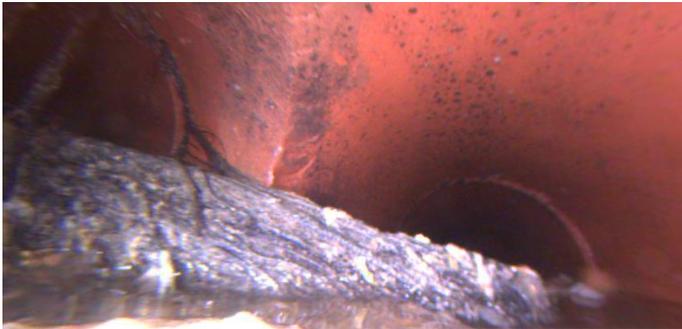
Code: **TFD**  
Description: **Tap Factory Defective**

Distance (ft): **72.5**  
Structural Grade: **0**  
O&M Grade: **2**  
Clock Start/From: **9**  
Clock To:  
1st Value: **4.000**  
2nd Value:  
Value Percent:  
Continuous Index:  
Within 8" of Joint:  
Remarks: **ROOTS**

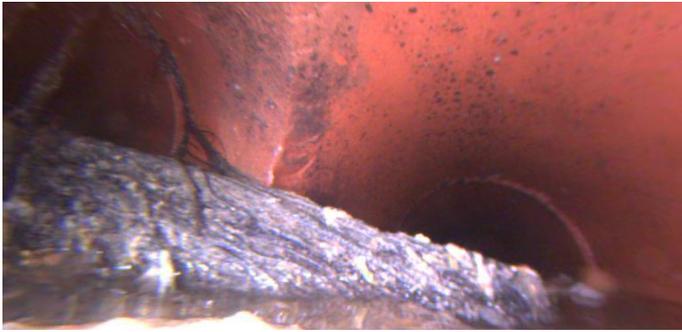
Code: **RML**  
Description: **Roots Medium Lateral**

Distance (ft): **72.5**  
Structural Grade: **0**  
O&M Grade: **3**  
Clock Start/From: **9**  
Clock To: **10**  
1st Value:  
2nd Value:  
Value Percent: **20.000**  
Continuous Index:  
Within 8" of Joint: **NO**  
Remarks:

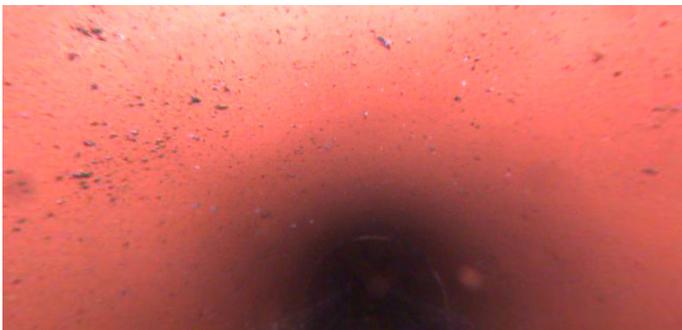
Code: **MSA**  
Description: **Abandoned Survey**

Distance (ft): **82.2**  
Structural Grade: **0**  
O&M Grade: **0**  
Clock Start/From:  
Clock To:  
1st Value:  
2nd Value:  
Value Percent:  
Continuous Index:  
Within 8" of Joint: **NO**  
Remarks: **ROOTS**

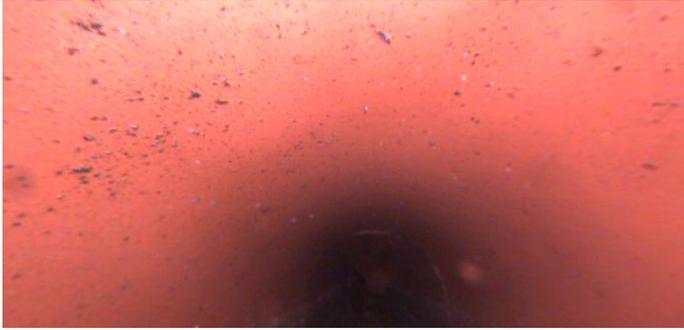
Code:	<b>DAGS</b>
Description:	<b>Deposits Attached Grease</b>
Distance (ft):	<b>82.2</b>
Structural Grade:	<b>0</b>
O&M Grade:	<b>2</b>
Clock Start/From:	<b>7</b>
Clock To:	<b>5</b>
1st Value:	
2nd Value:	
Value Percent:	<b>5.000</b>
Continuous Index:	<b>F01</b>
Within 8" of Joint:	<b>NO</b>
Remarks:
