## Profile/Photo Observation Report

Street:	<b>E 38th Ave</b>	Flow Control:	<b>Not Controlled</b>
City:	<b>Hobart, IN</b>	Year Renewed:	
Location:	<b>Other</b>	Tape/Media #:	
Purpose:	<b>Not Known</b>	Dia/Height:	<b>8"</b>
Use:	<b>Sanitary</b>	Material:	<b>VCP</b>
Drain Area:	<b>NA</b>	Lining:	
Category:	<b>NA</b>		
Comment:

Location Details:		Direction of Survey:	<b>Downstream</b>
US MH:	<b>M-203-063</b>	DS MH:	<b>M-203-064</b>
		Total Length Surveyed (ft):	<b>73.7</b>

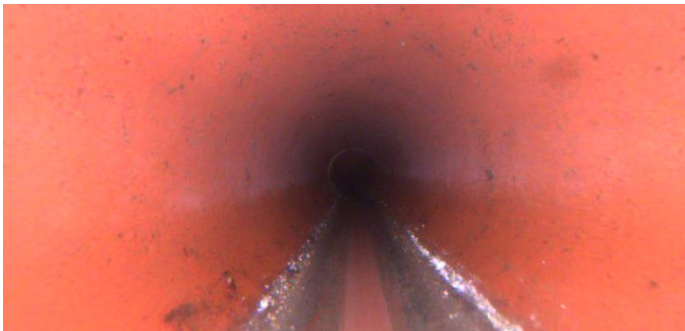
Code: **AMH**  
Description: **Manhole**

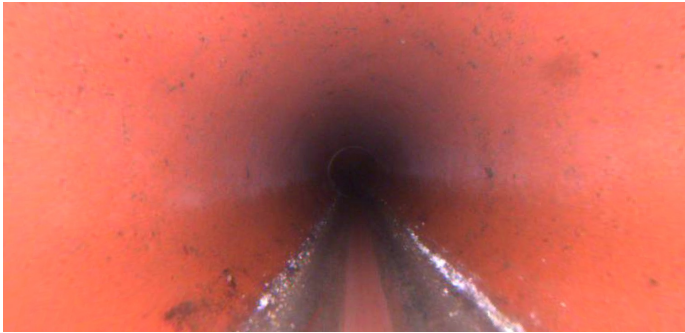
Code:	<b>MWL</b>
Description:	<b>Water Level</b>

Distance (ft):	<b>.0</b>
Structural Grade:	<b>0</b>
O&M Grade:	<b>0</b>
Clock Start/From:	
Clock To:	
1st Value:	
2nd Value:	
Value Percent:	<b>5.000</b>
Continuous Index:	
Within 8" of Joint:	<b>NO</b>
Remarks:

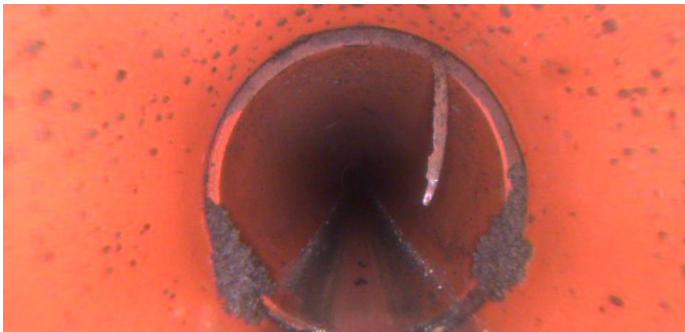
Code:	<b>DAZ</b>
Description:	<b>Deposits Attached Other</b>

Distance (ft):	<b>9.2</b>
Structural Grade:	<b>0</b>
O&M Grade:	<b>2</b>
Clock Start/From:	<b>8</b>
Clock To:	<b>4</b>
1st Value:	
2nd Value:	
Value Percent:	<b>5.000</b>
Continuous Index:	
Within 8" of Joint:	<b>YES</b>
Remarks:

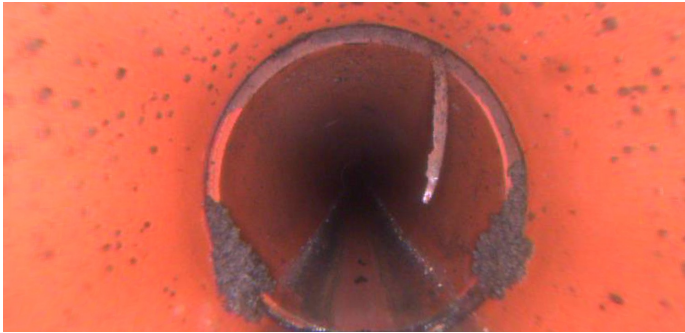
Code: **ISSRB**  
Description: **Intruding Sealing Ring Broken**

Distance (ft): **9.2**  
Structural Grade: **0**  
O&M Grade: **2**  
Clock Start/From: **12**  
Clock To: **1**  
1st Value:  
2nd Value:  
Value Percent: **5.000**  
Continuous Index:  
Within 8" of Joint: **NO**  
Remarks:

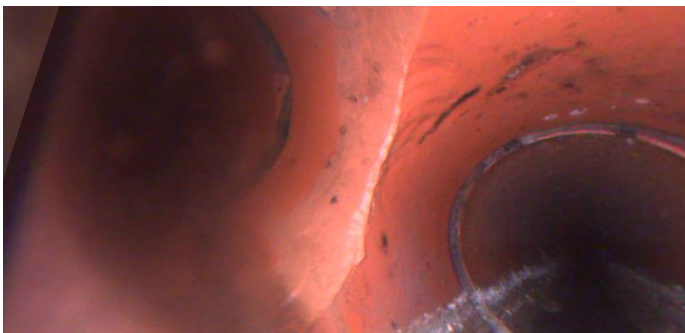
Code: **TF**  
Description: **Tap Factory**

Distance (ft): **36.6**  
Structural Grade: **0**  
O&M Grade: **0**  
Clock Start/From: **9**  
Clock To:  
1st Value: **4.000**  
2nd Value:  
Value Percent:  
Continuous Index:  
Within 8" of Joint:  
Remarks:

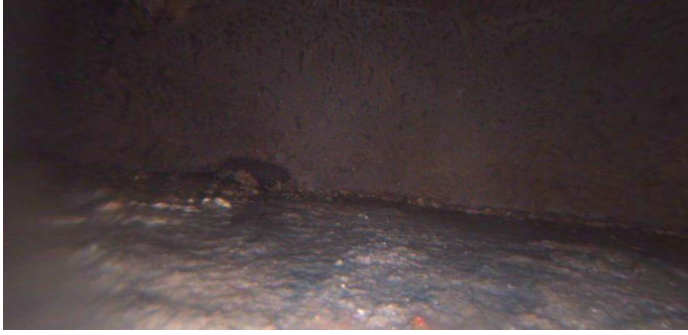
Code:	AMH
Description:	Manhole
Distance (ft):	73.7
Structural Grade:	0
O&M Grade:	0
Clock Start/From:	
Clock To:	
1st Value:	
2nd Value:	
Value Percent:	
Continuous Index:	
Within 8" of Joint:	NO
Remarks:	M-203-064
