Profile/Photo Observation Report

Date:	03/23/2018	Weather:		Coding:	PACP 6.0
Pipe Length (ft):	271.6	Owner:	NA	Pre Clean:	Not Known
P.O.#:		Surveyor:	Justin Gonzales	PSR:	P-203-065-060
Customer:		Clean Date:	01/01/1900	Shape:	C

Street:	E 38th Ave	Flow Control:	Not Controlled
City:	Hobart, IN	Year Renewed:	
Location:	Other	Tape/Media #:	
Purpose:	Not Known	Dia/Height:	12"
Use:	Sanitary	Material:	PVC
Drain Area:	NA	Lining:	
Category:	NA		
Comment:

Location Details:		Direction of Survey:	Upstream
US MH:	M-203-065	DS MH:	M-203-060
		Total Length Surveyed (ft):	251.6

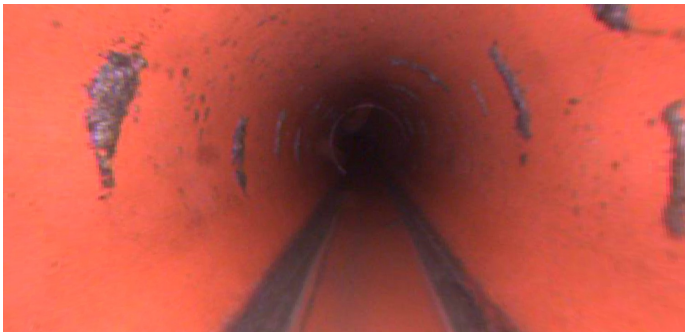
Code:	DAZ
Description:	Deposits Attached Other

Distance (ft):	.0
Structural Grade:	0
O&M Grade:	2
Clock Start/From:	7
Clock To:	5
1st Value:	
2nd Value:	
Value Percent:	5.000
Continuous Index:	S01
Within 8" of Joint:	YES
Remarks:	WANDER

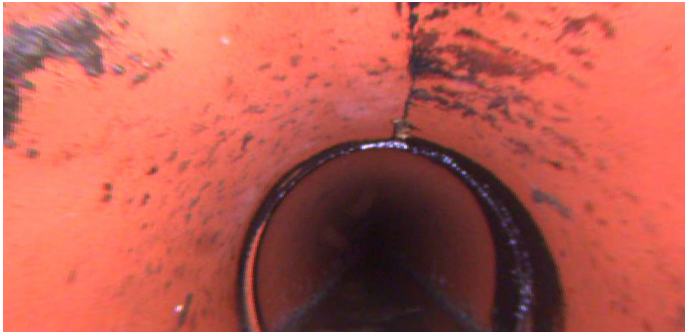
Code: **CL**
Description: **Crack Longitudinal**

Distance (ft): **10.6**
Structural Grade: **2**
O&M Grade: **0**
Clock Start/From: **12**
Clock To:
1st Value:
2nd Value:
Value Percent:
Continuous Index:
Within 8" of Joint:
Remarks:

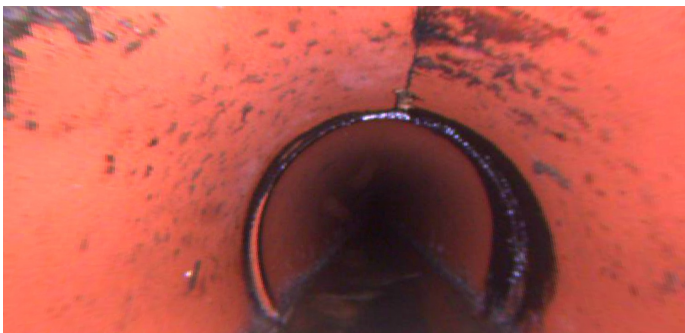
Code: **IS**
Description: **Infil Stain**

Distance (ft): **10.6**
Structural Grade: **0**
O&M Grade: **0**
Clock Start/From: **7**
Clock To: **5**
1st Value:
2nd Value:
Value Percent:
Continuous Index:
Within 8" of Joint: **YES**
Remarks:

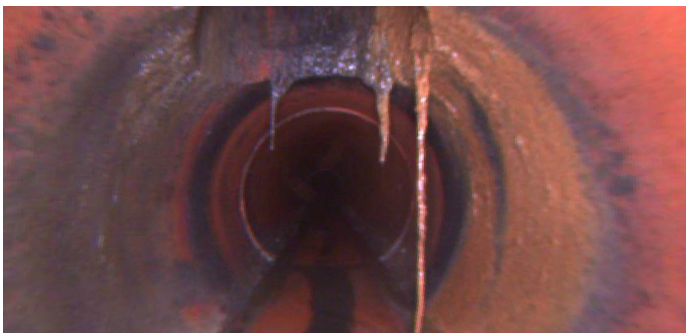
Code: **DAE**
Description: **Deposits Attached Encrustation**

Distance (ft): **178.3**
Structural Grade: **0**
O&M Grade: **2**
Clock Start/From: **3**
Clock To: **7**
1st Value:
2nd Value:
Value Percent: **5.000**
Continuous Index:
Within 8" of Joint: **NO**
Remarks: **TAP**

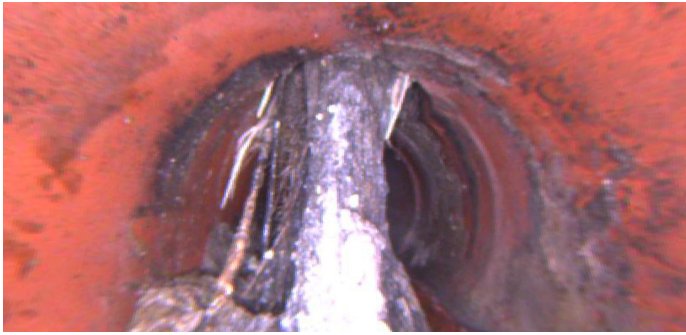
Code: **TFD**
Description: **Tap Factory Defective**

Distance (ft): **209.7**
Structural Grade: **0**
O&M Grade: **2**
Clock Start/From: **11**
Clock To:
1st Value: **4.000**
2nd Value:
Value Percent:
Continuous Index:
Within 8" of Joint:
Remarks: **UNKNOWN DEPOSITS BLOCKING TAP**

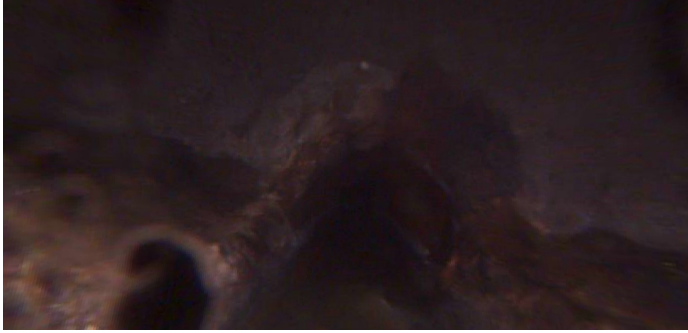
Code:	DAZ
Description:	Deposits Attached Other
Distance (ft):	251.6
Structural Grade:	0
O&M Grade:	2
Clock Start/From:	7
Clock To:	5
1st Value:	
2nd Value:	
Value Percent:	5.000
Continuous Index:	F01
Within 8" of Joint:	YES
Remarks:	WANDER
