## Profile/Photo Observation Report

Street:	<b>OFF W 17TH ST</b>	Flow Control:	<b>Not Controlled</b>
City:	<b>Hobart, IN</b>	Year Renewed:	
Location:	<b>Light Highway</b>	Tape/Media #:	
Purpose:	<b>Routine Assessment</b>	Dia/Height:	<b>8"</b>
Use:	<b>Sanitary</b>	Material:	<b>PVC</b>
Drain Area:	<b>NA</b>	Lining:	
Category:	<b>NA</b>		
Comment:	<b>Flow direction wrong</b>

Location Details:		Direction of Survey:	<b>Upstream</b>
US MH:	<b>M-208-002</b>	DS MH:	<b>M-208-025</b>
		Total Length Surveyed (ft):	<b>93.8</b>

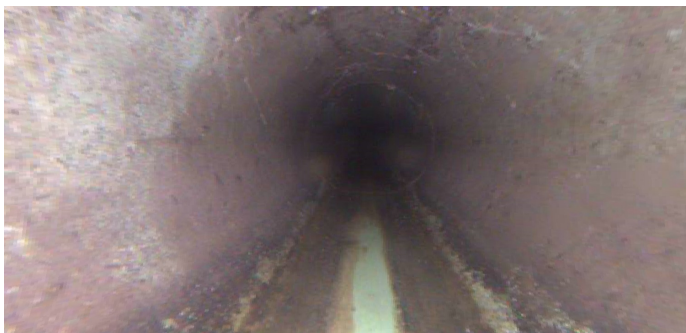
Code: **AMH**  
Description: **Manhole**

Distance (ft): **.0**  
Structural Grade: **0**  
O&M Grade: **0**  
Clock Start/From:  
Clock To:  
1st Value:  
2nd Value:  
Value Percent:  
Continuous Index:  
Within 8" of Joint: **NO**  
Remarks: **M-208-025**

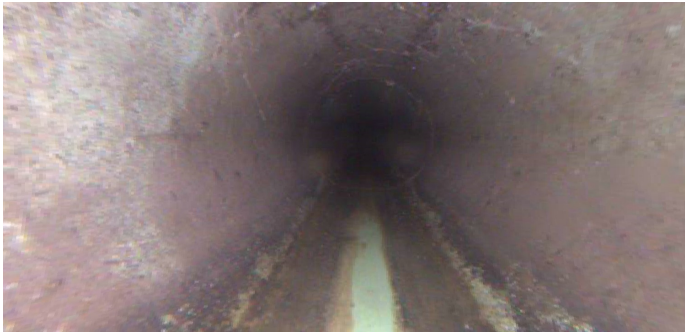
Code:	<b>MWL</b>
Description:	<b>Water Level</b>

Distance (ft):	<b>.0</b>
Structural Grade:	<b>0</b>
O&M Grade:	<b>0</b>
Clock Start/From:	
Clock To:	
1st Value:	
2nd Value:	
Value Percent:	<b>5.000</b>
Continuous Index:	
Within 8" of Joint:	<b>NO</b>
Remarks:

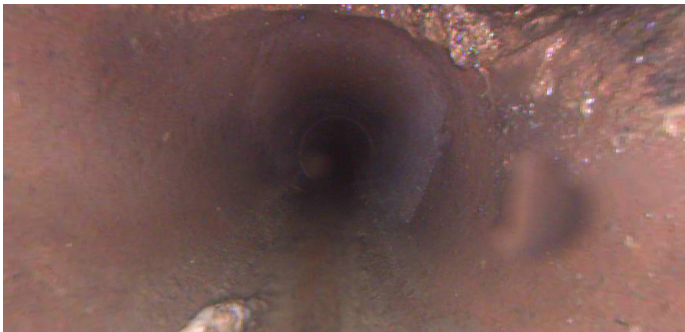
Code:	<b>AMH</b>
Description:	<b>Manhole</b>

Distance (ft):	<b>93.8</b>
Structural Grade:	<b>0</b>
O&M Grade:	<b>0</b>
Clock Start/From:	
Clock To:	
1st Value:	
2nd Value:	
Value Percent:	
Continuous Index:	
Within 8" of Joint:	<b>NO</b>
Remarks:	<b>M-208-002</b>
