Profile/Photo Observation Report

Street:	OFF MINNESOTA ST	Flow Control:	Not Controlled
City:	Hobart, IN	Year Renewed:	
Location:	Light Highway	Tape/Media #:	
Purpose:	Routine Assessment	Dia/Height:	8"
Use:	Sanitary	Material:	PVC
Drain Area:	NA	Lining:	
Category:	NA		
Comment:	P_C at 41 ft debris . Flow direction wrong		
Location Details:		Direction of Survey:	Upstream
US MH:	M-208-003	DS MH:	M-208-002
		Total Length Surveyed (ft):	42.2

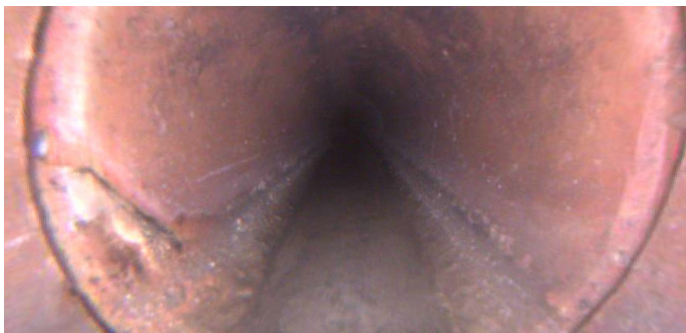
Code: **AMH**
Description: **Manhole**

Distance (ft): **.0**
Structural Grade: **0**
O&M Grade: **0**
Clock Start/From:
Clock To:
1st Value:
2nd Value:
Value Percent:
Continuous Index:
Within 8" of Joint: **NO**
Remarks: **M-208-002**

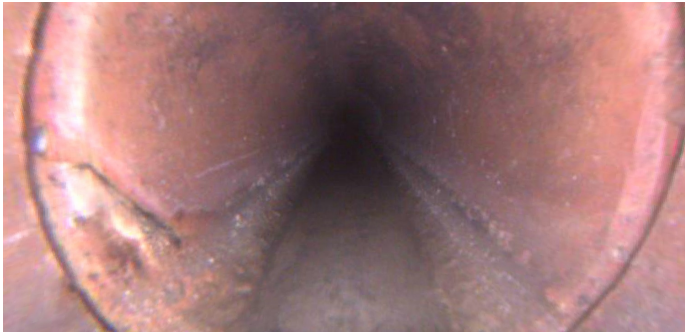
Code:	MWL
Description:	Water Level

Distance (ft):	.0
Structural Grade:	0
O&M Grade:	0
Clock Start/From:	
Clock To:	
1st Value:	
2nd Value:	
Value Percent:	5.000
Continuous Index:	
Within 8" of Joint:	NO
Remarks:

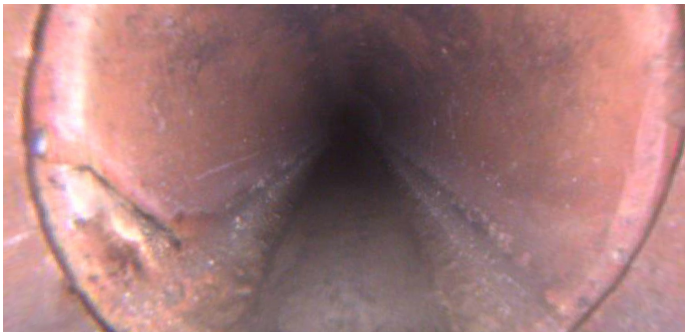
Code:	FS
Description:	Fracture Spiral

Distance (ft):	.0
Structural Grade:	3
O&M Grade:	0
Clock Start/From:	8
Clock To:	9
1st Value:	
2nd Value:	
Value Percent:	
Continuous Index:	
Within 8" of Joint:	YES
Remarks:

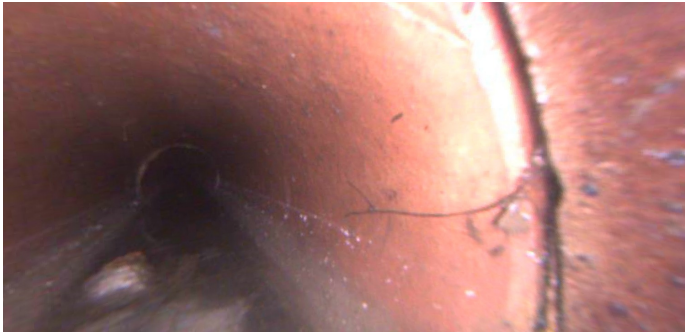
Code: **RFJ**
Description: **Roots Fine Joint**

Distance (ft): **21.8**
Structural Grade: **0**
O&M Grade: **1**
Clock Start/From: **3**
Clock To:
1st Value:
2nd Value:
Value Percent:
Continuous Index:
Within 8" of Joint: **YES**
Remarks:

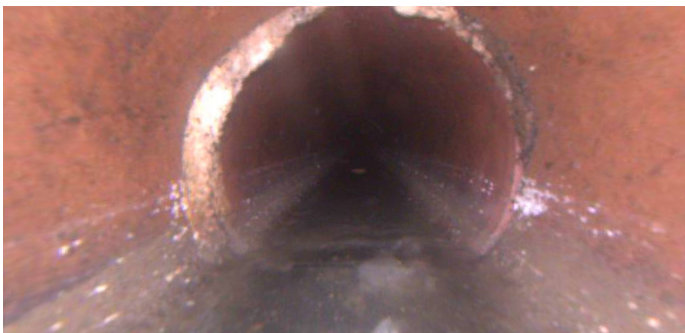
Code: **DAE**
Description: **Deposits Attached Encrustation**

Distance (ft): **24.2**
Structural Grade: **0**
O&M Grade: **2**
Clock Start/From: **8**
Clock To: **4**
1st Value:
2nd Value:
Value Percent: **5.000**
Continuous Index:
Within 8" of Joint: **YES**
Remarks:

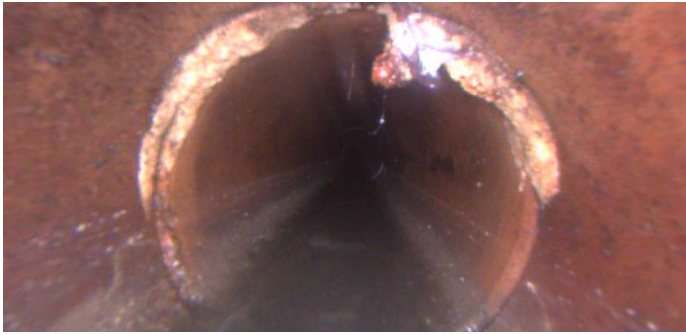
Code: **DAE**
Description: **Deposits Attached Encrustation**

Distance (ft): **30.1**
Structural Grade: **0**
O&M Grade: **2**
Clock Start/From: **8**
Clock To: **4**
1st Value:
2nd Value:
Value Percent: **10.000**
Continuous Index:
Within 8" of Joint: **YES**
Remarks:

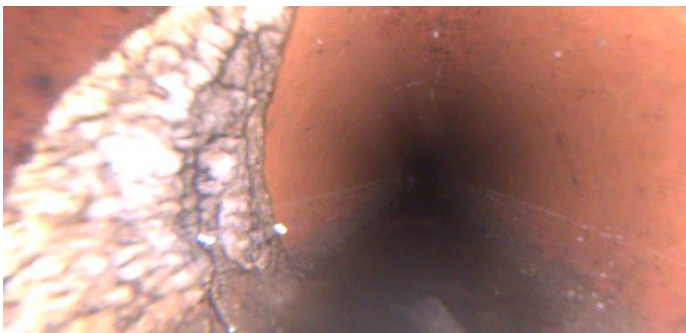
Code: **DAE**
Description: **Deposits Attached Encrustation**

Distance (ft): **36.1**
Structural Grade: **0**
O&M Grade: **2**
Clock Start/From: **8**
Clock To: **11**
1st Value:
2nd Value:
Value Percent: **5.000**
Continuous Index:
Within 8" of Joint: **YES**
Remarks:

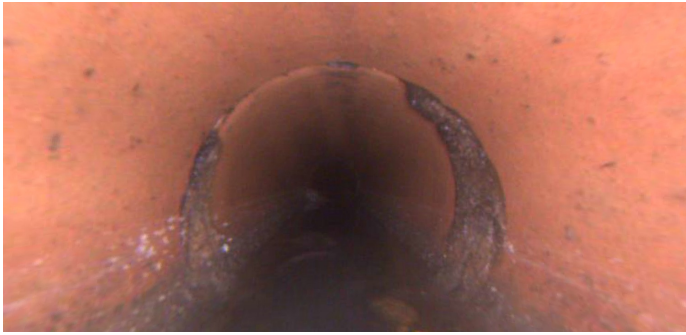
Code: **DAE**
Description: **Deposits Attached Encrustation**

Distance (ft): **38.7**
Structural Grade: **0**
O&M Grade: **2**
Clock Start/From: **8**
Clock To: **4**
1st Value:
2nd Value:
Value Percent: **5.000**
Continuous Index:
Within 8" of Joint: **YES**
Remarks:

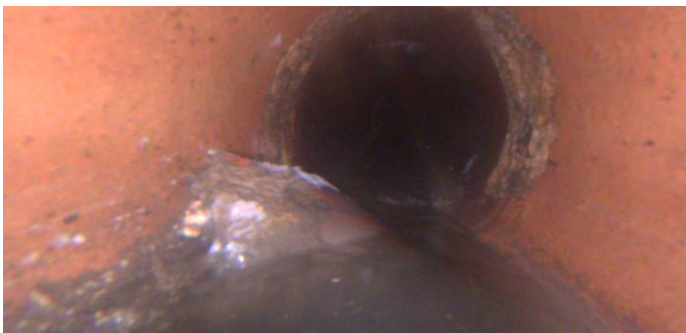
Code: **OBM**
Description: **Obstacle Pipe Material**

Distance (ft): **41.5**
Structural Grade: **0**
O&M Grade: **2**
Clock Start/From: **6**
Clock To: **8**
1st Value:
2nd Value:
Value Percent: **10.000**
Continuous Index:
Within 8" of Joint: **NO**
Remarks:

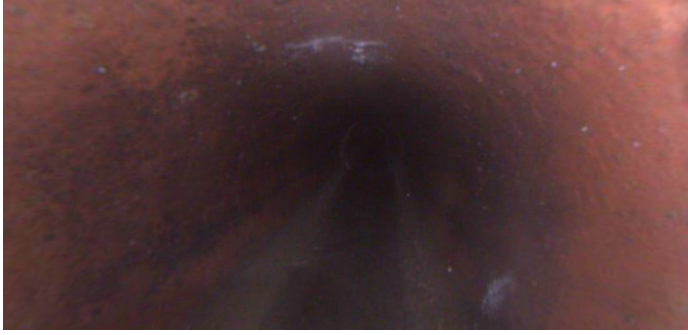
Code:	MSA
Description:	Abandoned Survey
Distance (ft):	42.2
Structural Grade:	0
O&M Grade:	0
Clock Start/From:	
Clock To:	
1st Value:	
2nd Value:	
Value Percent:	
Continuous Index:	
Within 8" of Joint:	NO
Remarks:	OBM
