Profile/Photo Observation Report

Street:	FOXCROFT STREET	Flow Control:	Not Controlled
City:	Hobart, IN	Year Renewed:	
Location:	Light Highway	Tape/Media #:	
Purpose:	Routine Assessment	Dia/Height:	8"
Use:	Sanitary	Material:	PVC
Drain Area:	NA	Lining:	
Category:	NA		
Comment:	P_C at 41 ft debris . Flow direction wrong		
Location Details:		Direction of Survey:	Upstream
US MH:	M-208-003	DS MH:	M-208-002
		Total Length Surveyed (ft):	42.2

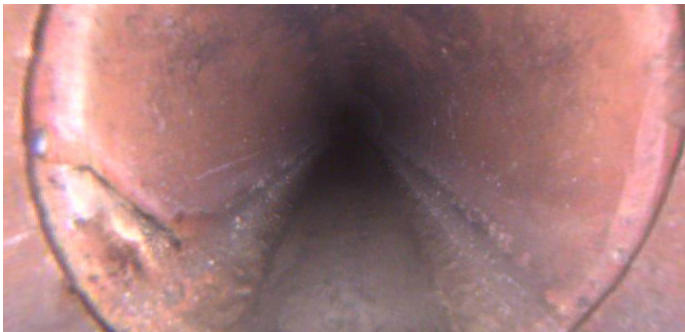
Code:	FS
Description:	Fracture Spiral

Distance (ft):	.0
Structural Grade:	3
O&M Grade:	0
Clock Start/From:	8
Clock To:	9
1st Value:	
2nd Value:	
Value Percent:	
Continuous Index:	
Within 8" of Joint:	YES
Remarks:

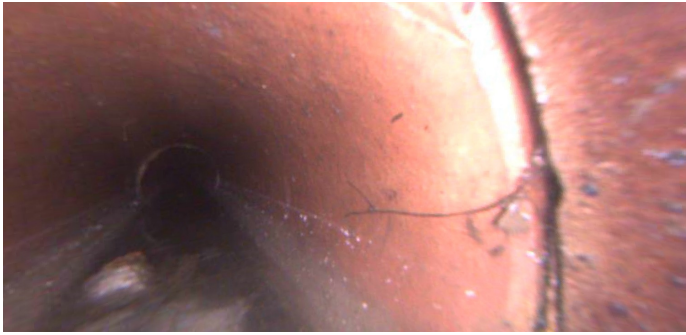
Code: **RFJ**
Description: **Roots Fine Joint**

Distance (ft): **21.8**
Structural Grade: **0**
O&M Grade: **1**
Clock Start/From: **3**
Clock To:
1st Value:
2nd Value:
Value Percent:
Continuous Index:
Within 8" of Joint: **YES**
Remarks:

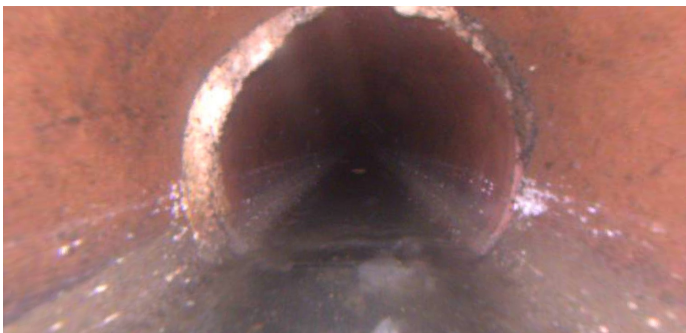
Code: **DAE**
Description: **Deposits Attached Encrustation**

Distance (ft): **24.2**
Structural Grade: **0**
O&M Grade: **2**
Clock Start/From: **8**
Clock To: **4**
1st Value:
2nd Value:
Value Percent: **5.000**
Continuous Index:
Within 8" of Joint: **YES**
Remarks:

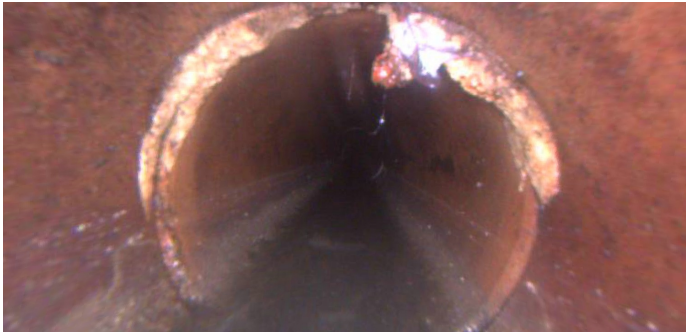
Code: **DAE**
Description: **Deposits Attached Encrustation**

Distance (ft): **30.1**
Structural Grade: **0**
O&M Grade: **2**
Clock Start/From: **8**
Clock To: **4**
1st Value:
2nd Value:
Value Percent: **10.000**
Continuous Index:
Within 8" of Joint: **YES**
Remarks:

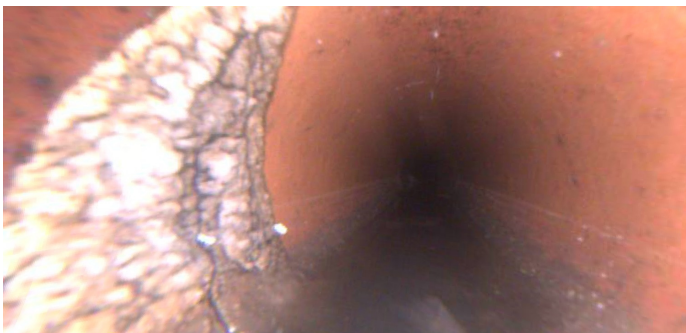
Code: **DAE**
Description: **Deposits Attached Encrustation**

Distance (ft): **36.1**
Structural Grade: **0**
O&M Grade: **2**
Clock Start/From: **8**
Clock To: **11**
1st Value:
2nd Value:
Value Percent: **5.000**
Continuous Index:
Within 8" of Joint: **YES**
Remarks:

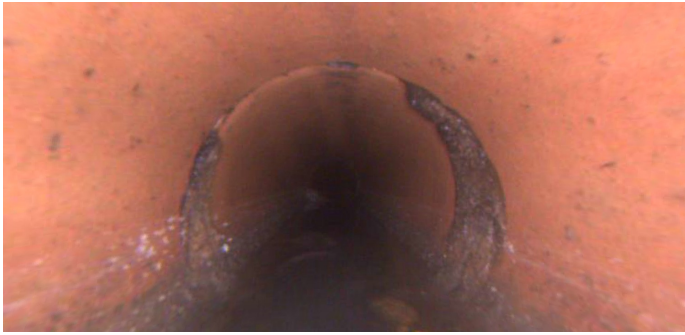
Code: **DAE**
Description: **Deposits Attached Encrustation**

Distance (ft): **38.7**
Structural Grade: **0**
O&M Grade: **2**
Clock Start/From: **8**
Clock To: **4**
1st Value:
2nd Value:
Value Percent: **5.000**
Continuous Index:
Within 8" of Joint: **YES**
Remarks:

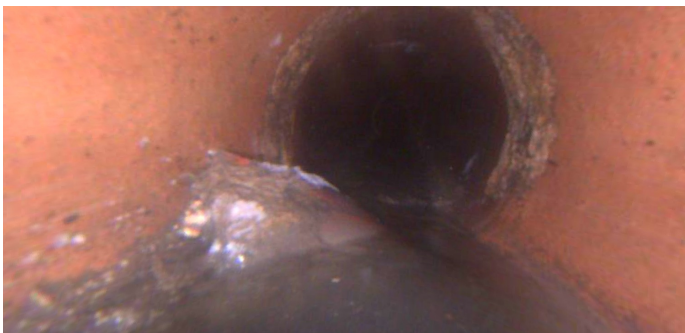
Code: **OBM**
Description: **Obstacle Pipe Material**

Distance (ft): **41.5**
Structural Grade: **0**
O&M Grade: **2**
Clock Start/From: **6**
Clock To: **8**
1st Value:
2nd Value:
Value Percent: **10.000**
Continuous Index:
Within 8" of Joint: **NO**
Remarks:

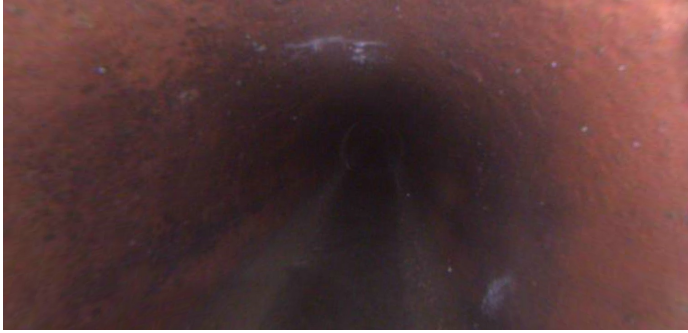
Code:	MSA
Description:	Abandoned Survey
Distance (ft):	42.2
Structural Grade:	0
O&M Grade:	0
Clock Start/From:	
Clock To:	
1st Value:	
2nd Value:	
Value Percent:	
Continuous Index:	
Within 8" of Joint:	NO
Remarks:	OBM
