Profile/Photo Observation Report

| Street: | FOXCROFT STREET | Flow Control: | Not Controlled |
| City: | Hobart, IN | Year Renewed: | |
| US MH: | M-208-004 | DS MH: | M-208-003 |

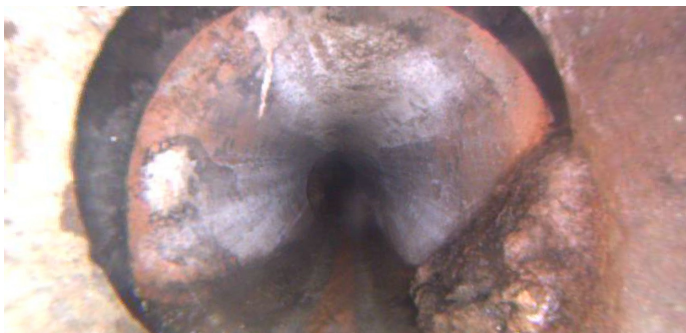
Code: **JOM**
Description: **Joint Offset Medium**

Distance (ft): **.0**
Structural Grade: **1**
O&M Grade: **0**
Clock Start/From:
Clock To:
1st Value:
2nd Value:
Value Percent:
Continuous Index:
Within 8" of Joint: **NO**
Remarks:

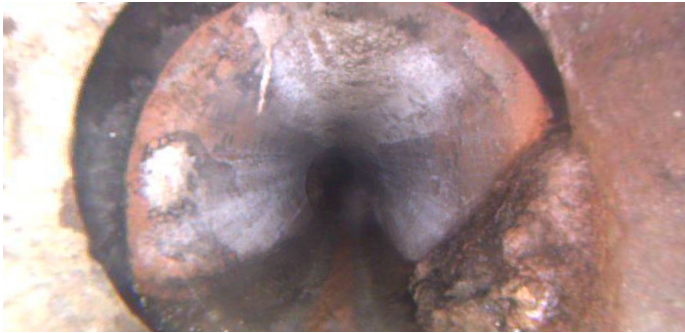
| Code: | DAE |
| Description: | Deposits Attached Encrustation |

| O&M Grade: | 2 |
| Value Percent: | 5.000 |

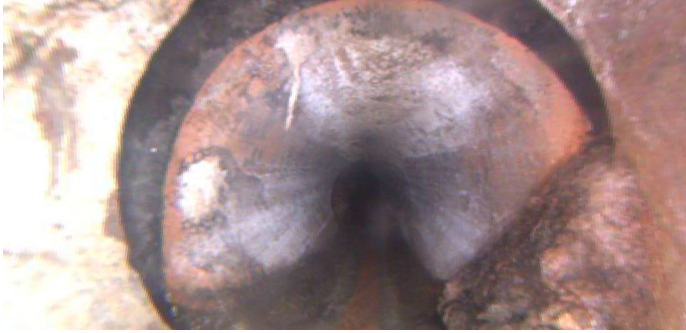
Code: **MWL**
Description: **Water Level**

Distance (ft): **.0**
Structural Grade: **0**
O&M Grade: **0**
Clock Start/From:
Clock To:
1st Value:
2nd Value:
Value Percent: **5.000**
Continuous Index:
Within 8" of Joint: **NO**
Remarks:

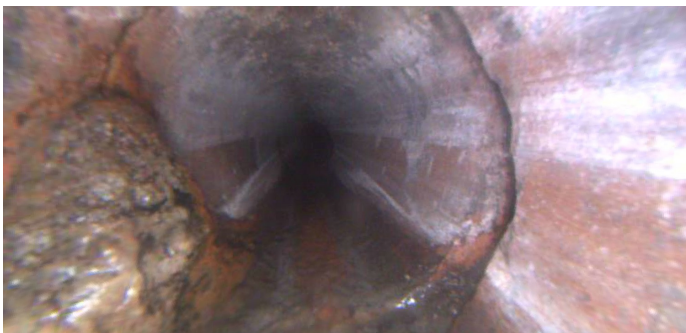
Code: **DAE**
Description: **Deposits Attached Encrustation**

Distance (ft): **3.4**
Structural Grade: **0**
O&M Grade: **2**
Clock Start/From: **7**
Clock To: **9**
1st Value:
2nd Value:
Value Percent: **10.000**
Continuous Index:
Within 8" of Joint: **YES**
Remarks:

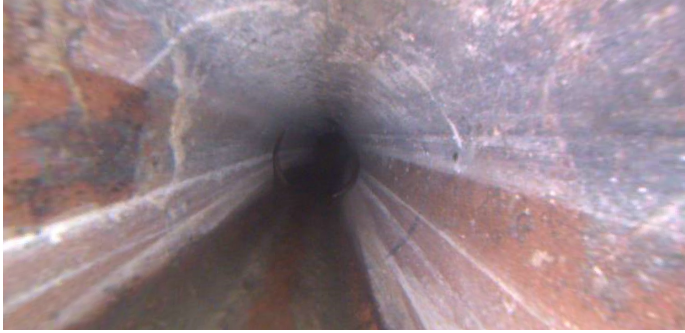
Code: **CC**
Description: **Crack Circumferential**

Distance (ft): **4.6**
Structural Grade: **1**
O&M Grade: **0**
Clock Start/From: **9**
Clock To: **3**
1st Value:
2nd Value:
Value Percent:
Continuous Index:
Within 8" of Joint:
Remarks:

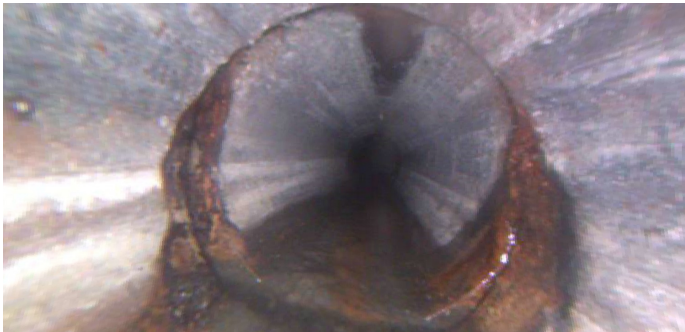
Code: **DAE**
Description: **Deposits Attached Encrustation**

Distance (ft): **6.4**
Structural Grade: **0**
O&M Grade: **2**
Clock Start/From: **2**
Clock To: **10**
1st Value:
2nd Value:
Value Percent: **10.000**
Continuous Index: **S01**
Within 8" of Joint: **YES**
Remarks:

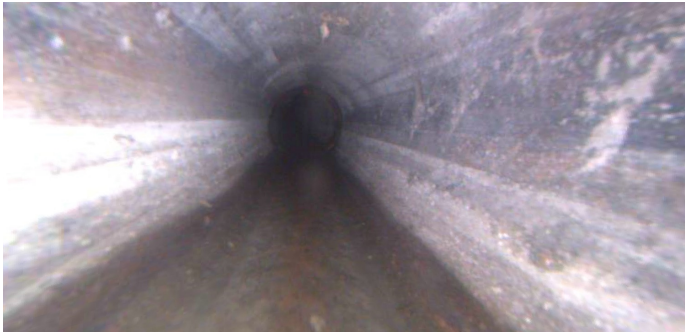
Code: **DAGS**
Description: **Deposits Attached Grease**

Distance (ft): **7.3**
Structural Grade: **0**
O&M Grade: **2**
Clock Start/From: **8**
Clock To: **4**
1st Value:
2nd Value:
Value Percent: **5.000**
Continuous Index: **S04**
Within 8" of Joint: **NO**
Remarks:

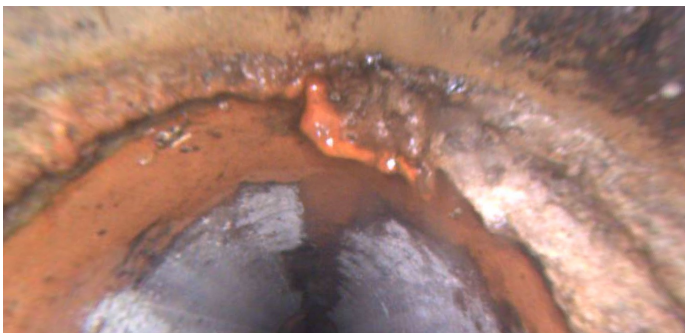
Code: **ID**
Description: **Infil Dripper**

Distance (ft): **9.8**
Structural Grade: **0**
O&M Grade: **3**
Clock Start/From: **12**
Clock To:
1st Value:
2nd Value:
Value Percent:
Continuous Index:
Within 8" of Joint: **YES**
Remarks:

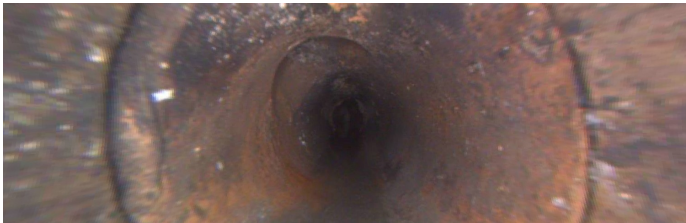
Code: **DAE**
Description: **Deposits Attached Encrustation**

Distance (ft): **19.2**
Structural Grade: **0**
O&M Grade: **2**
Clock Start/From: **7**
Clock To: **9**
1st Value:
2nd Value:
Value Percent: **5.000**
Continuous Index:
Within 8" of Joint: **NO**
Remarks:

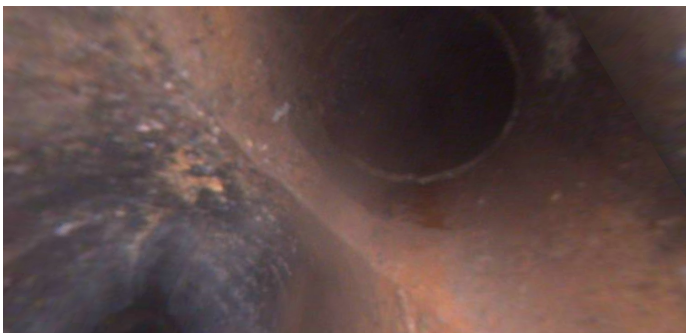
Code: **TF**
Description: **Tap Factory**

Distance (ft): **20.5**
Structural Grade: **0**
O&M Grade: **0**
Clock Start/From: **10**
Clock To:
1st Value: **4.000**
2nd Value:
Value Percent:
Continuous Index:
Within 8" of Joint:
Remarks:

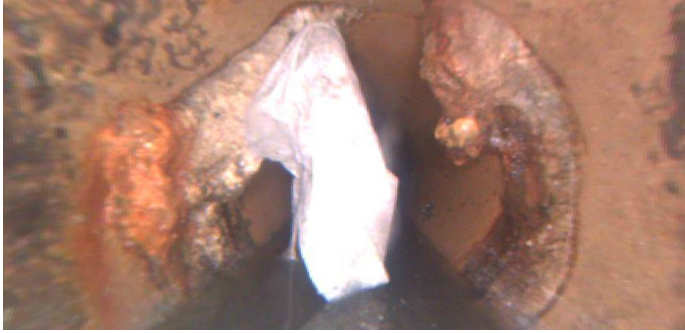
Code: **DAR**
Description: **Deposits Attached Ragging**

Distance (ft): **25.3**
Structural Grade: **0**
O&M Grade: **4**
Clock Start/From: **9**
Clock To: **11**
1st Value:
2nd Value:
Value Percent: **25.000**
Continuous Index:
Within 8" of Joint: **NO**
Remarks:

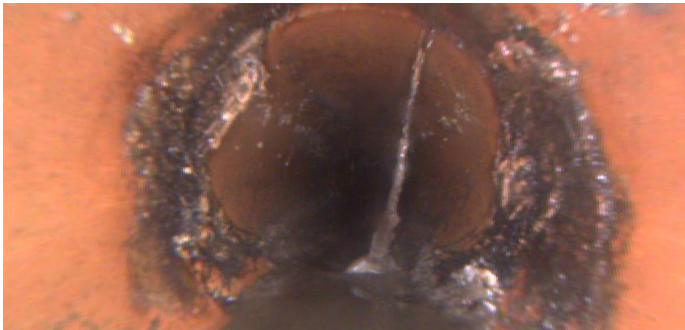
Code: **RMJ**
Description: **Roots Medium Joint**

Distance (ft): **57.0**
Structural Grade: **0**
O&M Grade: **3**
Clock Start/From: **7**
Clock To: **5**
1st Value:
2nd Value:
Value Percent: **10.000**
Continuous Index: **S02**
Within 8" of Joint: **YES**
Remarks:

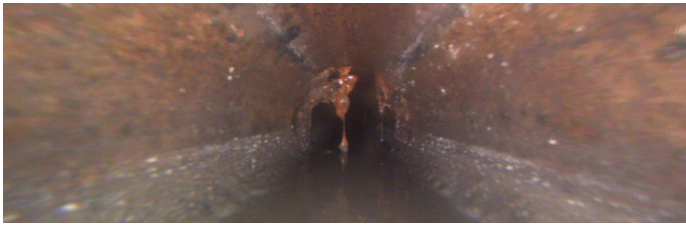
Code: **RMJ**
Description: **Roots Medium Joint**

Distance (ft): **72.3**
Structural Grade: **0**
O&M Grade: **3**
Clock Start/From: **7**
Clock To: **5**
1st Value:
2nd Value:
Value Percent: **10.000**
Continuous Index: **F02**
Within 8" of Joint: **YES**
Remarks:

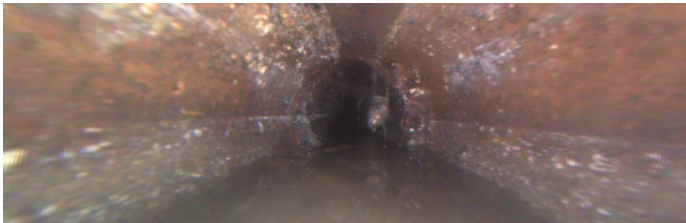
Code: **RMJ**
Description: **Roots Medium Joint**

Distance (ft): **78.7**
Structural Grade: **0**
O&M Grade: **3**
Clock Start/From: **7**
Clock To: **5**
1st Value:
2nd Value:
Value Percent: **10.000**
Continuous Index: **S03**
Within 8" of Joint: **YES**
Remarks:

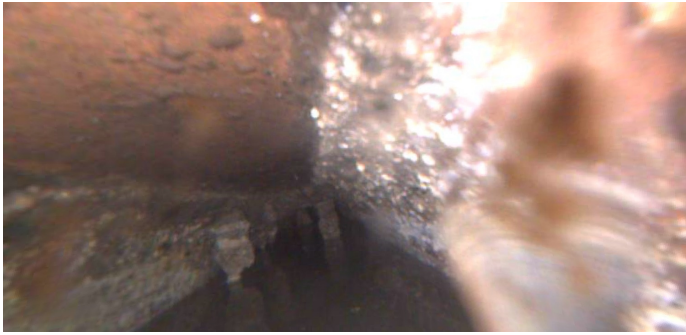
Code: **DAGS**
Description: **Deposits Attached Grease**

Distance (ft): **99.0**
Structural Grade: **0**
O&M Grade: **2**
Clock Start/From: **8**
Clock To: **4**
1st Value:
2nd Value:
Value Percent: **5.000**
Continuous Index: **F04**
Within 8" of Joint: **NO**
Remarks:

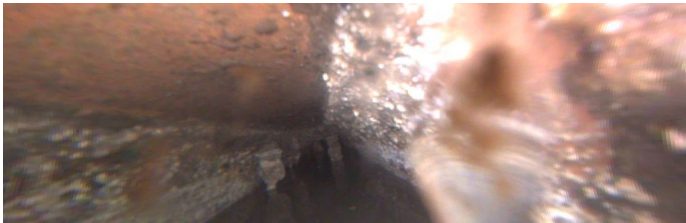
Code: **RMJ**
Description: **Roots Medium Joint**

Distance (ft): **99.0**
Structural Grade: **0**
O&M Grade: **3**
Clock Start/From: **7**
Clock To: **5**
1st Value:
2nd Value:
Value Percent: **10.000**
Continuous Index: **F03**
Within 8" of Joint: **YES**
Remarks:

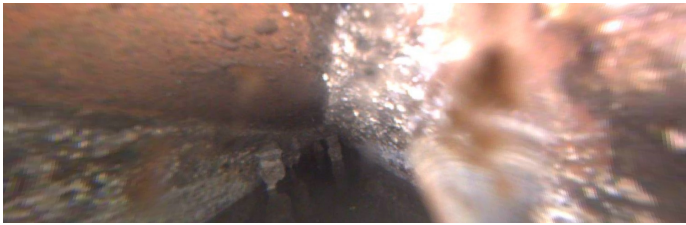
Code: **DAE**
Description: **Deposits Attached Encrustation**

Distance (ft): **99.0**
Structural Grade: **0**
O&M Grade: **2**
Clock Start/From: **2**
Clock To: **10**
1st Value:
2nd Value:
Value Percent: **10.000**
Continuous Index: **F01**
Within 8" of Joint: **YES**
Remarks:

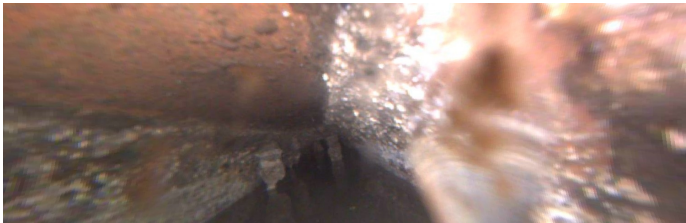
Code: **MSA**
Description: **Abandoned Survey**

Distance (ft): **99.0**
Structural Grade: **0**
O&M Grade: **0**
Clock Start/From:
Clock To:
1st Value:
2nd Value:
Value Percent:
Continuous Index:
Within 8" of Joint: **NO**
Remarks: **camera stopped**
