Profile/Ph	oto Observatior	n Report			RedZone
Date:	03/22/2018	Weather:		Coding:	PACP 6.0
Pipe Length (ft)	: 318.8	Owner:	NA	Pre Clean:	No Pre-Cleaning
P.O.#:		Surveyor:	Selasie Honu	PSR:	P-208-003-004
Customer:		Clean Date:	01/01/1900	Shape:	C
Street:	FOXCROFT STREET	г	Flow Control:	Not Controlled	
City:	Hobart, IN		Year Renewed:		
Location:	Light Highway		Tape/Media #:		
Purpose:	Routine Assessme	ent	Dia/Height:	8"	
Use:	Sanitary		Material:	VCP	
Drain Area:	NA		Lining:		
Category:	NA				
Comment:	F_S_P_C at 0 ft bu	ild up on the pipe			
Location Detail	s:		Direction of Survey:	Downstream	
US MH:	M-208-004	DS MH: N	1-208-003	Total Length Surveyed (ft)	: 2.1
0&M Index:	3.00	O&M Quick:	4121	O&M Rating:	6.00
tructural Index:	0.00	Structural Quic	k: 0000	Structural Rating:	0.00
Overall Index:	3.00	Overall Quick:	4121	Overall Rating:	6.00

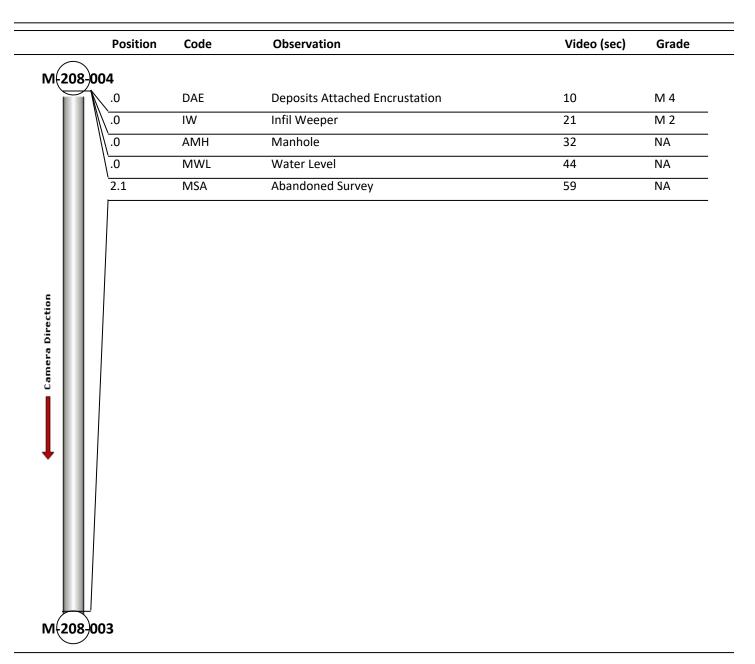
Code: Description:	DAE Deposits Attached Encrustation
Distance (ft):	.0
Structural Grade:	0
O&M Grade:	4
Clock Start/From:	8
Clock To:	4
1st Value:	
2nd Value:	
Value Percent:	30.000
Continuous Index:	
Within 8" of Joint:	YES
Remarks:

Code: IW Description: Infil Weeper

Distance (ft):	.0
Structural Grade:	0
O&M Grade:	2
Clock Start/From:	8
Clock To:	4
1st Value:	
2nd Value:	
Value Percent:	
Continuous Index:	
Within 8" of Joint:	YES
Remarks:
