Profile/Photo Observation Report

Date:	03/23/2018	Weather:		Coding:	PACP 6.0
Pipe Length (ft):	204.1	Owner:	NA	Pre Clean:	No Pre-Cleaning
P.O.#:		Surveyor:	Justin Gonzales	PSR:	P-208-006-007
Customer:		Clean Date:	01/01/1900	Shape:	C

Street:	ALLEY BETWEEN MINNESOTA ST & V	Flow Control:	Not Controlled
City:	Hobart, IN	Year Renewed:	
Location:	Light Highway	Tape/Media #:	
Purpose:	Routine Assessment	Dia/Height:	8"
Use:	Sanitary	Material:	VCP
Drain Area:	NA	Lining:	
Category:	NA		
Comment:	P_C at 123 nothing visible. Flow direction wrong		
Location Details:		Direction of Survey:	Downstream
US MH:	M-208-007	DS MH:	M-208-006
		Total Length Surveyed (ft):	124.6

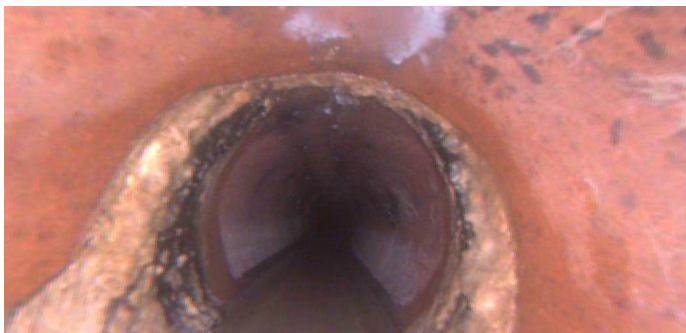
Code: **AMH**
Description: **Manhole**

Distance (ft): **.0**
Structural Grade: **0**
O&M Grade: **0**
Clock Start/From:
Clock To:
1st Value:
2nd Value:
Value Percent:
Continuous Index:
Within 8" of Joint: **NO**
Remarks: **M-208-007**

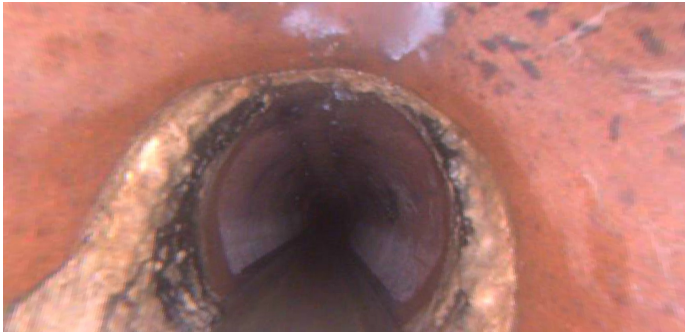
Code:	MWL
Description:	Water Level

Distance (ft):	.0
Structural Grade:	0
O&M Grade:	0
Clock Start/From:	
Clock To:	
1st Value:	
2nd Value:	
Value Percent:	5.000
Continuous Index:	
Within 8" of Joint:	NO
Remarks:

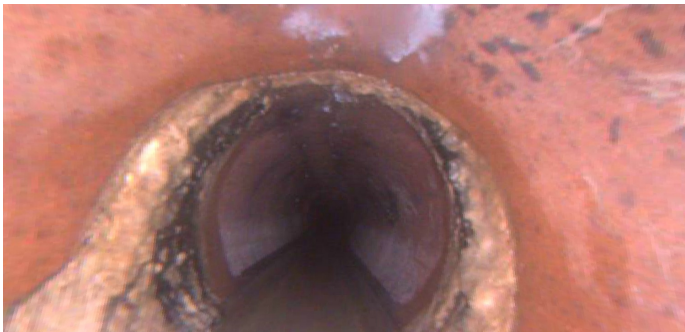
Code:	DAE
Description:	Deposits Attached Encrustation

Distance (ft):	.0
Structural Grade:	0
O&M Grade:	2
Clock Start/From:	7
Clock To:	5
1st Value:	
2nd Value:	
Value Percent:	5.000
Continuous Index:	
Within 8" of Joint:	YES
Remarks:

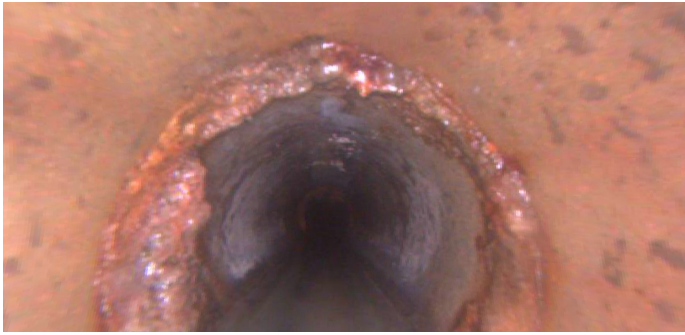
Code: **DAE**
Description: **Deposits Attached Encrustation**

Distance (ft): **4.1**
Structural Grade: **0**
O&M Grade: **2**
Clock Start/From: **7**
Clock To: **5**
1st Value:
2nd Value:
Value Percent: **5.000**
Continuous Index: **S01**
Within 8" of Joint: **YES**
Remarks: **WANDER**

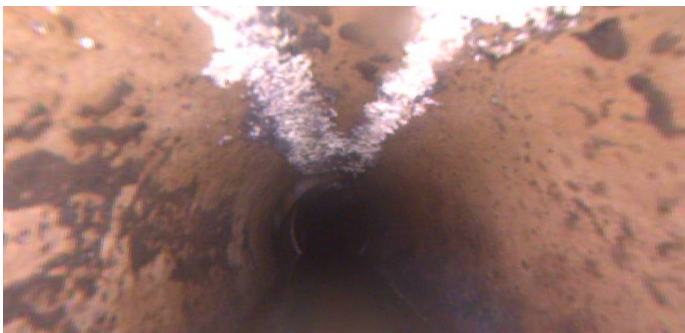
Code: **DAGS**
Description: **Deposits Attached Grease**

Distance (ft): **8.1**
Structural Grade: **0**
O&M Grade: **2**
Clock Start/From: **7**
Clock To: **5**
1st Value:
2nd Value:
Value Percent: **5.000**
Continuous Index: **S02**
Within 8" of Joint: **YES**
Remarks: **WANDER**

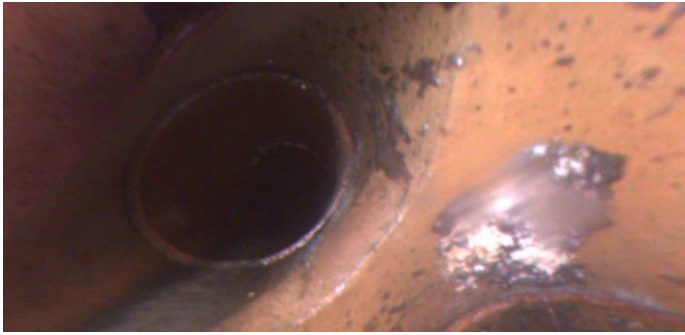
Code: **TF**
Description: **Tap Factory**

Distance (ft): **9.8**
Structural Grade: **0**
O&M Grade: **0**
Clock Start/From: **10**
Clock To:
1st Value: **4.000**
2nd Value:
Value Percent:
Continuous Index:
Within 8" of Joint:
Remarks:

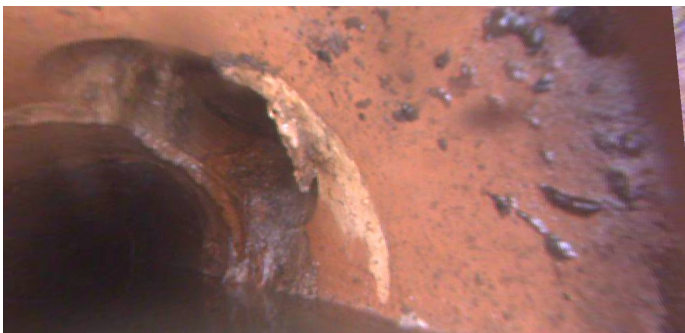
Code: **DAE**
Description: **Deposits Attached Encrustation**

Distance (ft): **53.2**
Structural Grade: **0**
O&M Grade: **2**
Clock Start/From: **1**
Clock To: **5**
1st Value:
2nd Value:
Value Percent: **5.000**
Continuous Index:
Within 8" of Joint: **NO**
Remarks:

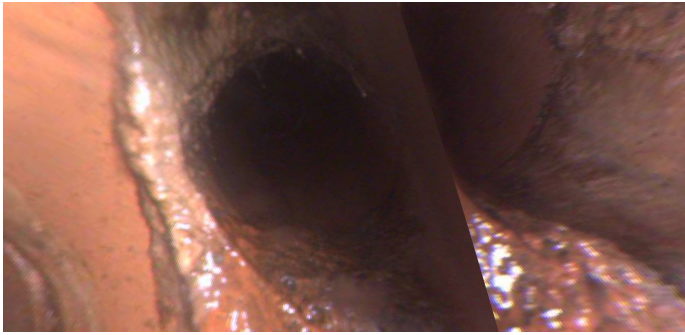
Code: **TF**
Description: **Tap Factory**

Distance (ft): **53.8**
Structural Grade: **0**
O&M Grade: **0**
Clock Start/From: **2**
Clock To:
1st Value: **4.000**
2nd Value:
Value Percent:
Continuous Index:
Within 8" of Joint:
Remarks:

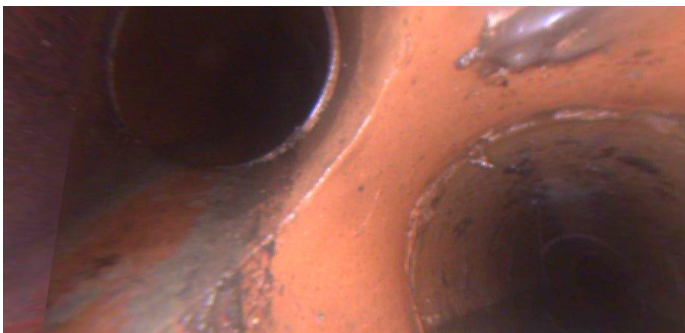
Code: **TF**
Description: **Tap Factory**

Distance (ft): **68.2**
Structural Grade: **0**
O&M Grade: **0**
Clock Start/From: **10**
Clock To:
1st Value: **4.000**
2nd Value:
Value Percent:
Continuous Index:
Within 8" of Joint:
Remarks:

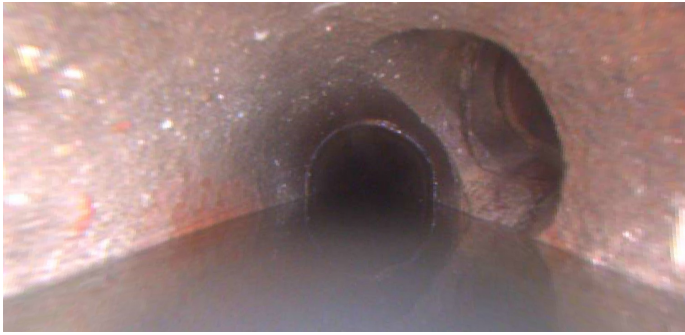
Code: **TF**
Description: **Tap Factory**

Distance (ft): **102.8**
Structural Grade: **0**
O&M Grade: **0**
Clock Start/From: **2**
Clock To:
1st Value: **4.000**
2nd Value:
Value Percent:
Continuous Index:
Within 8" of Joint:
Remarks:

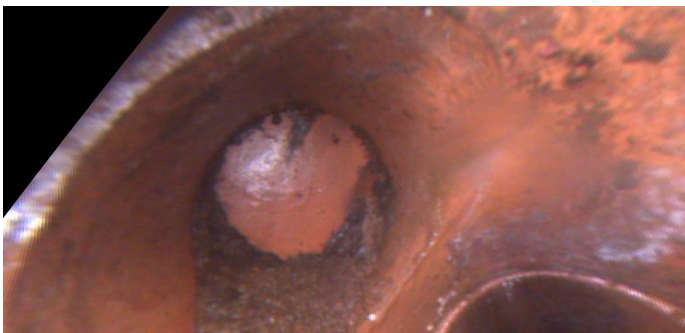
Code: **TFC**
Description: **Tap Factory Capped**

Distance (ft): **123.9**
Structural Grade: **0**
O&M Grade: **0**
Clock Start/From: **10**
Clock To:
1st Value: **4.000**
2nd Value:
Value Percent:
Continuous Index:
Within 8" of Joint:
Remarks:

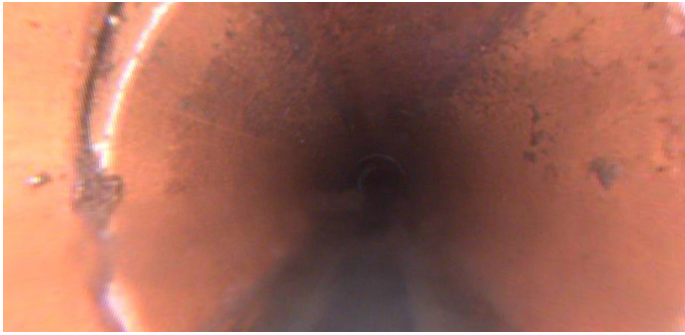
Code: **MSA**
Description: **Abandoned Survey**

Distance (ft): **124.6**
Structural Grade: **0**
O&M Grade: **0**
Clock Start/From:
Clock To:
1st Value:
2nd Value:
Value Percent:
Continuous Index:
Within 8" of Joint: **NO**
Remarks: **ROBOT HAS STOPPED**

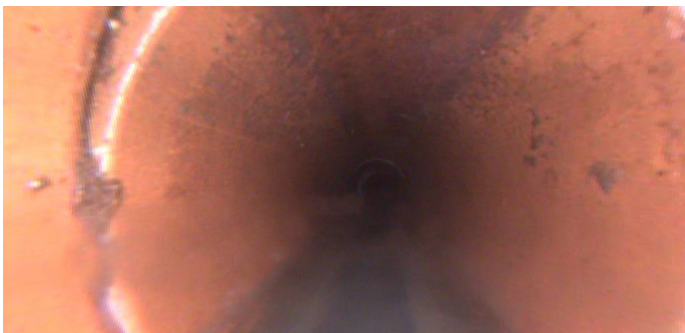
Code: **DAGS**
Description: **Deposits Attached Grease**

Distance (ft): **124.6**
Structural Grade: **0**
O&M Grade: **2**
Clock Start/From: **7**
Clock To: **5**
1st Value:
2nd Value:
Value Percent: **5.000**
Continuous Index: **F02**
Within 8" of Joint: **YES**
Remarks: **WANDER**

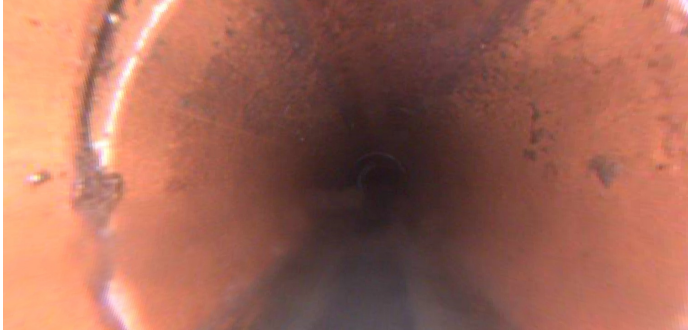
Code:	DAE
Description:	Deposits Attached Encrustation
Distance (ft):	124.6
Structural Grade:	0
O&M Grade:	2
Clock Start/From:	7
Clock To:	5
1st Value:	
2nd Value:	
Value Percent:	5.000
Continuous Index:	F01
Within 8" of Joint:	YES
Remarks:	WANDER
