## Profile/Photo Observation Report

Date:	<b>03/22/2018</b>	Weather:		Coding:	<b>PACP 6.0</b>
Pipe Length (ft):	<b>201.5</b>	Owner:	<b>NA</b>	Pre Clean:	<b>No Pre-Cleaning</b>
P.O.#:		Surveyor:	<b>Selasie Honu</b>	PSR:	<b>P-208-007-008</b>
Customer:		Clean Date:	<b>01/01/1900</b>	Shape:	<b>C</b>

Street:	<b>16TH ST</b>	Flow Control:	<b>Not Controlled</b>
City:	<b>Hobart, IN</b>	Year Renewed:	
Location:	<b>Light Highway</b>	Tape/Media #:	
Purpose:	<b>Routine Assessment</b>	Dia/Height:	<b>8"</b>
Use:	<b>Sanitary</b>	Material:	<b>VCP</b>
Drain Area:	<b>NA</b>	Lining:	
Category:	<b>NA</b>		
Comment:

Location Details:		Direction of Survey:	<b>Upstream</b>
US MH:	<b>M-208-007</b>	DS MH:	<b>M-208-008</b>
		Total Length Surveyed (ft):	<b>68.9</b>

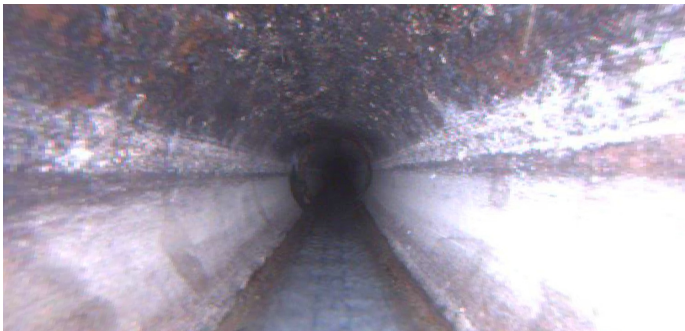
Code: **AMH**  
Description: **Manhole**

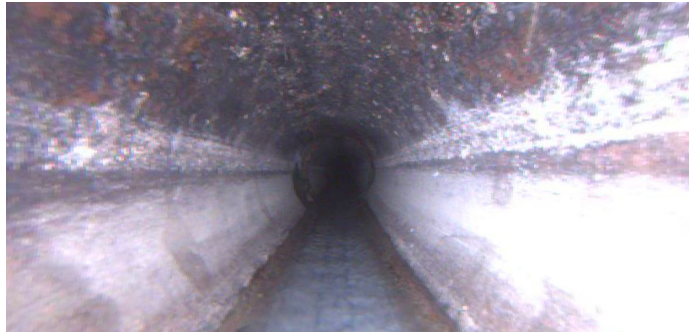
Code: **MWL**  
Description: **Water Level**

Distance (ft): **.0**  
Structural Grade: **0**  
O&M Grade: **0**  
Clock Start/From:  
Clock To:  
1st Value:  
2nd Value:  
Value Percent: **5.000**  
Continuous Index:  
Within 8" of Joint: **NO**  
Remarks:

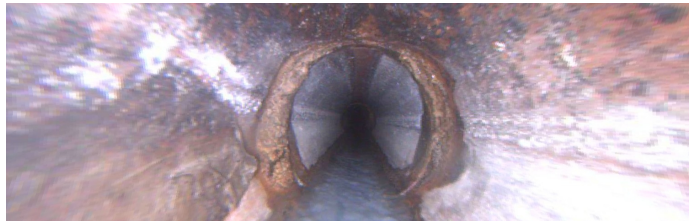
Code: **DAE**  
Description: **Deposits Attached Encrustation**

Distance (ft): **3.1**  
Structural Grade: **0**  
O&M Grade: **2**  
Clock Start/From: **7**  
Clock To: **5**  
1st Value:  
2nd Value:  
Value Percent: **5.000**  
Continuous Index:  
Within 8" of Joint: **YES**  
Remarks:

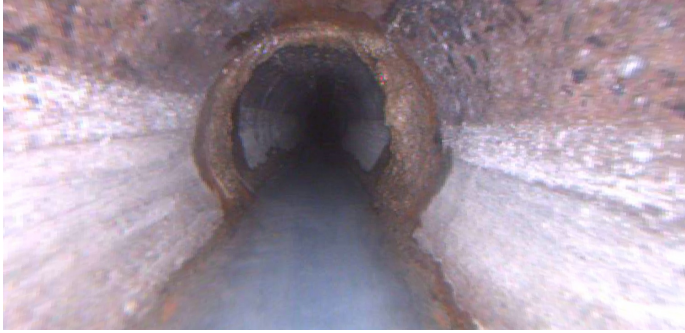
Code: **DAE**  
Description: **Deposits Attached Encrustation**

Distance (ft): **5.9**  
Structural Grade: **0**  
O&M Grade: **2**  
Clock Start/From: **7**  
Clock To: **5**  
1st Value:  
2nd Value:  
Value Percent: **10.000**  
Continuous Index: **S01**  
Within 8" of Joint: **YES**  
Remarks:

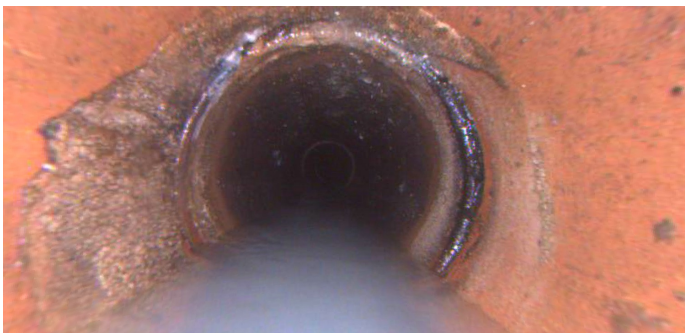
Code: **IW**  
Description: **Infil Weeper**

Distance (ft): **24.5**  
Structural Grade: **0**  
O&M Grade: **2**  
Clock Start/From: **8**  
Clock To: **4**  
1st Value:  
2nd Value:  
Value Percent:  
Continuous Index:  
Within 8" of Joint: **YES**  
Remarks:

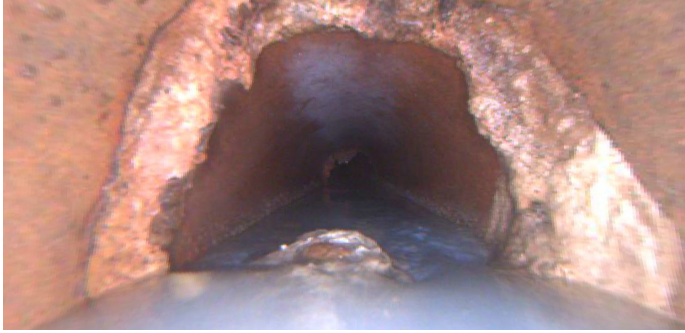
Code: **DSZ**  
Description: **Deposits Settled Other**

Distance (ft): **58.1**  
Structural Grade: **0**  
O&M Grade: **2**  
Clock Start/From: **6**  
Clock To:  
1st Value:  
2nd Value:  
Value Percent: **5.000**  
Continuous Index:  
Within 8" of Joint: **NO**  
Remarks: **mixed material**

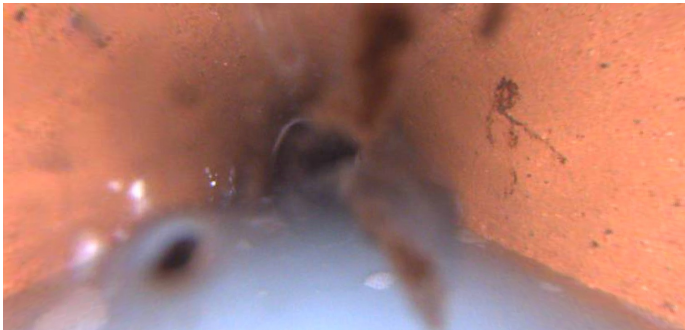
Code: **DAE**  
Description: **Deposits Attached Encrustation**

Distance (ft): **68.9**  
Structural Grade: **0**  
O&M Grade: **2**  
Clock Start/From: **7**  
Clock To: **5**  
1st Value:  
2nd Value:  
Value Percent: **10.000**  
Continuous Index: **F01**  
Within 8" of Joint: **YES**  
Remarks:

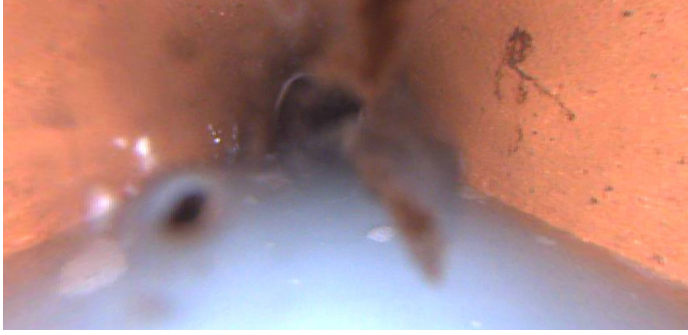
Code:	<b>MSA</b>
Description:	<b>Abandoned Survey</b>
Distance (ft):	<b>68.9</b>
Structural Grade:	<b>0</b>
O&M Grade:	<b>0</b>
Clock Start/From:	
Clock To:	
1st Value:	
2nd Value:	
Value Percent:	
Continuous Index:	
Within 8" of Joint:	<b>NO</b>
Remarks:	<b>camera stopped</b>
