Profile/Photo Observation Report

Date:	03/22/2018	Weather:		Coding:	PACP 6.0
Pipe Length (ft):	201.5	Owner:	NA	Pre Clean:	No Pre-Cleaning
P.O.#:		Surveyor:	Selasie Honu	PSR:	P-208-007-008
Customer:		Clean Date:	01/01/1900	Shape:	C

Street:	FOXCROFT STREET	Flow Control:	Not Controlled
City:	Hobart, IN	Year Renewed:	
Location:	Light Highway	Tape/Media #:	
Purpose:	Routine Assessment	Dia/Height:	8"
Use:	Sanitary	Material:	VCP
Drain Area:	NA	Lining:	
Category:	NA		
Comment:

Location Details:		Direction of Survey:	Upstream
US MH:	M-208-007	DS MH:	M-208-008
		Total Length Surveyed (ft):	68.9

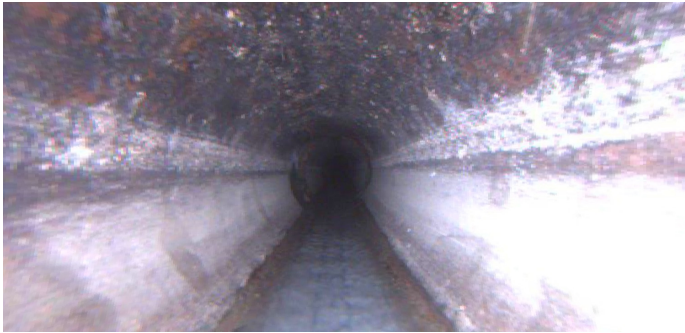
Code:	MWL
Description:	Water Level

Distance (ft):	.0
Structural Grade:	0
O&M Grade:	0
Clock Start/From:	
Clock To:	
1st Value:	
2nd Value:	
Value Percent:	5.000
Continuous Index:	
Within 8" of Joint:	NO
Remarks:

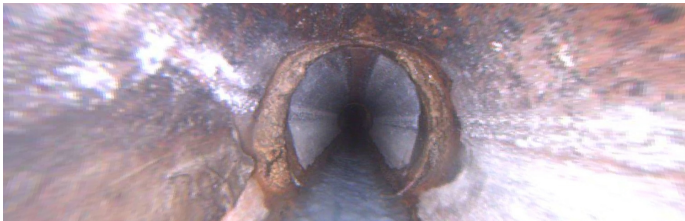
Code:	DAE
Description:	Deposits Attached Encrustation

Distance (ft):	3.1
Structural Grade:	0
O&M Grade:	2
Clock Start/From:	7
Clock To:	5
1st Value:	
2nd Value:	
Value Percent:	5.000
Continuous Index:	
Within 8" of Joint:	YES
Remarks:

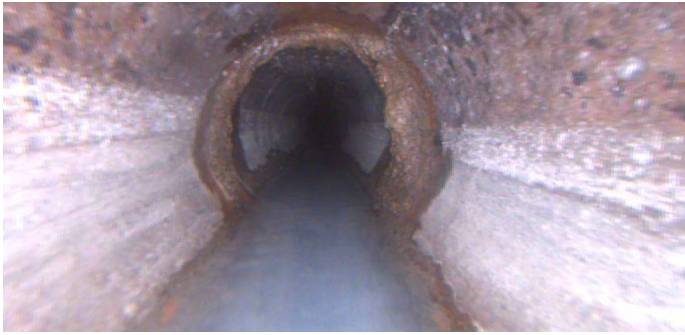
Code: **DAE**
Description: **Deposits Attached Encrustation**

Distance (ft): **5.9**
Structural Grade: **0**
O&M Grade: **2**
Clock Start/From: **7**
Clock To: **5**
1st Value:
2nd Value:
Value Percent: **10.000**
Continuous Index: **S01**
Within 8" of Joint: **YES**
Remarks:

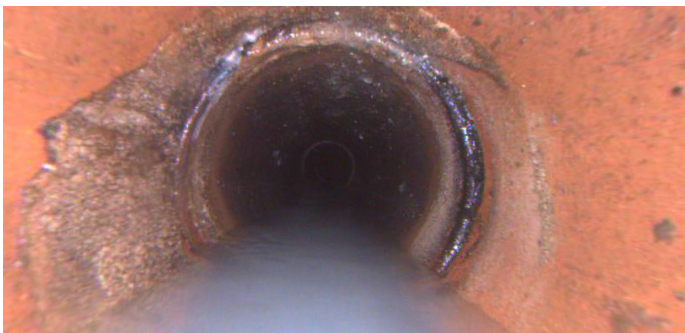
Code: **IW**
Description: **Infil Weeper**

Distance (ft): **24.5**
Structural Grade: **0**
O&M Grade: **2**
Clock Start/From: **8**
Clock To: **4**
1st Value:
2nd Value:
Value Percent:
Continuous Index:
Within 8" of Joint: **YES**
Remarks:

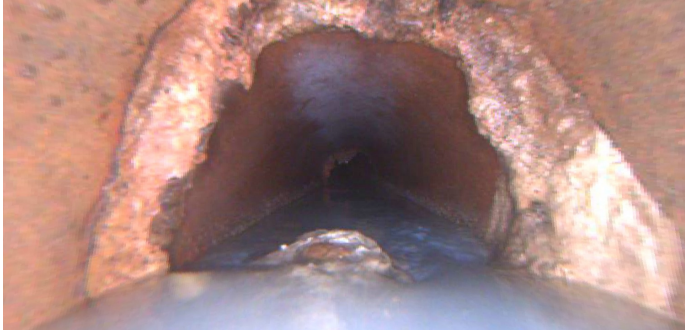
Code: **DSZ**
Description: **Deposits Settled Other**

Distance (ft): **58.1**
Structural Grade: **0**
O&M Grade: **2**
Clock Start/From: **6**
Clock To:
1st Value:
2nd Value:
Value Percent: **5.000**
Continuous Index:
Within 8" of Joint: **NO**
Remarks: **mixed material**

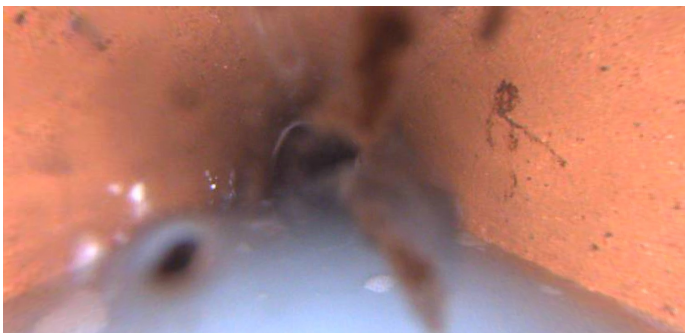
Code: **DAE**
Description: **Deposits Attached Encrustation**

Distance (ft): **68.9**
Structural Grade: **0**
O&M Grade: **2**
Clock Start/From: **7**
Clock To: **5**
1st Value:
2nd Value:
Value Percent: **10.000**
Continuous Index: **F01**
Within 8" of Joint: **YES**
Remarks:

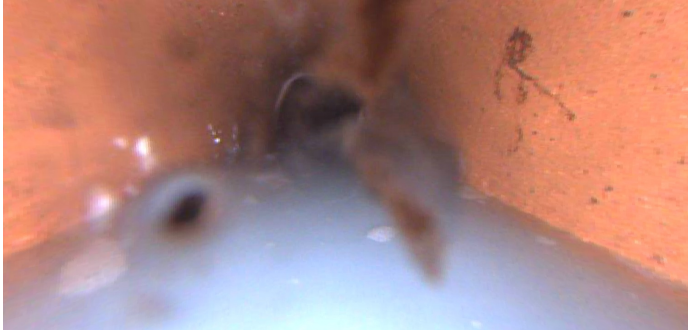
Code:	MSA
Description:	Abandoned Survey
Distance (ft):	68.9
Structural Grade:	0
O&M Grade:	0
Clock Start/From:	
Clock To:	
1st Value:	
2nd Value:	
Value Percent:	
Continuous Index:	
Within 8" of Joint:	NO
Remarks:	camera stopped
