Profile/Photo Observation Report

Date:	03/22/2018	Weather:		Coding:	PACP 6.0
Pipe Length (ft):	310.9	Owner:	NA	Pre Clean:	No Pre-Cleaning
P.O.#:		Surveyor:	Selasie Honu	PSR:	P-208-004-008
Customer:		Clean Date:	01/01/1900	Shape:	C

Street:	16TH ST & MINNESOTA ST	Flow Control:	Not Controlled
City:	Hobart, IN	Year Renewed:	
Location:	Light Highway	Tape/Media #:	
Purpose:	Routine Assessment	Dia/Height:	12"
Use:	Sanitary	Material:	VCP
Drain Area:	NA	Lining:	
Category:	NA		
Comment:	R_M at 15 ft nothing visible . Flow direction wrong		
Location Details:		Direction of Survey:	Upstream
US MH:	M-208-008	DS MH:	M-208-004
		Total Length Surveyed (ft):	16.9

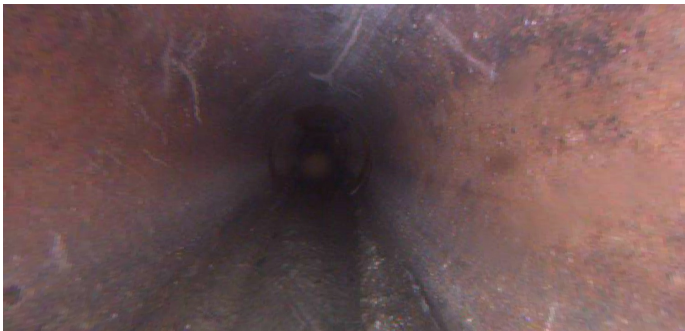
Code: **AMH**
Description: **Manhole**

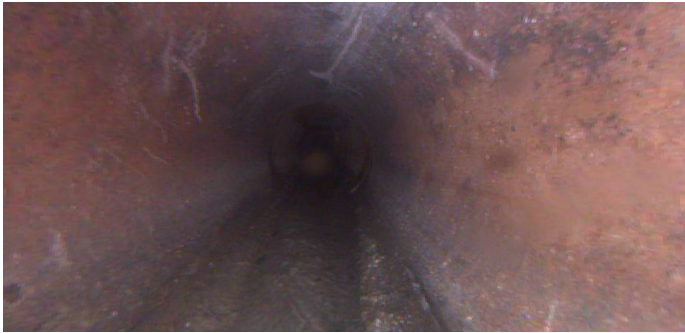
Code:	MWL
Description:	Water Level

Distance (ft):	.0
Structural Grade:	0
O&M Grade:	0
Clock Start/From:	
Clock To:	
1st Value:	
2nd Value:	
Value Percent:	5.000
Continuous Index:	
Within 8" of Joint:	NO
Remarks:

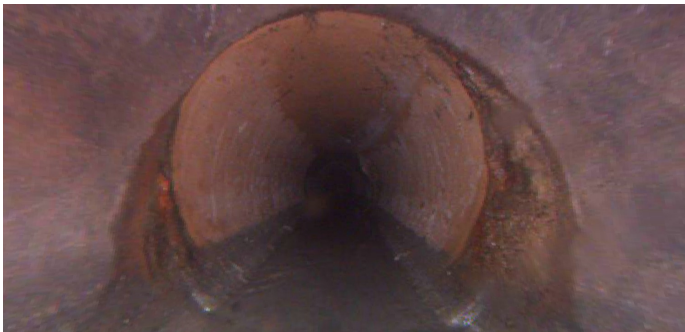
Code:	DAE
Description:	Deposits Attached Encrustation

Distance (ft):	3.1
Structural Grade:	0
O&M Grade:	2
Clock Start/From:	7
Clock To:	5
1st Value:	
2nd Value:	
Value Percent:	10.000
Continuous Index:	S01
Within 8" of Joint:	YES
Remarks:

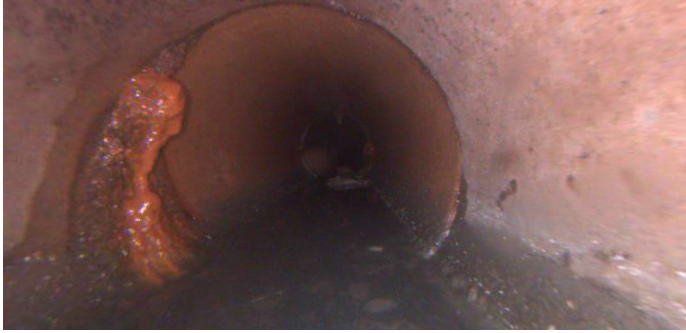
Code: **IW**
Description: **Infil Weeper**

Distance (ft): **11.9**
Structural Grade: **0**
O&M Grade: **2**
Clock Start/From: **7**
Clock To: **11**
1st Value:
2nd Value:
Value Percent:
Continuous Index:
Within 8" of Joint: **YES**
Remarks:

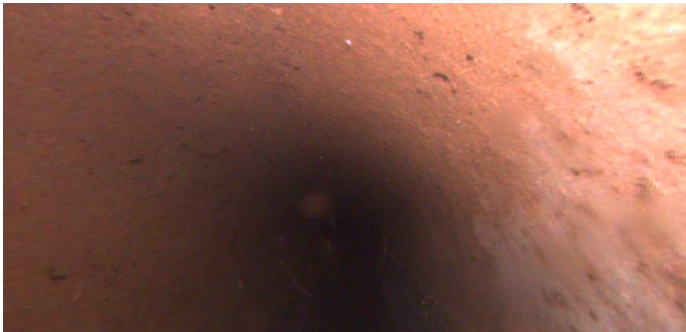
Code: **DAE**
Description: **Deposits Attached Encrustation**

Distance (ft): **16.9**
Structural Grade: **0**
O&M Grade: **2**
Clock Start/From: **7**
Clock To: **5**
1st Value:
2nd Value:
Value Percent: **10.000**
Continuous Index: **F01**
Within 8" of Joint: **YES**
Remarks:

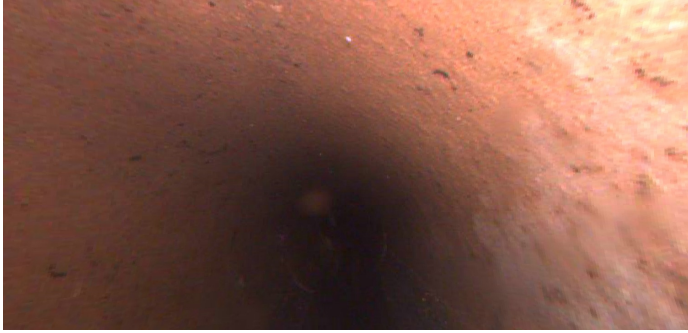
Code:	MSA
Description:	Abandoned Survey
Distance (ft):	16.9
Structural Grade:	0
O&M Grade:	0
Clock Start/From:	
Clock To:	
1st Value:	
2nd Value:	
Value Percent:	
Continuous Index:	
Within 8" of Joint:	NO
Remarks:	camera stopped
