## Profile/Photo Observation Report

Street:	<b>16TH ST &amp; MINNESOTA ST</b>	Flow Control:	<b>Not Controlled</b>
City:	<b>Hobart, IN</b>	Year Renewed:	
Location:	<b>Light Highway</b>	Tape/Media #:	
Purpose:	<b>Routine Assessment</b>	Dia/Height:	<b>12"</b>
Use:	<b>Sanitary</b>	Material:	<b>VCP</b>
Drain Area:	<b>NA</b>	Lining:	
Category:	<b>NA</b>		
Comment:	<b>F_S_P_C at 8 ft debris.Flow direction wrong</b>		
Location Details:		Direction of Survey:	<b>Downstream</b>
US MH:	<b>M-208-008</b>	DS MH:	<b>M-208-004</b>
		Total Length Surveyed (ft):	<b>9.4</b>

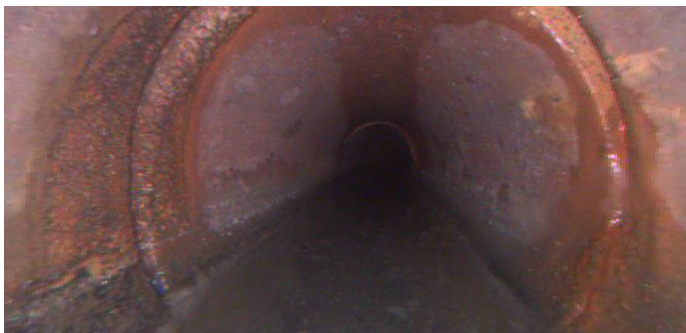
Code: **AMH**  
Description: **Manhole**

Distance (ft): **.0**  
Structural Grade: **0**  
O&M Grade: **0**  
Clock Start/From:  
Clock To:  
1st Value:  
2nd Value:  
Value Percent:  
Continuous Index:  
Within 8" of Joint: **NO**  
Remarks: **M-208-008**

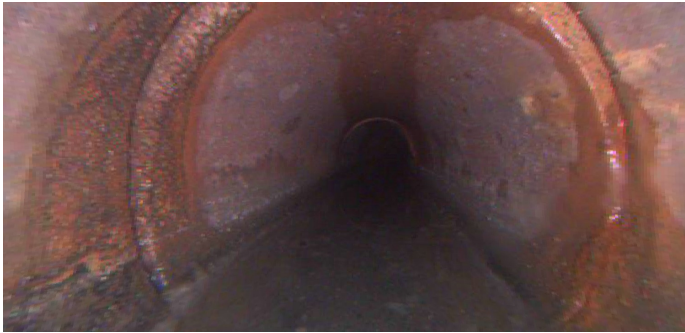
Code:	<b>MWL</b>
Description:	<b>Water Level</b>

Distance (ft):	<b>.0</b>
Structural Grade:	<b>0</b>
O&M Grade:	<b>0</b>
Clock Start/From:	
Clock To:	
1st Value:	
2nd Value:	
Value Percent:	<b>5.000</b>
Continuous Index:	
Within 8" of Joint:	<b>NO</b>
Remarks:

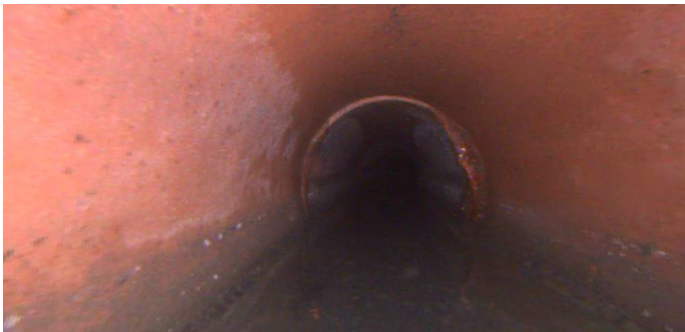
Code:	<b>DAE</b>
Description:	<b>Deposits Attached Encrustation</b>

Distance (ft):	<b>3.3</b>
Structural Grade:	<b>0</b>
O&M Grade:	<b>2</b>
Clock Start/From:	<b>7</b>
Clock To:	<b>5</b>
1st Value:	
2nd Value:	
Value Percent:	<b>5.000</b>
Continuous Index:	
Within 8" of Joint:	<b>YES</b>
Remarks:
