Profile/Photo Observation Report

Date:	03/22/2018	Weather:		Coding:	PACP 6.0
Pipe Length (ft):	310.9	Owner:	NA	Pre Clean:	No Pre-Cleaning
P.O.#:		Surveyor:	Selasie Honu	PSR:	P-208-004-008
Customer:		Clean Date:	01/01/1900	Shape:	C

Street:	FOXCROFT STREET	Flow Control:	Not Controlled
City:	Hobart, IN	Year Renewed:	
Location:	Light Highway	Tape/Media #:	
Purpose:	Routine Assessment	Dia/Height:	12"
Use:	Sanitary	Material:	VCP
Drain Area:	NA	Lining:	
Category:	NA		
Comment:	F_S_P_C at 8 ft debris.Flow direction wrong		
Location Details:		Direction of Survey:	Downstream
US MH:	M-208-008	DS MH:	M-208-004
		Total Length Surveyed (ft):	9.4

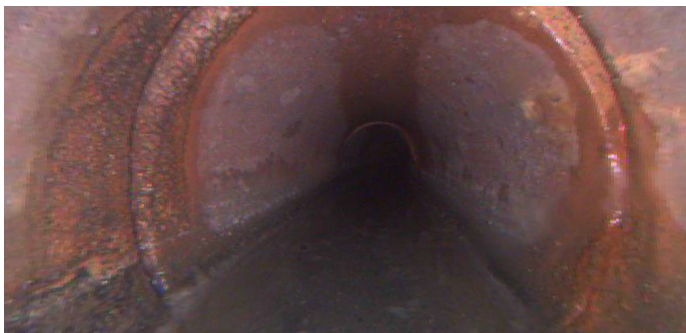
Code: **AMH**
Description: **Manhole**

Distance (ft): **.0**
Structural Grade: **0**
O&M Grade: **0**
Clock Start/From:
Clock To:
1st Value:
2nd Value:
Value Percent:
Continuous Index:
Within 8" of Joint: **NO**
Remarks: **M-208-008**

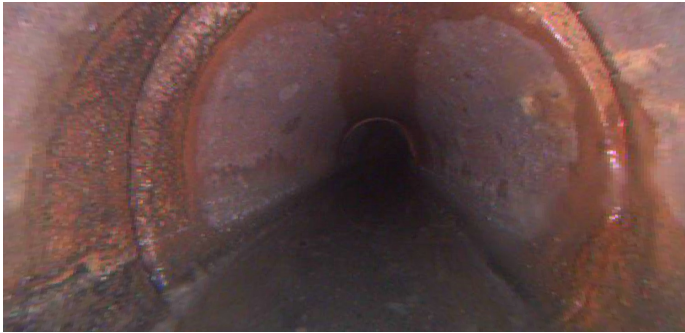
Code:	MWL
Description:	Water Level

Distance (ft):	.0
Structural Grade:	0
O&M Grade:	0
Clock Start/From:	
Clock To:	
1st Value:	
2nd Value:	
Value Percent:	5.000
Continuous Index:	
Within 8" of Joint:	NO
Remarks:

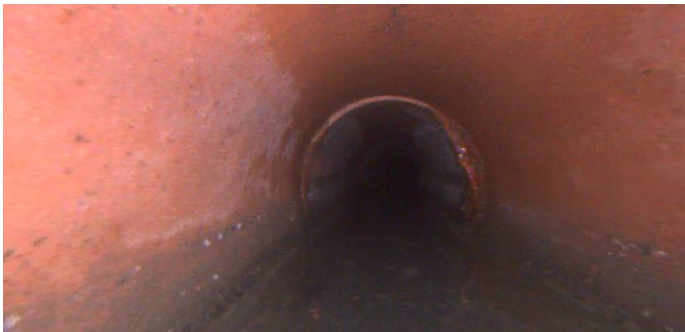
Code:	DAE
Description:	Deposits Attached Encrustation

Distance (ft):	3.3
Structural Grade:	0
O&M Grade:	2
Clock Start/From:	7
Clock To:	5
1st Value:	
2nd Value:	
Value Percent:	5.000
Continuous Index:	
Within 8" of Joint:	YES
Remarks:
