## Profile/Photo Observation Report

Date:	<b>03/23/2018</b>	Weather:		Coding:	<b>PACP 6.0</b>
Pipe Length (ft):	<b>244.7</b>	Owner:	<b>NA</b>	Pre Clean:	<b>No Pre-Cleaning</b>
P.O.#:		Surveyor:	<b>Jen Costello</b>	PSR:	<b>P-208-009-010</b>
Customer:		Clean Date:	<b>01/01/1900</b>	Shape:	<b>C</b>

Street:	<b>ALLEY BETWEEN BROOKVIEW CT &amp;</b>	Flow Control:	<b>Not Controlled</b>
City:	<b>Hobart, IN</b>	Year Renewed:	
Location:	<b>Light Highway</b>	Tape/Media #:	
Purpose:	<b>Routine Assessment</b>	Dia/Height:	<b>8"</b>
Use:	<b>Sanitary</b>	Material:	<b>VCP</b>
Drain Area:	<b>NA</b>	Lining:	
Category:	<b>NA</b>		
Comment:	<b>P_C at 17 ft build up around pipe. Flow direction wrong</b>		
Location Details:		Direction of Survey:	<b>Downstream</b>
US MH:	<b>M-208-010</b>	DS MH:	<b>M-208-009</b>
		Total Length Surveyed (ft):	<b>18.7</b>

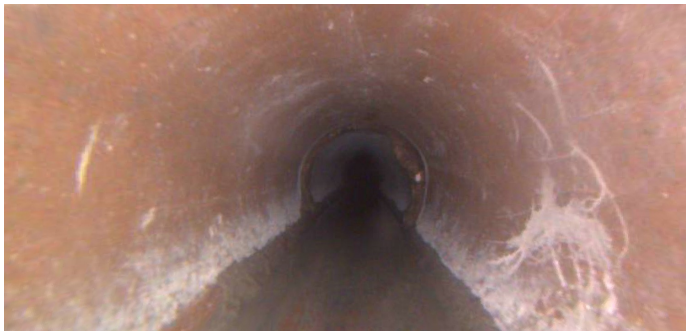
Code: **AMH**  
Description: **Manhole**

Distance (ft): **.0**  
Structural Grade: **0**  
O&M Grade: **0**  
Clock Start/From:  
Clock To:  
1st Value:  
2nd Value:  
Value Percent:  
Continuous Index:  
Within 8" of Joint: **NO**  
Remarks: **M-208-010**

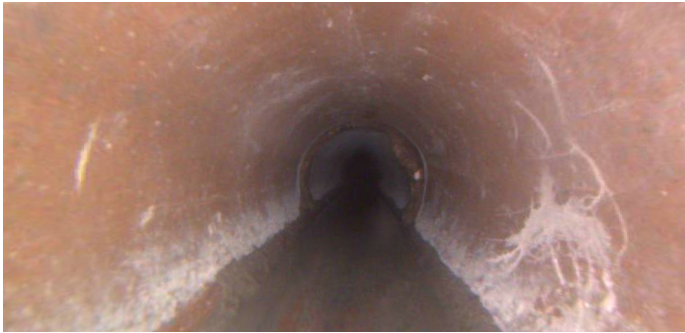
Code:	<b>MWL</b>
Description:	<b>Water Level</b>

Distance (ft):	<b>.0</b>
Structural Grade:	<b>0</b>
O&M Grade:	<b>0</b>
Clock Start/From:	
Clock To:	
1st Value:	
2nd Value:	
Value Percent:	<b>10.000</b>
Continuous Index:	
Within 8" of Joint:	<b>NO</b>
Remarks:

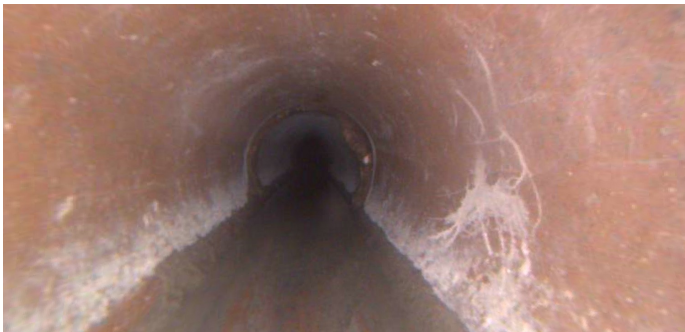
Code:	<b>CM</b>
Description:	<b>Crack Multiple</b>

Distance (ft):	<b>.0</b>
Structural Grade:	<b>3</b>
O&M Grade:	<b>0</b>
Clock Start/From:	<b>1</b>
Clock To:	<b>4</b>
1st Value:	
2nd Value:	
Value Percent:	
Continuous Index:	
Within 8" of Joint:	
Remarks:

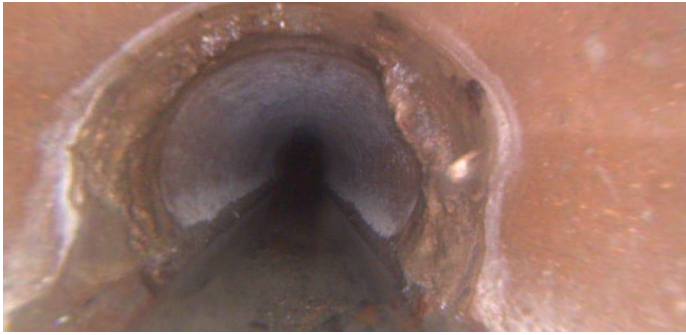
Code: **DAE**  
Description: **Deposits Attached Encrustation**

Distance (ft): **2.3**  
Structural Grade: **0**  
O&M Grade: **2**  
Clock Start/From: **8**  
Clock To: **4**  
1st Value:  
2nd Value:  
Value Percent: **10.000**  
Continuous Index: **S01**  
Within 8" of Joint: **YES**  
Remarks:

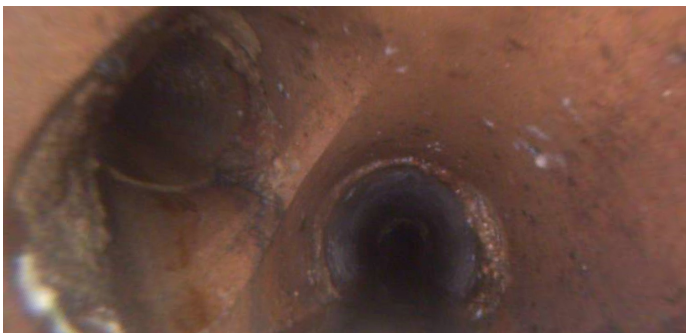
Code: **TF**  
Description: **Tap Factory**

Distance (ft): **7.9**  
Structural Grade: **0**  
O&M Grade: **0**  
Clock Start/From: **10**  
Clock To:  
1st Value: **4.000**  
2nd Value:  
Value Percent:  
Continuous Index:  
Within 8" of Joint:  
Remarks:

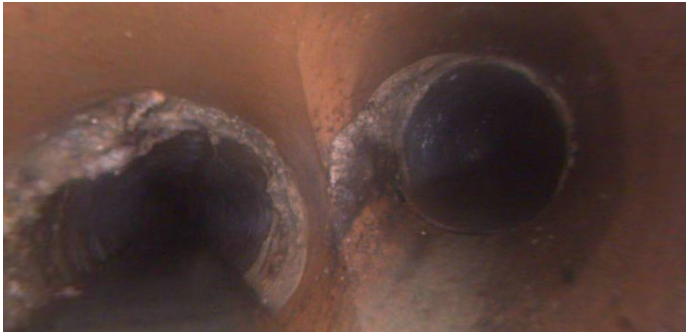
Code: **TF**  
Description: **Tap Factory**

Distance (ft): **11.3**  
Structural Grade: **0**  
O&M Grade: **0**  
Clock Start/From: **3**  
Clock To:  
1st Value: **4.000**  
2nd Value:  
Value Percent:  
Continuous Index:  
Within 8" of Joint:  
Remarks:

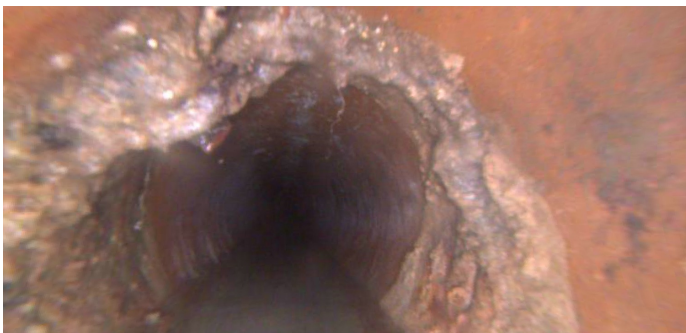
Code: **DAE**  
Description: **Deposits Attached Encrustation**

Distance (ft): **11.7**  
Structural Grade: **0**  
O&M Grade: **3**  
Clock Start/From: **8**  
Clock To: **4**  
1st Value:  
2nd Value:  
Value Percent: **20.000**  
Continuous Index:  
Within 8" of Joint: **YES**  
Remarks:

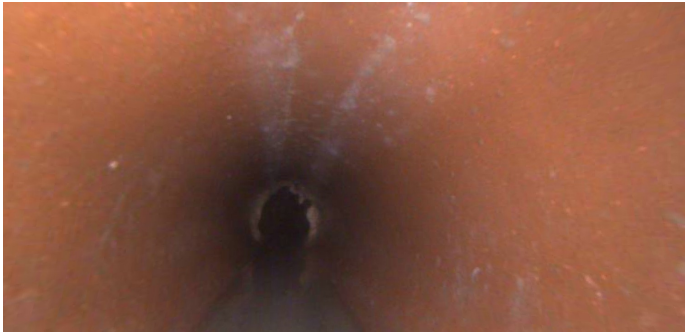
Code: **MSA**  
Description: **Abandoned Survey**

Distance (ft): **18.7**  
Structural Grade: **0**  
O&M Grade: **0**  
Clock Start/From:  
Clock To:  
1st Value:  
2nd Value:  
Value Percent:  
Continuous Index:  
Within 8" of Joint: **NO**  
Remarks: **DAE**

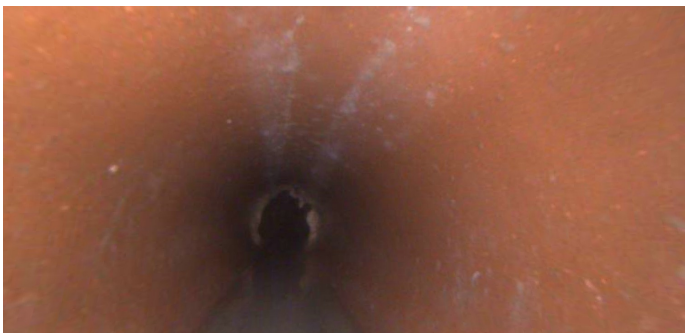
Code: **DAE**  
Description: **Deposits Attached Encrustation**

Distance (ft): **18.7**  
Structural Grade: **0**  
O&M Grade: **2**  
Clock Start/From: **8**  
Clock To: **4**  
1st Value:  
2nd Value:  
Value Percent: **10.000**  
Continuous Index: **F01**  
Within 8" of Joint: **YES**  
Remarks:
