Profile/Photo Observation Report

Street:	FOXCROFT STREET	Flow Control:	Not Controlled
City:	Hobart, IN	Year Renewed:	
Location:	Light Highway	Tape/Media #:	
Purpose:	Routine Assessment	Dia/Height:	8"
Use:	Sanitary	Material:	VCP
Drain Area:	NA	Lining:	
Category:	NA		
Comment:	P_C at 17 ft build up around pipe. Flow direction wrong		
Location Details:		Direction of Survey:	Downstream
US MH:	M-208-010	DS MH:	M-208-009
		Total Length Surveyed (ft):	18.7

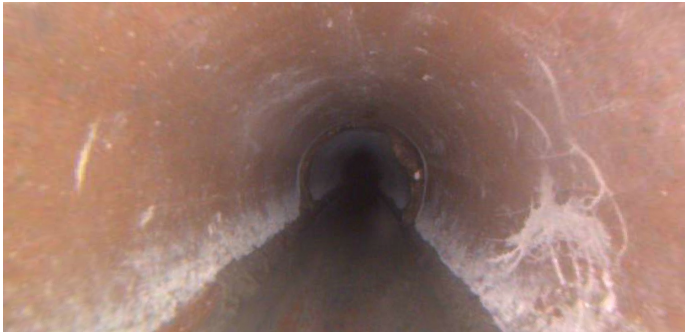
Code:	MWL
Description:	Water Level

Distance (ft):	.0
Structural Grade:	0
O&M Grade:	0
Clock Start/From:	
Clock To:	
1st Value:	
2nd Value:	
Value Percent:	10.000
Continuous Index:	
Within 8" of Joint:	NO
Remarks:

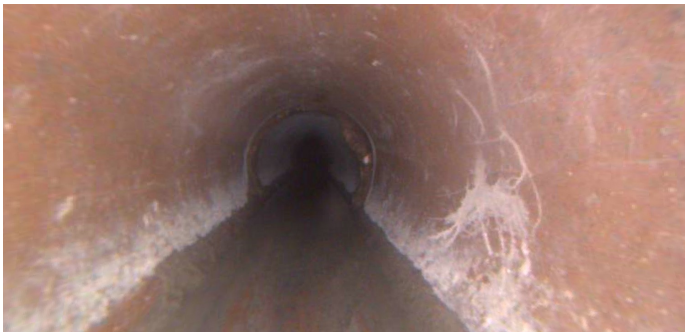
Code:	CM
Description:	Crack Multiple

Distance (ft):	.0
Structural Grade:	3
O&M Grade:	0
Clock Start/From:	1
Clock To:	4
1st Value:	
2nd Value:	
Value Percent:	
Continuous Index:	
Within 8" of Joint:	
Remarks:

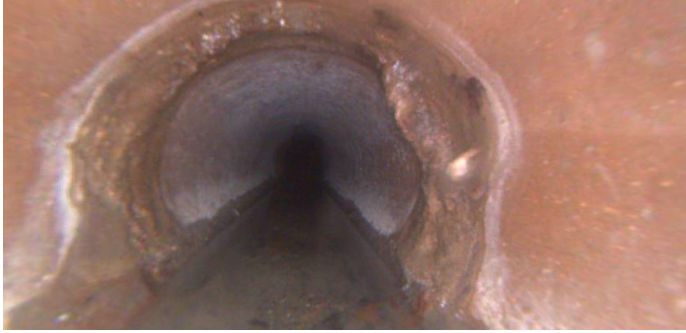
Code: **DAE**
Description: **Deposits Attached Encrustation**

Distance (ft): **2.3**
Structural Grade: **0**
O&M Grade: **2**
Clock Start/From: **8**
Clock To: **4**
1st Value:
2nd Value:
Value Percent: **10.000**
Continuous Index: **S01**
Within 8" of Joint: **YES**
Remarks:

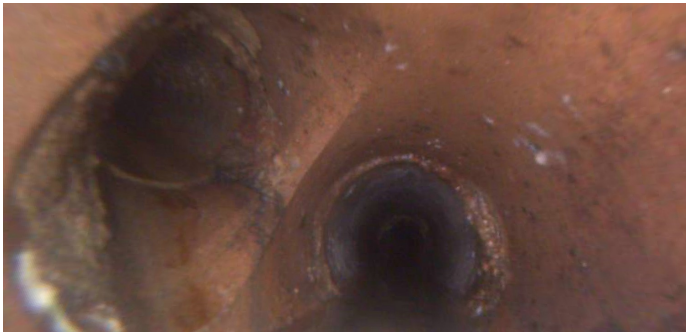
Code: **TF**
Description: **Tap Factory**

Distance (ft): **7.9**
Structural Grade: **0**
O&M Grade: **0**
Clock Start/From: **10**
Clock To:
1st Value: **4.000**
2nd Value:
Value Percent:
Continuous Index:
Within 8" of Joint:
Remarks:

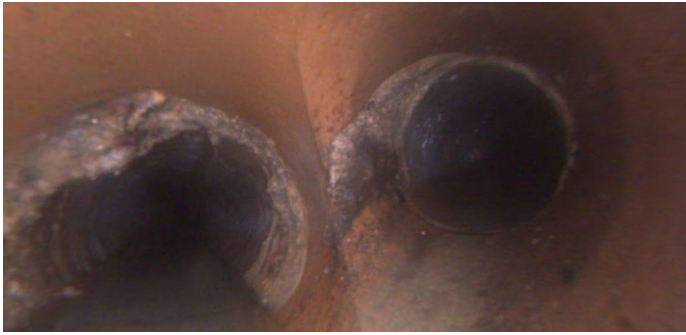
Code: **TF**
Description: **Tap Factory**

Distance (ft): **11.3**
Structural Grade: **0**
O&M Grade: **0**
Clock Start/From: **3**
Clock To:
1st Value: **4.000**
2nd Value:
Value Percent:
Continuous Index:
Within 8" of Joint:
Remarks:

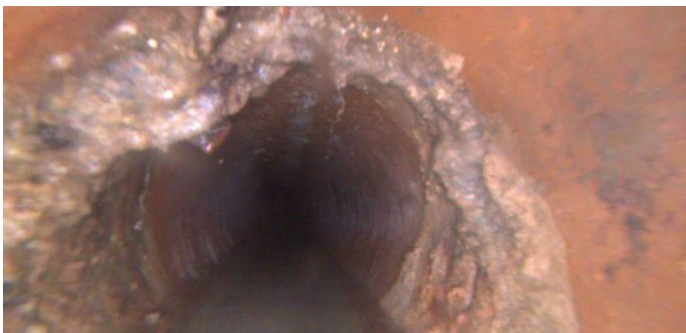
Code: **DAE**
Description: **Deposits Attached Encrustation**

Distance (ft): **11.7**
Structural Grade: **0**
O&M Grade: **3**
Clock Start/From: **8**
Clock To: **4**
1st Value:
2nd Value:
Value Percent: **20.000**
Continuous Index:
Within 8" of Joint: **YES**
Remarks:

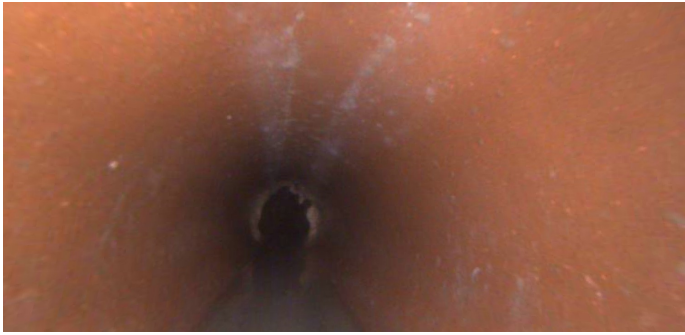
Code: **MSA**
Description: **Abandoned Survey**

Distance (ft): **18.7**
Structural Grade: **0**
O&M Grade: **0**
Clock Start/From:
Clock To:
1st Value:
2nd Value:
Value Percent:
Continuous Index:
Within 8" of Joint: **NO**
Remarks: **DAE**

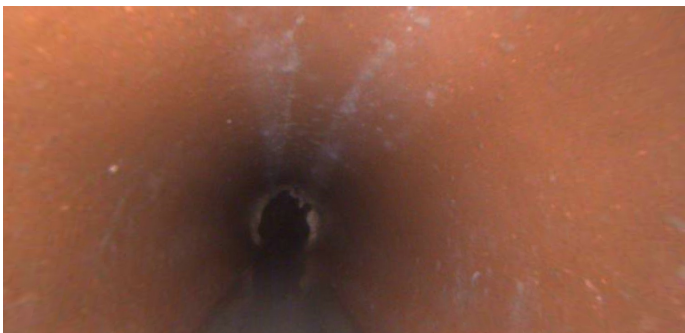
Code: **DAE**
Description: **Deposits Attached Encrustation**

Distance (ft): **18.7**
Structural Grade: **0**
O&M Grade: **2**
Clock Start/From: **8**
Clock To: **4**
1st Value:
2nd Value:
Value Percent: **10.000**
Continuous Index: **F01**
Within 8" of Joint: **YES**
Remarks:
