Profile/Photo Observation Report

Date:	03/22/2018	Weather:		Coding:	PACP 6.0
Pipe Length (ft):	310.1	Owner:	NA	Pre Clean:	No Pre-Cleaning
P.O.#:		Surveyor:	Selasie Honu	PSR:	P-208-008-012
Customer:		Clean Date:	01/01/1900	Shape:	C

Street:	16TH ST	Flow Control:	Not Controlled
City:	Hobart, IN	Year Renewed:	
Location:	Light Highway	Tape/Media #:	
Purpose:	Routine Assessment	Dia/Height:	12"
Use:	Sanitary	Material:	VCP
Drain Area:	NA	Lining:	
Category:	NA		
Comment:	P_C at 52 ft nothing visible . Flow Direction		
Location Details:		Direction of Survey:	Upstream
US MH:	M-208-012	DS MH:	M-208-008
		Total Length Surveyed (ft):	54.3

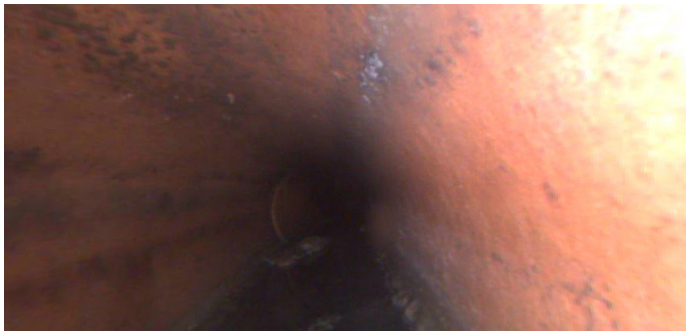
Code: **AMH**
Description: **Manhole**

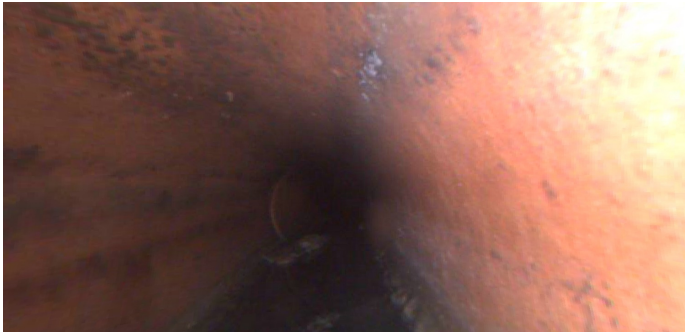
Code:	MWL
Description:	Water Level

Distance (ft):	.0
Structural Grade:	0
O&M Grade:	0
Clock Start/From:	
Clock To:	
1st Value:	
2nd Value:	
Value Percent:	5.000
Continuous Index:	
Within 8" of Joint:	NO
Remarks:

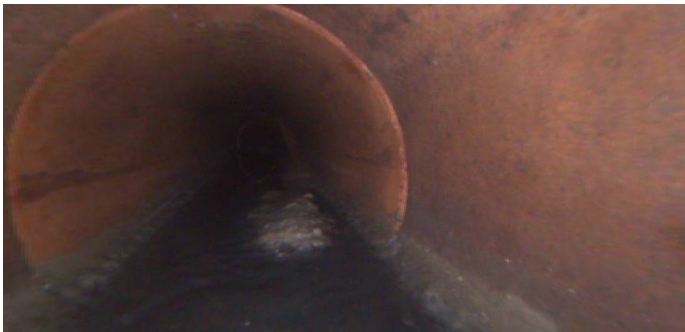
Code:	FL
Description:	Fracture Longitudinal

Distance (ft):	6.2
Structural Grade:	3
O&M Grade:	0
Clock Start/From:	9
Clock To:	
1st Value:	
2nd Value:	
Value Percent:	
Continuous Index:	S02
Within 8" of Joint:	YES
Remarks:

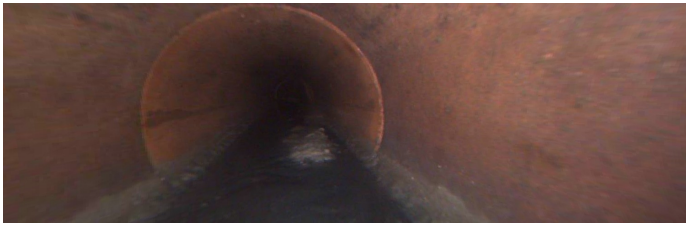
Code: **FL**
Description: **Fracture Longitudinal**

Distance (ft): **6.2**
Structural Grade: **3**
O&M Grade: **0**
Clock Start/From: **3**
Clock To:
1st Value:
2nd Value:
Value Percent:
Continuous Index: **S03**
Within 8" of Joint: **YES**
Remarks:

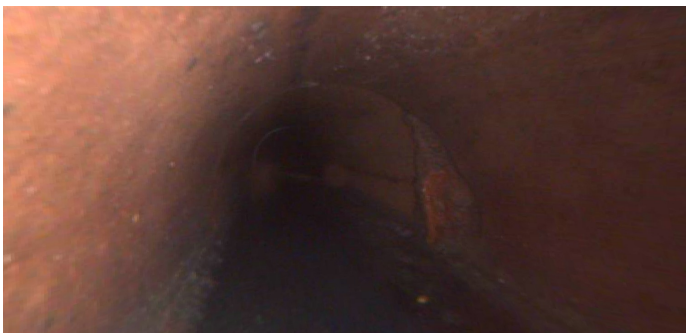
Code: **DAE**
Description: **Deposits Attached Encrustation**

Distance (ft): **9.1**
Structural Grade: **0**
O&M Grade: **2**
Clock Start/From: **7**
Clock To: **5**
1st Value:
2nd Value:
Value Percent: **5.000**
Continuous Index: **S01**
Within 8" of Joint: **YES**
Remarks:

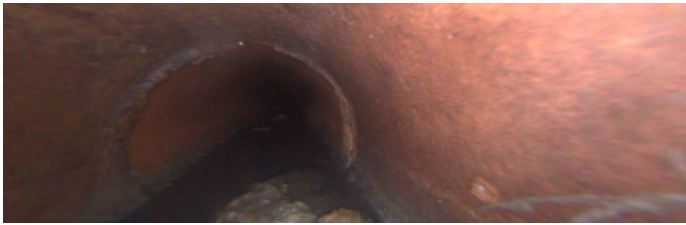
Code: **FL**
Description: **Fracture Longitudinal**

Distance (ft): **18.7**
Structural Grade: **3**
O&M Grade: **0**
Clock Start/From: **9**
Clock To:
1st Value:
2nd Value:
Value Percent:
Continuous Index: **F02**
Within 8" of Joint: **YES**
Remarks:

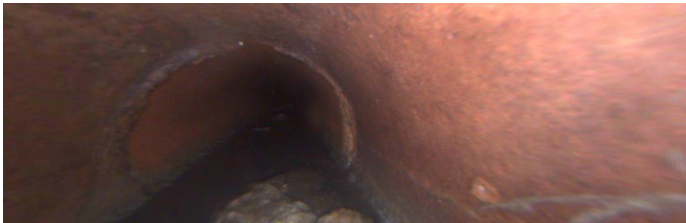
Code: **FL**
Description: **Fracture Longitudinal**

Distance (ft): **18.7**
Structural Grade: **3**
O&M Grade: **0**
Clock Start/From: **3**
Clock To:
1st Value:
2nd Value:
Value Percent:
Continuous Index: **F03**
Within 8" of Joint: **YES**
Remarks:

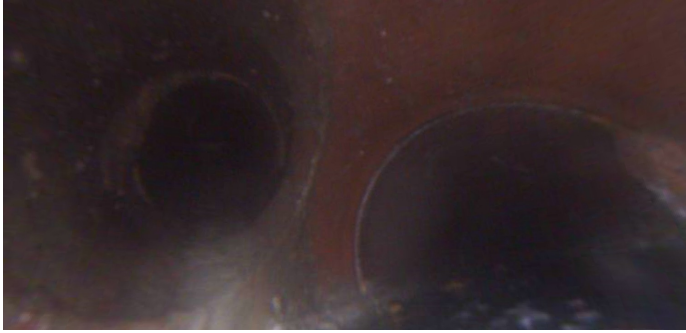
Code: **TF**
Description: **Tap Factory**

Distance (ft): **40.1**
Structural Grade: **0**
O&M Grade: **0**
Clock Start/From: **3**
Clock To:
1st Value: **4.000**
2nd Value:
Value Percent:
Continuous Index:
Within 8" of Joint:
Remarks:

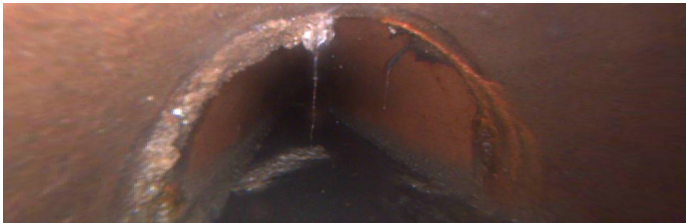
Code: **RFJ**
Description: **Roots Fine Joint**

Distance (ft): **44.6**
Structural Grade: **0**
O&M Grade: **1**
Clock Start/From: **12**
Clock To: **1**
1st Value:
2nd Value:
Value Percent:
Continuous Index:
Within 8" of Joint: **YES**
Remarks:

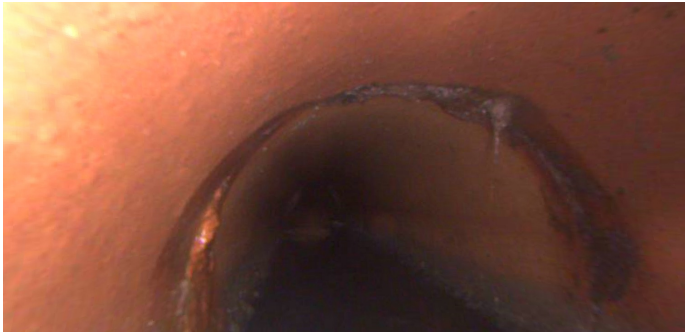
Code: **IW**
Description: **Infil Weeper**

Distance (ft): **47.6**
Structural Grade: **0**
O&M Grade: **2**
Clock Start/From: **8**
Clock To: **4**
1st Value:
2nd Value:
Value Percent:
Continuous Index:
Within 8" of Joint: **YES**
Remarks:

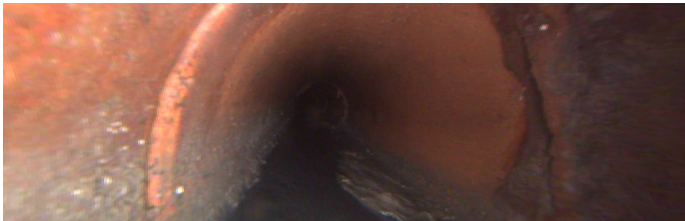
Code: **DAE**
Description: **Deposits Attached Encrustation**

Distance (ft): **54.3**
Structural Grade: **0**
O&M Grade: **2**
Clock Start/From: **7**
Clock To: **5**
1st Value:
2nd Value:
Value Percent: **5.000**
Continuous Index: **F01**
Within 8" of Joint: **YES**
Remarks:

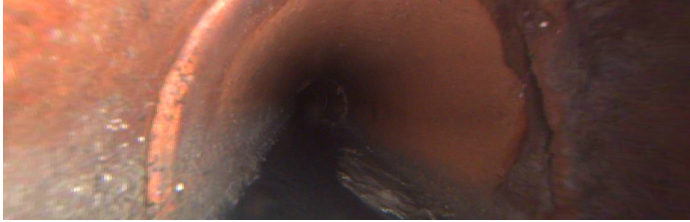
Code:	MSA
Description:	Abandoned Survey
Distance (ft):	54.3
Structural Grade:	0
O&M Grade:	0
Clock Start/From:	
Clock To:	
1st Value:	
2nd Value:	
Value Percent:	
Continuous Index:	
Within 8" of Joint:	NO
Remarks:	camera stopped
