Profile/Photo Observation Report

Date:	03/22/2018	Weather:		Coding:	PACP 6.0
Pipe Length (ft):	310.1	Owner:	NA	Pre Clean:	No Pre-Cleaning
P.O.#:		Surveyor:	Selasie Honu	PSR:	P-208-008-012
Customer:		Clean Date:	01/01/1900	Shape:	C

Street:	FOXCROFT STREET	Flow Control:	Not Controlled
City:	Hobart, IN	Year Renewed:	
Location:	Light Highway	Tape/Media #:	
Purpose:	Routine Assessment	Dia/Height:	12"
Use:	Sanitary	Material:	VCP
Drain Area:	NA	Lining:	
Category:	NA		
Comment:	P_C at 52 ft nothing visible . Flow Direction		
Location Details:		Direction of Survey:	Upstream
US MH:	M-208-012	DS MH:	M-208-008
		Total Length Surveyed (ft):	54.3

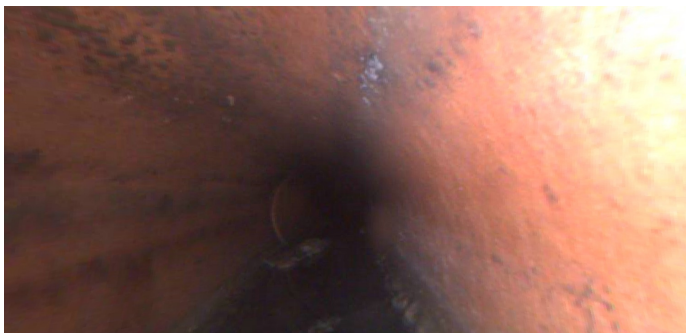
Code: **AMH**
Description: **Manhole**

Distance (ft): **.0**
Structural Grade: **0**
O&M Grade: **0**
Clock Start/From:
Clock To:
1st Value:
2nd Value:
Value Percent:
Continuous Index:
Within 8" of Joint: **NO**
Remarks: **M-208-008**

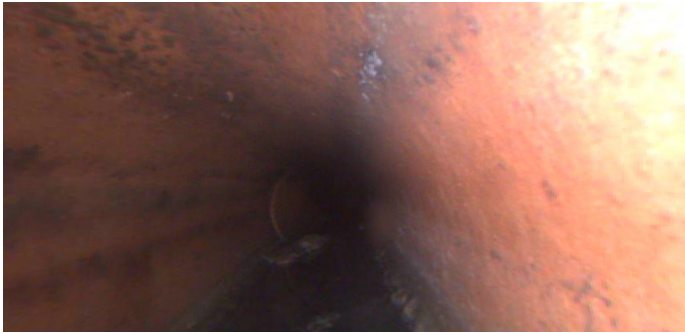
Code:	MWL
Description:	Water Level

Distance (ft):	.0
Structural Grade:	0
O&M Grade:	0
Clock Start/From:	
Clock To:	
1st Value:	
2nd Value:	
Value Percent:	5.000
Continuous Index:	
Within 8" of Joint:	NO
Remarks:

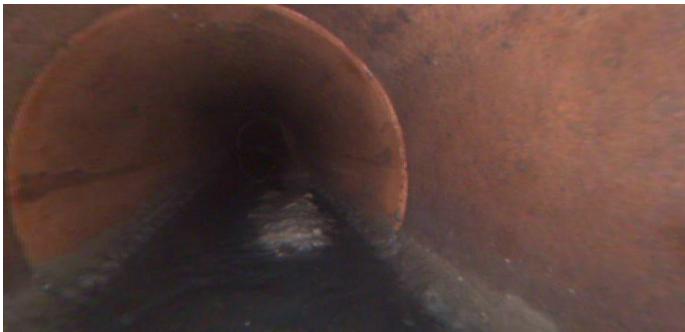
Code:	FL
Description:	Fracture Longitudinal

Distance (ft):	6.2
Structural Grade:	3
O&M Grade:	0
Clock Start/From:	9
Clock To:	
1st Value:	
2nd Value:	
Value Percent:	
Continuous Index:	S02
Within 8" of Joint:	YES
Remarks:

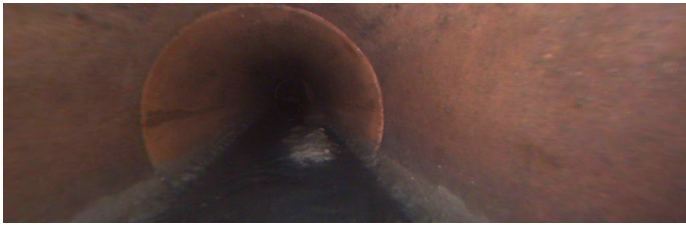
Code: **FL**
Description: **Fracture Longitudinal**

Distance (ft): **6.2**
Structural Grade: **3**
O&M Grade: **0**
Clock Start/From: **3**
Clock To:
1st Value:
2nd Value:
Value Percent:
Continuous Index: **S03**
Within 8" of Joint: **YES**
Remarks:

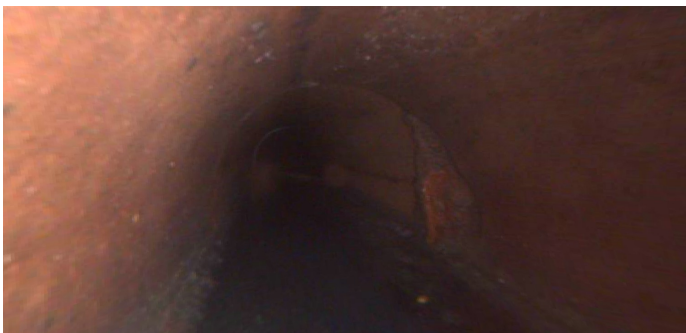
Code: **DAE**
Description: **Deposits Attached Encrustation**

Distance (ft): **9.1**
Structural Grade: **0**
O&M Grade: **2**
Clock Start/From: **7**
Clock To: **5**
1st Value:
2nd Value:
Value Percent: **5.000**
Continuous Index: **S01**
Within 8" of Joint: **YES**
Remarks:

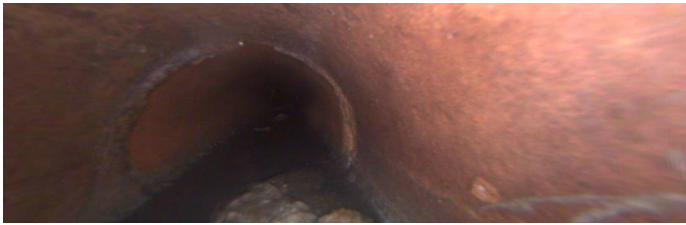
Code: **FL**
Description: **Fracture Longitudinal**

Distance (ft): **18.7**
Structural Grade: **3**
O&M Grade: **0**
Clock Start/From: **9**
Clock To:
1st Value:
2nd Value:
Value Percent:
Continuous Index: **F02**
Within 8" of Joint: **YES**
Remarks:

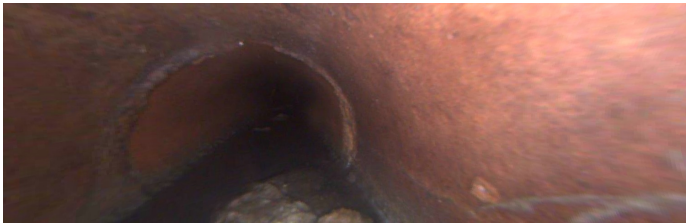
Code: **FL**
Description: **Fracture Longitudinal**

Distance (ft): **18.7**
Structural Grade: **3**
O&M Grade: **0**
Clock Start/From: **3**
Clock To:
1st Value:
2nd Value:
Value Percent:
Continuous Index: **F03**
Within 8" of Joint: **YES**
Remarks:

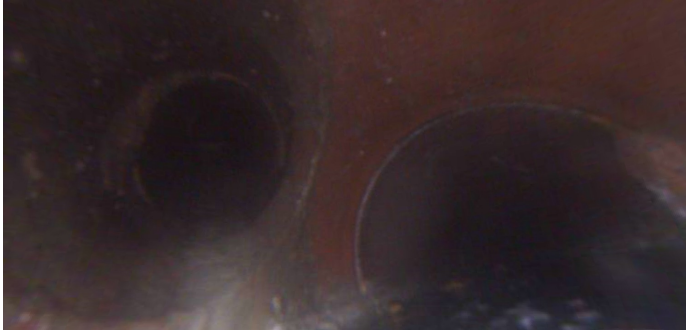
Code: **TF**
Description: **Tap Factory**

Distance (ft): **40.1**
Structural Grade: **0**
O&M Grade: **0**
Clock Start/From: **3**
Clock To:
1st Value: **4.000**
2nd Value:
Value Percent:
Continuous Index:
Within 8" of Joint:
Remarks:

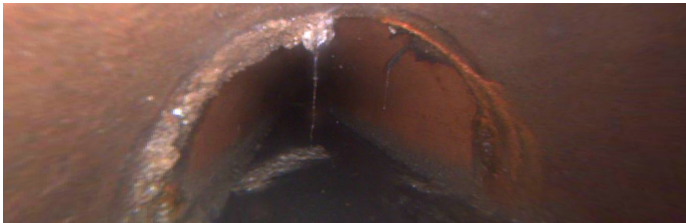
Code: **RFJ**
Description: **Roots Fine Joint**

Distance (ft): **44.6**
Structural Grade: **0**
O&M Grade: **1**
Clock Start/From: **12**
Clock To: **1**
1st Value:
2nd Value:
Value Percent:
Continuous Index:
Within 8" of Joint: **YES**
Remarks:

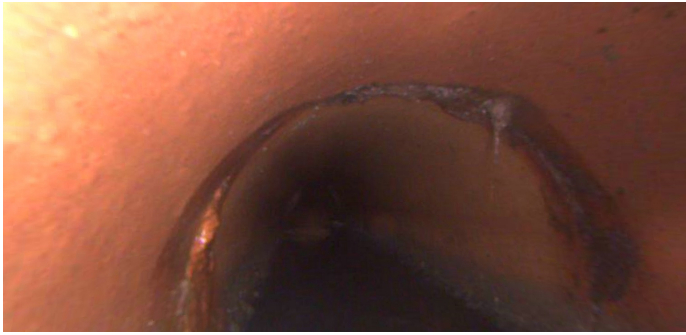
Code: **IW**
Description: **Infil Weeper**

Distance (ft): **47.6**
Structural Grade: **0**
O&M Grade: **2**
Clock Start/From: **8**
Clock To: **4**
1st Value:
2nd Value:
Value Percent:
Continuous Index:
Within 8" of Joint: **YES**
Remarks:

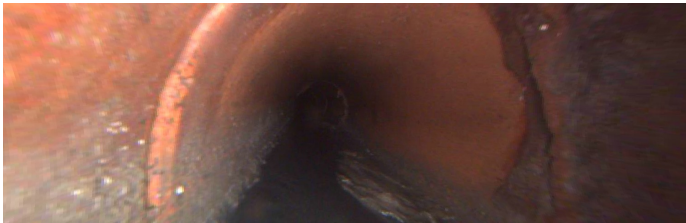
Code: **DAE**
Description: **Deposits Attached Encrustation**

Distance (ft): **54.3**
Structural Grade: **0**
O&M Grade: **2**
Clock Start/From: **7**
Clock To: **5**
1st Value:
2nd Value:
Value Percent: **5.000**
Continuous Index: **F01**
Within 8" of Joint: **YES**
Remarks:

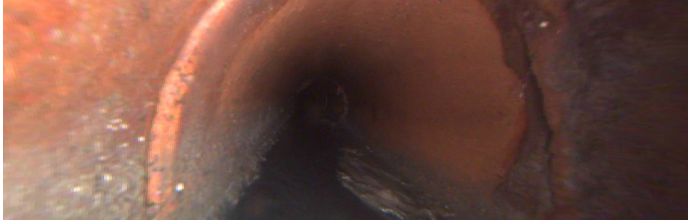
Code:	MSA
Description:	Abandoned Survey
Distance (ft):	54.3
Structural Grade:	0
O&M Grade:	0
Clock Start/From:	
Clock To:	
1st Value:	
2nd Value:	
Value Percent:	
Continuous Index:	
Within 8" of Joint:	NO
Remarks:	camera stopped
