Profile/Photo Observation Report

Date:	03/23/2018	Weather:		Coding:	PACP 6.0
Pipe Length (ft):	310.1	Owner:	NA	Pre Clean:	No Pre-Cleaning
P.O.#:		Surveyor:	Jen Costello	PSR:	P-208-008-012
Customer:		Clean Date:	01/01/1900	Shape:	C

Street:	16TH ST	Flow Control:	Not Controlled
City:	Hobart, IN	Year Renewed:	
Location:	Light Highway	Tape/Media #:	
Purpose:	Routine Assessment	Dia/Height:	12"
Use:	Sanitary	Material:	VCP
Drain Area:	NA	Lining:	
Category:	NA		
Comment:	P_C at 26 ft nothing visilbe . Flow direction wrong		
Location Details:		Direction of Survey:	Downstream
US MH:	M-208-012	DS MH:	M-208-008
		Total Length Surveyed (ft):	27.6

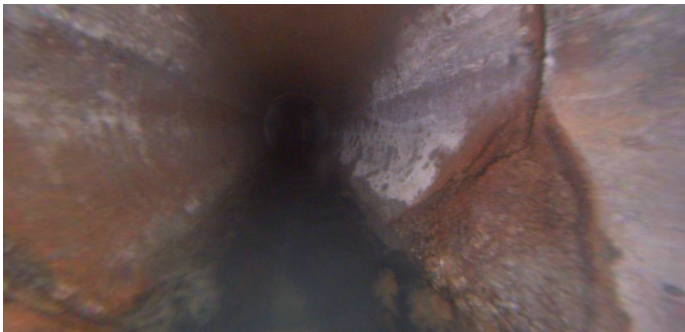
Code:	DAE
Description:	Deposits Attached Encrustation

Distance (ft):	3.4
Structural Grade:	0
O&M Grade:	2
Clock Start/From:	3
Clock To:	4
1st Value:	
2nd Value:	
Value Percent:	5.000
Continuous Index:	
Within 8" of Joint:	YES
Remarks:

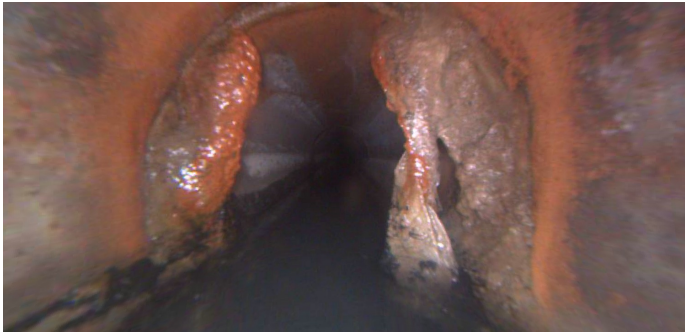
Code: **DAE**
Description: **Deposits Attached Encrustation**

Distance (ft): **9.4**
Structural Grade: **0**
O&M Grade: **4**
Clock Start/From: **8**
Clock To: **4**
1st Value:
2nd Value:
Value Percent: **30.000**
Continuous Index:
Within 8" of Joint: **YES**
Remarks:

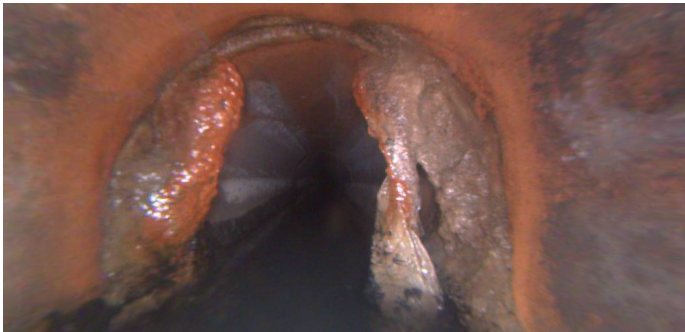
Code: **IW**
Description: **Infil Weeper**

Distance (ft): **9.4**
Structural Grade: **0**
O&M Grade: **2**
Clock Start/From: **8**
Clock To: **4**
1st Value:
2nd Value:
Value Percent:
Continuous Index:
Within 8" of Joint: **YES**
Remarks:

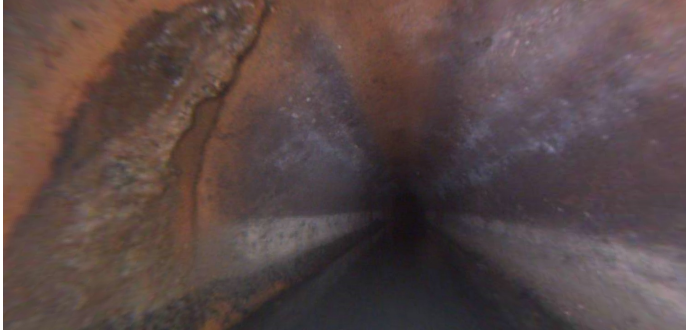
Code: **DAE**
Description: **Deposits Attached Encrustation**

Distance (ft): **13.0**
Structural Grade: **0**
O&M Grade: **2**
Clock Start/From: **7**
Clock To: **12**
1st Value:
2nd Value:
Value Percent: **5.000**
Continuous Index:
Within 8" of Joint: **YES**
Remarks:

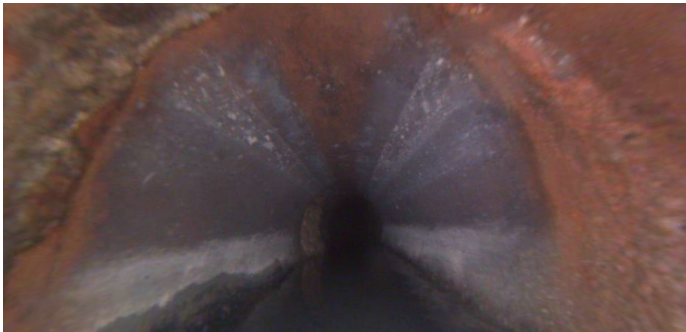
Code: **DAE**
Description: **Deposits Attached Encrustation**

Distance (ft): **16.2**
Structural Grade: **0**
O&M Grade: **2**
Clock Start/From: **8**
Clock To: **4**
1st Value:
2nd Value:
Value Percent: **5.000**
Continuous Index:
Within 8" of Joint: **YES**
Remarks:

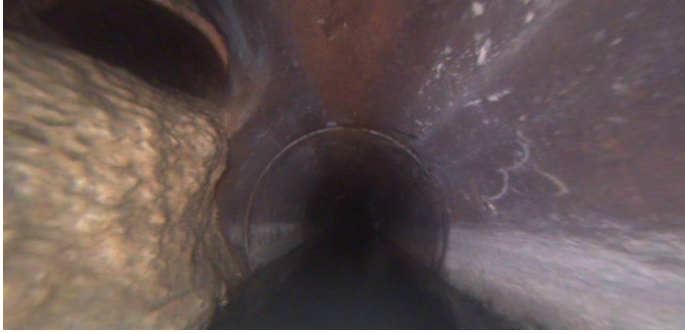
Code: **TFD**
Description: **Tap Factory Defective**

Distance (ft): **18.5**
Structural Grade: **0**
O&M Grade: **2**
Clock Start/From: **10**
Clock To:
1st Value: **4.000**
2nd Value:
Value Percent:
Continuous Index:
Within 8" of Joint:
Remarks: **DAE**

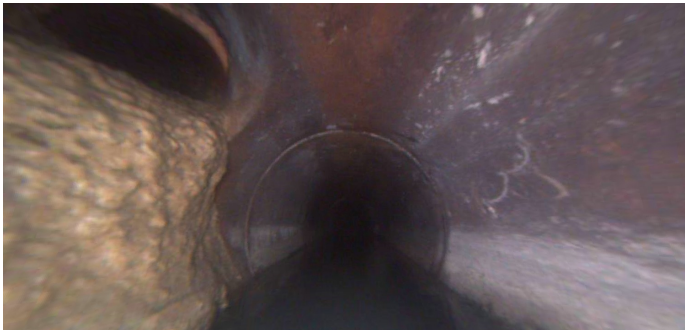
Code: **DAE**
Description: **Deposits Attached Encrustation**

Distance (ft): **18.5**
Structural Grade: **0**
O&M Grade: **2**
Clock Start/From: **7**
Clock To: **10**
1st Value:
2nd Value:
Value Percent: **10.000**
Continuous Index:
Within 8" of Joint: **NO**
Remarks:

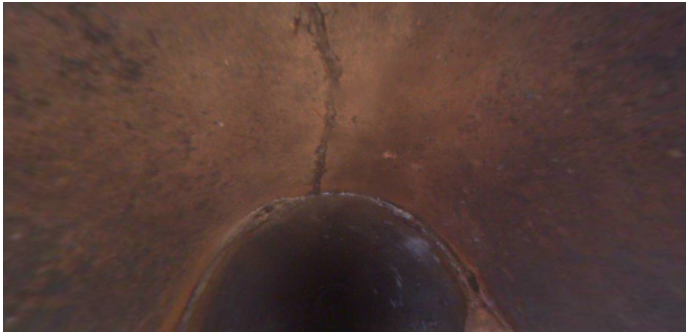
Code: **FL**
Description: **Fracture Longitudinal**

Distance (ft): **22.0**
Structural Grade: **3**
O&M Grade: **0**
Clock Start/From: **12**
Clock To:
1st Value:
2nd Value:
Value Percent:
Continuous Index:
Within 8" of Joint: **YES**
Remarks:

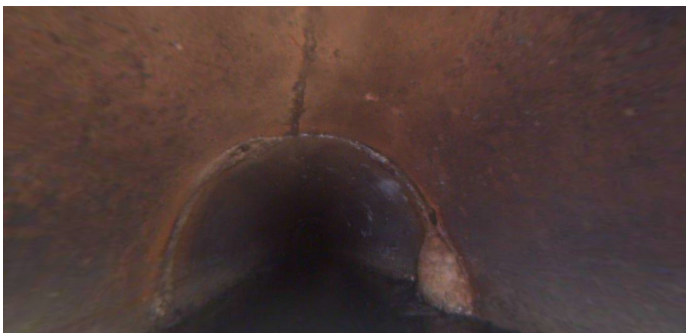
Code: **DAE**
Description: **Deposits Attached Encrustation**

Distance (ft): **22.0**
Structural Grade: **0**
O&M Grade: **2**
Clock Start/From: **8**
Clock To: **4**
1st Value:
2nd Value:
Value Percent: **5.000**
Continuous Index:
Within 8" of Joint: **YES**
Remarks:

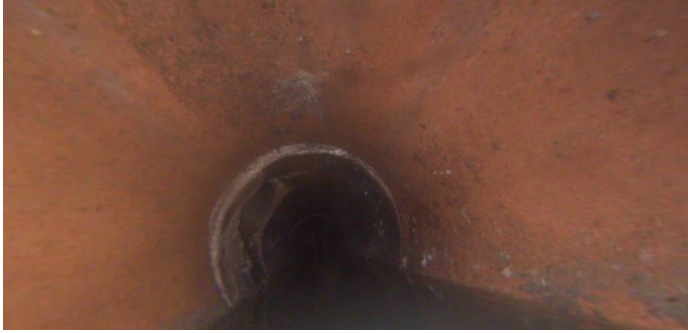
Code:	MSA
Description:	Abandoned Survey
Distance (ft):	27.6
Structural Grade:	0
O&M Grade:	0
Clock Start/From:	
Clock To:	
1st Value:	
2nd Value:	
Value Percent:	
Continuous Index:	
Within 8" of Joint:	NO
Remarks:	DEBRIS UNDER WATER
