Profile/Photo Observation Report

Date:	03/23/2018	Weather:		Coding:	PACP 6.0
Pipe Length (ft):	310.1	Owner:	NA	Pre Clean:	No Pre-Cleaning
P.O.#:		Surveyor:	Jen Costello	PSR:	P-208-008-012
Customer:		Clean Date:	01/01/1900	Shape:	C

Street:	FOXCROFT STREET	Flow Control:	Not Controlled
City:	Hobart, IN	Year Renewed:	
Location:	Light Highway	Tape/Media #:	
Purpose:	Routine Assessment	Dia/Height:	12"
Use:	Sanitary	Material:	VCP
Drain Area:	NA	Lining:	
Category:	NA		
Comment:	P_C at 26 ft nothing visilbe . Flow direction wrong		
Location Details:		Direction of Survey:	Downstream
US MH:	M-208-012	DS MH:	M-208-008
		Total Length Surveyed (ft):	27.6

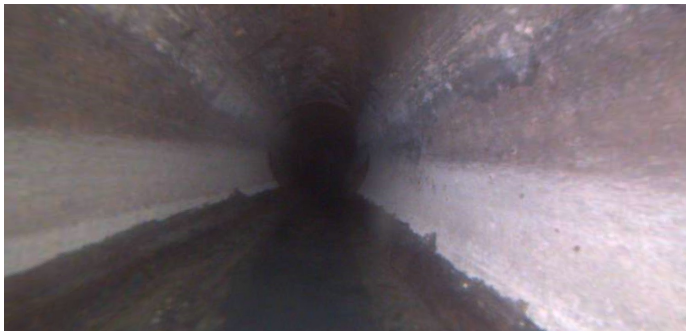
Code: **AMH**
Description: **Manhole**

Distance (ft): **.0**
Structural Grade: **0**
O&M Grade: **0**
Clock Start/From:
Clock To:
1st Value:
2nd Value:
Value Percent:
Continuous Index:
Within 8" of Joint: **NO**
Remarks: **M-208-012**

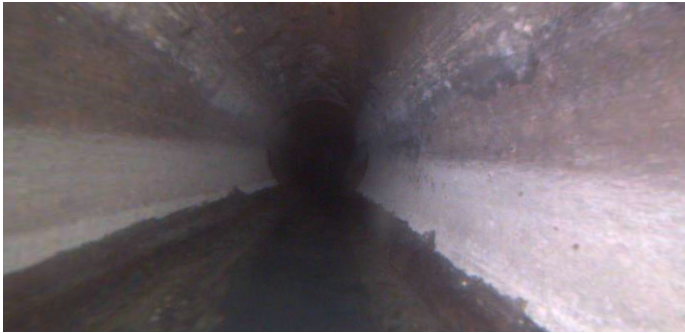
Code:	MWL
Description:	Water Level

Distance (ft):	.0
Structural Grade:	0
O&M Grade:	0
Clock Start/From:	
Clock To:	
1st Value:	
2nd Value:	
Value Percent:	5.000
Continuous Index:	
Within 8" of Joint:	NO
Remarks:

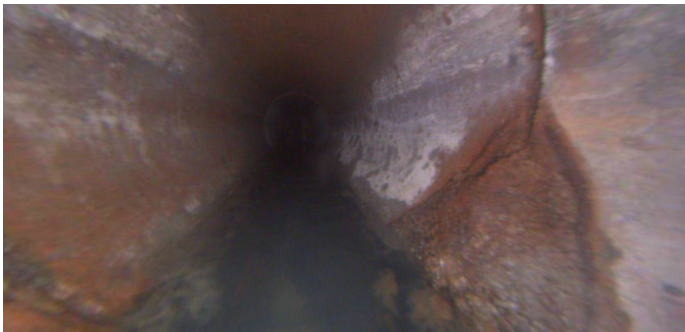
Code:	DAE
Description:	Deposits Attached Encrustation

Distance (ft):	3.4
Structural Grade:	0
O&M Grade:	2
Clock Start/From:	3
Clock To:	4
1st Value:	
2nd Value:	
Value Percent:	5.000
Continuous Index:	
Within 8" of Joint:	YES
Remarks:

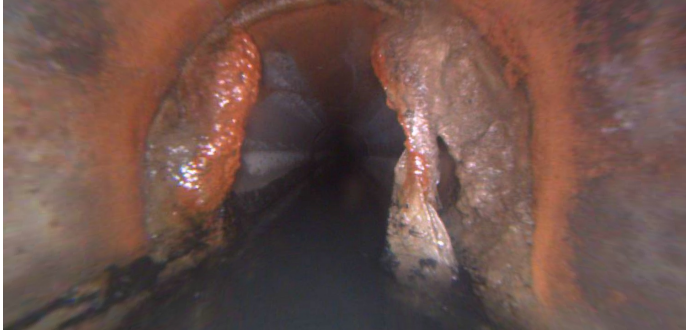
Code: **DAE**
Description: **Deposits Attached Encrustation**

Distance (ft): **9.4**
Structural Grade: **0**
O&M Grade: **4**
Clock Start/From: **8**
Clock To: **4**
1st Value:
2nd Value:
Value Percent: **30.000**
Continuous Index:
Within 8" of Joint: **YES**
Remarks:

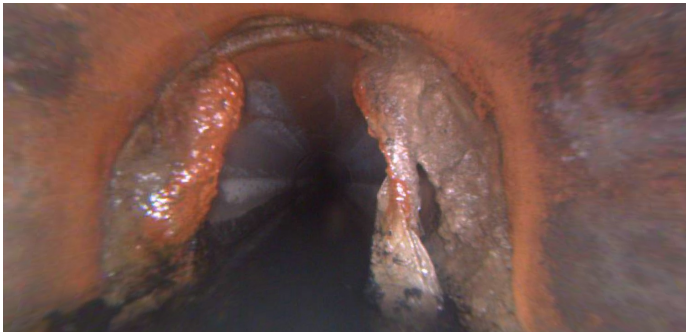
Code: **IW**
Description: **Infil Weeper**

Distance (ft): **9.4**
Structural Grade: **0**
O&M Grade: **2**
Clock Start/From: **8**
Clock To: **4**
1st Value:
2nd Value:
Value Percent:
Continuous Index:
Within 8" of Joint: **YES**
Remarks:

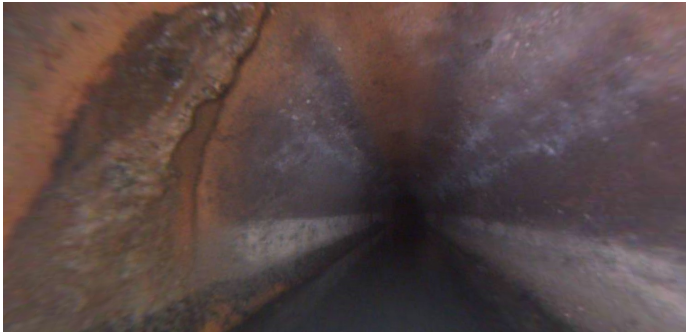
Code: **DAE**
Description: **Deposits Attached Encrustation**

Distance (ft): **13.0**
Structural Grade: **0**
O&M Grade: **2**
Clock Start/From: **7**
Clock To: **12**
1st Value:
2nd Value:
Value Percent: **5.000**
Continuous Index:
Within 8" of Joint: **YES**
Remarks:

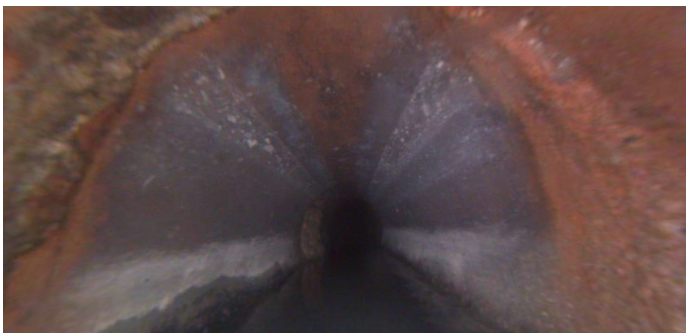
Code: **DAE**
Description: **Deposits Attached Encrustation**

Distance (ft): **16.2**
Structural Grade: **0**
O&M Grade: **2**
Clock Start/From: **8**
Clock To: **4**
1st Value:
2nd Value:
Value Percent: **5.000**
Continuous Index:
Within 8" of Joint: **YES**
Remarks:

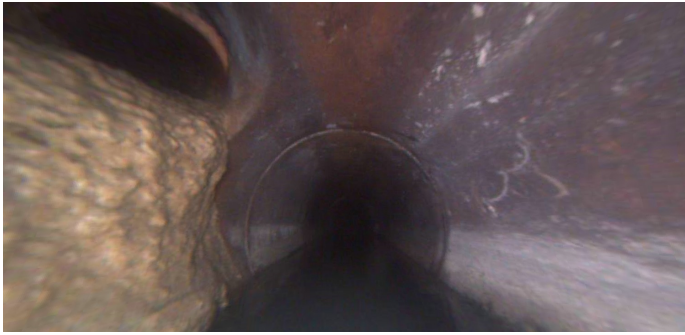
Code: **TFD**
Description: **Tap Factory Defective**

Distance (ft): **18.5**
Structural Grade: **0**
O&M Grade: **2**
Clock Start/From: **10**
Clock To:
1st Value: **4.000**
2nd Value:
Value Percent:
Continuous Index:
Within 8" of Joint:
Remarks: **DAE**

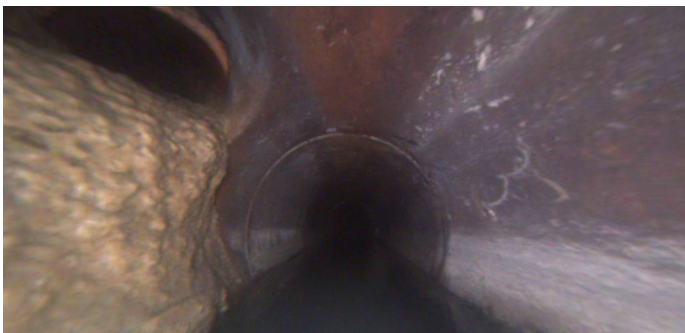
Code: **DAE**
Description: **Deposits Attached Encrustation**

Distance (ft): **18.5**
Structural Grade: **0**
O&M Grade: **2**
Clock Start/From: **7**
Clock To: **10**
1st Value:
2nd Value:
Value Percent: **10.000**
Continuous Index:
Within 8" of Joint: **NO**
Remarks:

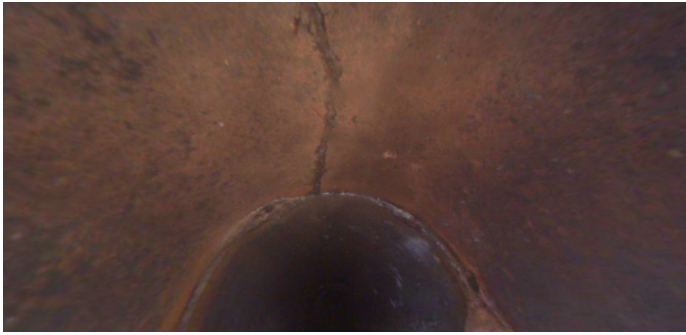
Code: **FL**
Description: **Fracture Longitudinal**

Distance (ft): **22.0**
Structural Grade: **3**
O&M Grade: **0**
Clock Start/From: **12**
Clock To:
1st Value:
2nd Value:
Value Percent:
Continuous Index:
Within 8" of Joint: **YES**
Remarks:

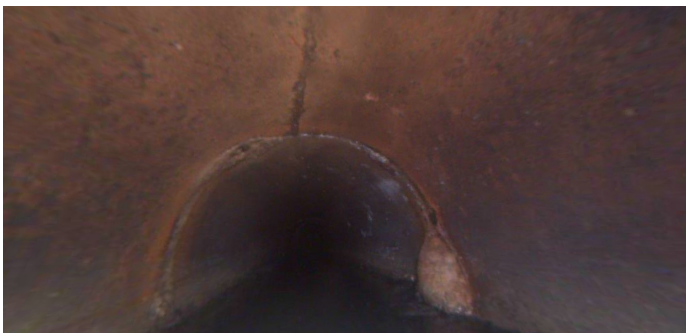
Code: **DAE**
Description: **Deposits Attached Encrustation**

Distance (ft): **22.0**
Structural Grade: **0**
O&M Grade: **2**
Clock Start/From: **8**
Clock To: **4**
1st Value:
2nd Value:
Value Percent: **5.000**
Continuous Index:
Within 8" of Joint: **YES**
Remarks:

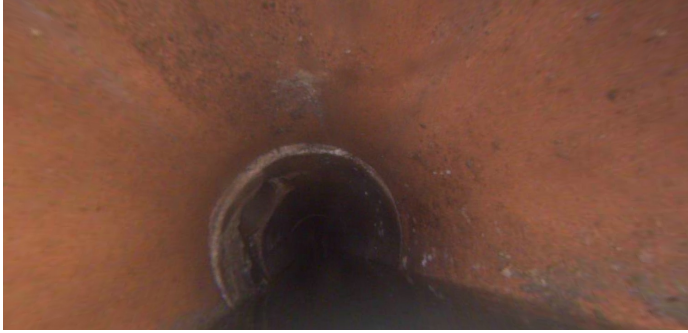
Code:	MSA
Description:	Abandoned Survey
Distance (ft):	27.6
Structural Grade:	0
O&M Grade:	0
Clock Start/From:	
Clock To:	
1st Value:	
2nd Value:	
Value Percent:	
Continuous Index:	
Within 8" of Joint:	NO
Remarks:	DEBRIS UNDER WATER
