Profile/Photo Observation Report

Date:	03/23/2018	Weather:		Coding:	PACP 6.0
Pipe Length (ft):	199.0	Owner:	NA	Pre Clean:	No Pre-Cleaning
P.O.#:		Surveyor:	Jen Costello	PSR:	P-208-011-012
Customer:		Clean Date:	01/01/1900	Shape:	C

Street:	16TH ST	Flow Control:	Not Controlled
City:	Hobart, IN	Year Renewed:	
Location:	Light Highway	Tape/Media #:	
Purpose:	Routine Assessment	Dia/Height:	12"
Use:	Sanitary	Material:	VCP
Drain Area:	NA	Lining:	
Category:	NA		
Comment:	False MH_F at 26 ft solo was stop at build on the top of pipe \nFlow direction wrong		
Location Details:		Direction of Survey:	Downstream
US MH:	M-208-012	DS MH:	M-208-011
		Total Length Surveyed (ft):	27.5

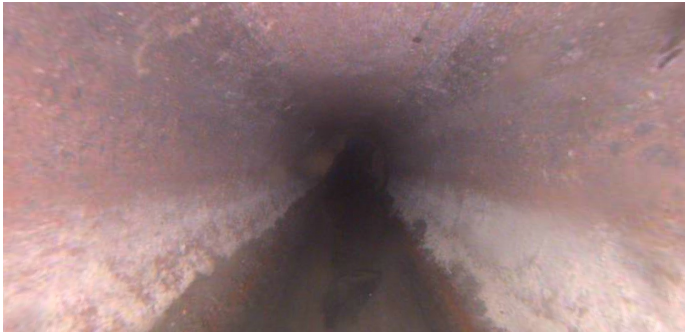
Code:	MWL
Description:	Water Level

Distance (ft):	.0
Structural Grade:	0
O&M Grade:	0
Clock Start/From:	
Clock To:	
1st Value:	
2nd Value:	
Value Percent:	5.000
Continuous Index:	
Within 8" of Joint:	NO
Remarks:

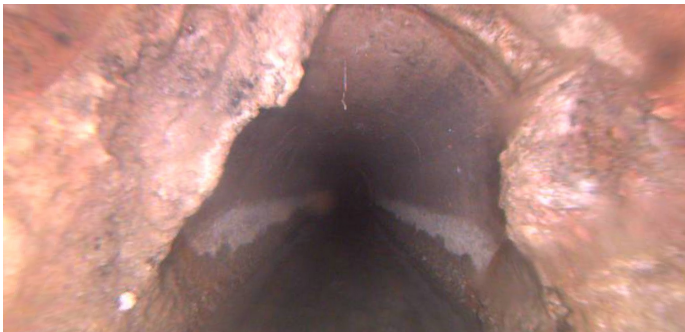
Code:	DAE
Description:	Deposits Attached Encrustation

Distance (ft):	3.0
Structural Grade:	0
O&M Grade:	3
Clock Start/From:	8
Clock To:	4
1st Value:	
2nd Value:	
Value Percent:	20.000
Continuous Index:	
Within 8" of Joint:	YES
Remarks:

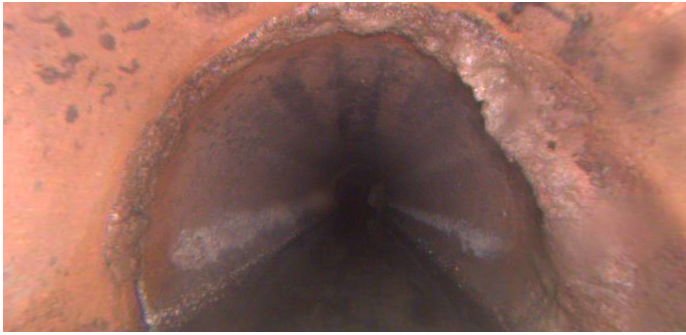
Code: **DAE**
Description: **Deposits Attached Encrustation**

Distance (ft): **6.0**
Structural Grade: **0**
O&M Grade: **2**
Clock Start/From: **8**
Clock To: **4**
1st Value:
2nd Value:
Value Percent: **10.000**
Continuous Index: **S01**
Within 8" of Joint: **YES**
Remarks:

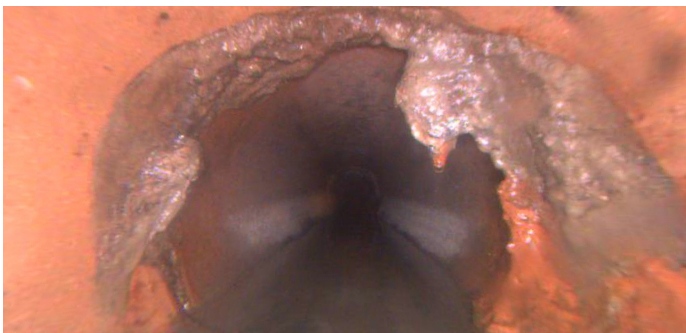
Code: **ID**
Description: **Infil Dripper**

Distance (ft): **11.9**
Structural Grade: **0**
O&M Grade: **3**
Clock Start/From: **1**
Clock To:
1st Value:
2nd Value:
Value Percent:
Continuous Index:
Within 8" of Joint: **YES**
Remarks:

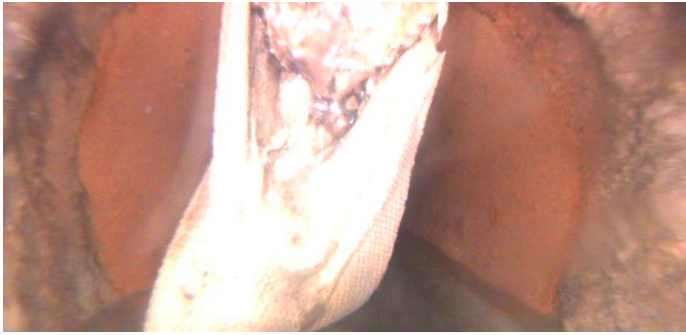
Code: **DAR**
Description: **Deposits Attached Ragging**

Distance (ft): **24.1**
Structural Grade: **0**
O&M Grade: **3**
Clock Start/From: **11**
Clock To: **1**
1st Value:
2nd Value:
Value Percent: **20.000**
Continuous Index:
Within 8" of Joint: **YES**
Remarks:

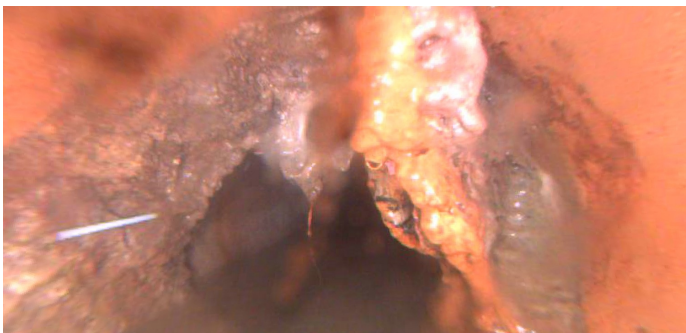
Code: **DAE**
Description: **Deposits Attached Encrustation**

Distance (ft): **26.8**
Structural Grade: **0**
O&M Grade: **5**
Clock Start/From: **8**
Clock To: **4**
1st Value:
2nd Value:
Value Percent: **70.000**
Continuous Index:
Within 8" of Joint: **YES**
Remarks:

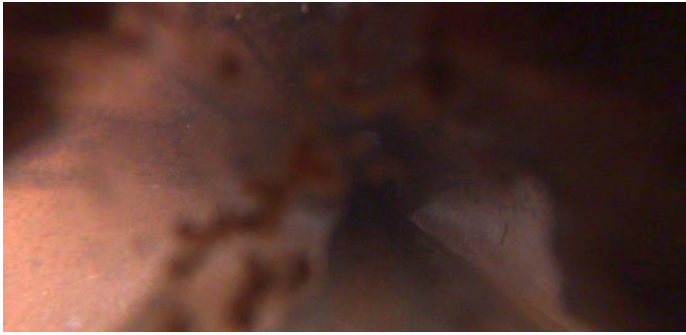
Code: **MSA**
Description: **Abandoned Survey**

Distance (ft): **27.5**
Structural Grade: **0**
O&M Grade: **0**
Clock Start/From:
Clock To:
1st Value:
2nd Value:
Value Percent:
Continuous Index:
Within 8" of Joint: **NO**
Remarks: **DAE**

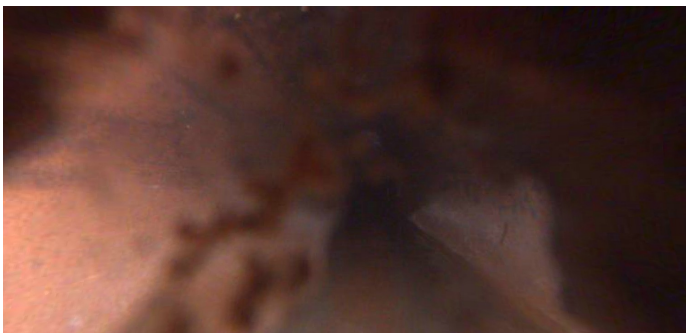
Code: **DAE**
Description: **Deposits Attached Encrustation**

Distance (ft): **27.5**
Structural Grade: **0**
O&M Grade: **2**
Clock Start/From: **8**
Clock To: **4**
1st Value:
2nd Value:
Value Percent: **10.000**
Continuous Index: **F01**
Within 8" of Joint: **YES**
Remarks:
