Profile/Photo Observation Report

Date:	03/23/2018	Weather:		Coding:	PACP 6.0
Pipe Length (ft):	199.0	Owner:	NA	Pre Clean:	No Pre-Cleaning
P.O.#:		Surveyor:	Jen Costello	PSR:	P-208-011-012
Customer:		Clean Date:	01/01/1900	Shape:	C

Street:	FOXCROFT STREET	Flow Control:	Not Controlled
City:	Hobart, IN	Year Renewed:	
Location:	Light Highway	Tape/Media #:	
Purpose:	Routine Assessment	Dia/Height:	12"
Use:	Sanitary	Material:	VCP
Drain Area:	NA	Lining:	
Category:	NA		
Comment:	False MH_F at 26 ft solo was stop at build on the top of pipe \nFlow direction wrong		
Location Details:		Direction of Survey:	Downstream
US MH:	M-208-012	DS MH:	M-208-011
		Total Length Surveyed (ft):	27.5

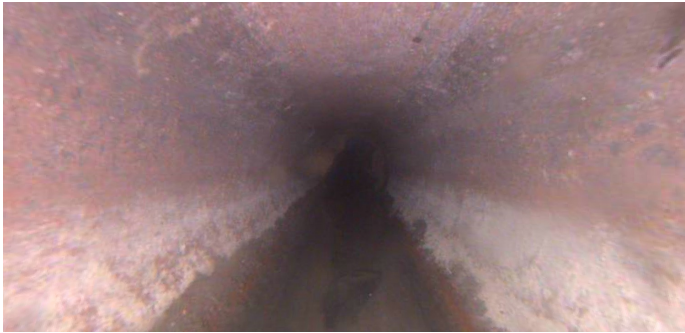
Code:	MWL
Description:	Water Level

Distance (ft):	.0
Structural Grade:	0
O&M Grade:	0
Clock Start/From:	
Clock To:	
1st Value:	
2nd Value:	
Value Percent:	5.000
Continuous Index:	
Within 8" of Joint:	NO
Remarks:

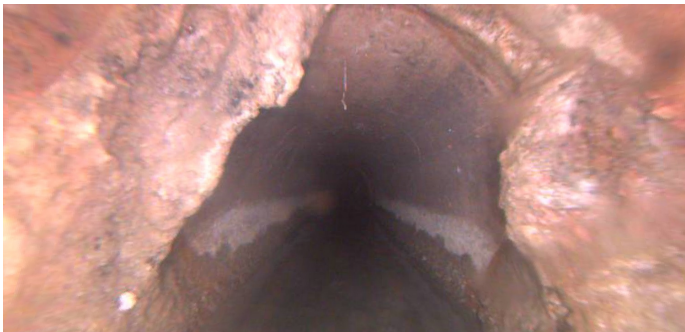
Code:	DAE
Description:	Deposits Attached Encrustation

Distance (ft):	3.0
Structural Grade:	0
O&M Grade:	3
Clock Start/From:	8
Clock To:	4
1st Value:	
2nd Value:	
Value Percent:	20.000
Continuous Index:	
Within 8" of Joint:	YES
Remarks:

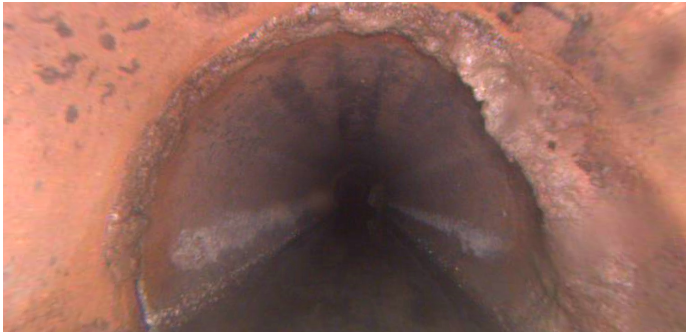
Code: **DAE**
Description: **Deposits Attached Encrustation**

Distance (ft): **6.0**
Structural Grade: **0**
O&M Grade: **2**
Clock Start/From: **8**
Clock To: **4**
1st Value:
2nd Value:
Value Percent: **10.000**
Continuous Index: **S01**
Within 8" of Joint: **YES**
Remarks:

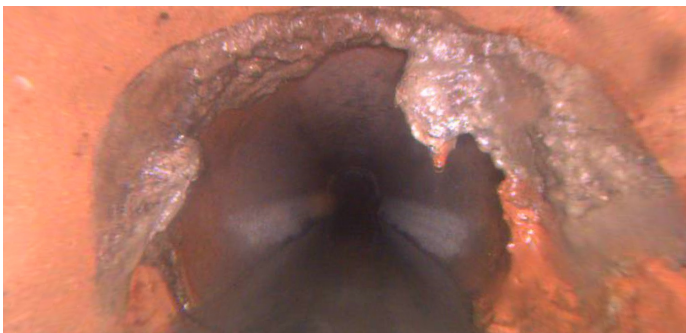
Code: **ID**
Description: **Infil Dripper**

Distance (ft): **11.9**
Structural Grade: **0**
O&M Grade: **3**
Clock Start/From: **1**
Clock To:
1st Value:
2nd Value:
Value Percent:
Continuous Index:
Within 8" of Joint: **YES**
Remarks:

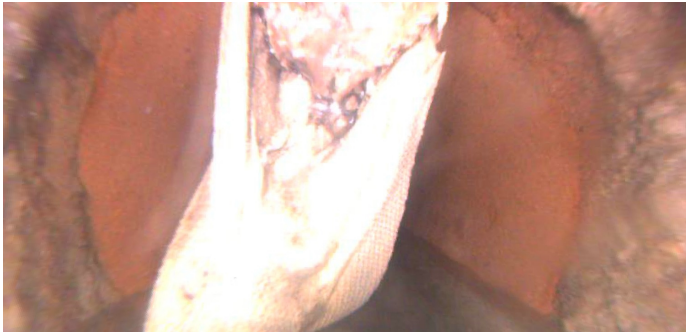
Code: **DAR**
Description: **Deposits Attached Ragging**

Distance (ft): **24.1**
Structural Grade: **0**
O&M Grade: **3**
Clock Start/From: **11**
Clock To: **1**
1st Value:
2nd Value:
Value Percent: **20.000**
Continuous Index:
Within 8" of Joint: **YES**
Remarks:

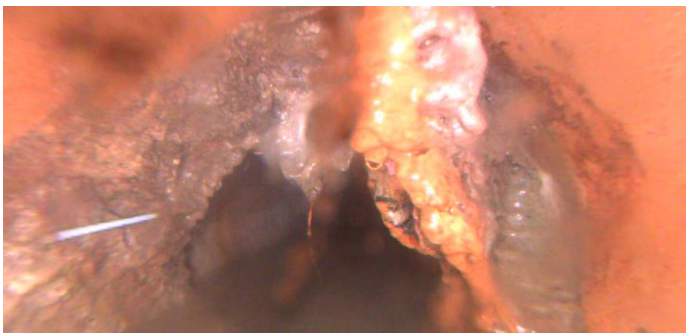
Code: **DAE**
Description: **Deposits Attached Encrustation**

Distance (ft): **26.8**
Structural Grade: **0**
O&M Grade: **5**
Clock Start/From: **8**
Clock To: **4**
1st Value:
2nd Value:
Value Percent: **70.000**
Continuous Index:
Within 8" of Joint: **YES**
Remarks:

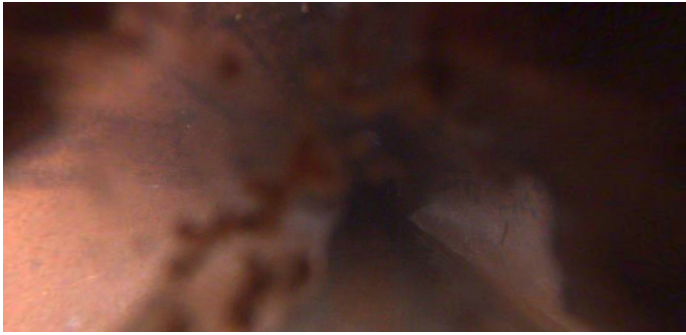
Code: **MSA**
Description: **Abandoned Survey**

Distance (ft): **27.5**
Structural Grade: **0**
O&M Grade: **0**
Clock Start/From:
Clock To:
1st Value:
2nd Value:
Value Percent:
Continuous Index:
Within 8" of Joint: **NO**
Remarks: **DAE**

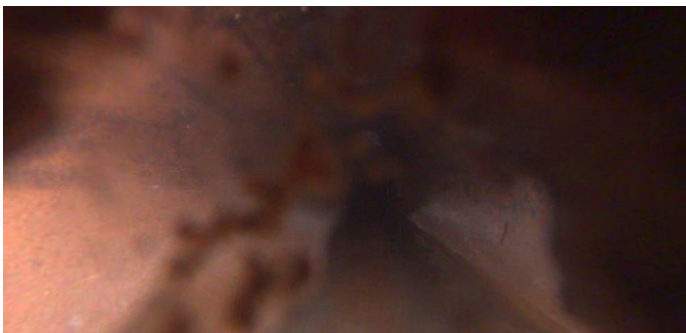
Code: **DAE**
Description: **Deposits Attached Encrustation**

Distance (ft): **27.5**
Structural Grade: **0**
O&M Grade: **2**
Clock Start/From: **8**
Clock To: **4**
1st Value:
2nd Value:
Value Percent: **10.000**
Continuous Index: **F01**
Within 8" of Joint: **YES**
Remarks:
