## Profile/Photo Observation Report

Street:	<b>E 34TH CT</b>	Flow Control:	<b>Not Controlled</b>
City:	<b>Hobart, IN</b>	Year Renewed:	
Location:	<b>Other</b>	Tape/Media #:	
Purpose:	<b>Not Known</b>	Dia/Height:	<b>10"</b>
Use:	<b>Sanitary</b>	Material:	<b>VCP</b>
Drain Area:	<b>NA</b>	Lining:	
Category:	<b>NA</b>		
Comment:

Location Details:		Direction of Survey:	<b>Downstream</b>
US MH:	<b>M-902-017</b>	DS MH:	<b>M-902-015</b>
		Total Length Surveyed (ft):	<b>41.0</b>

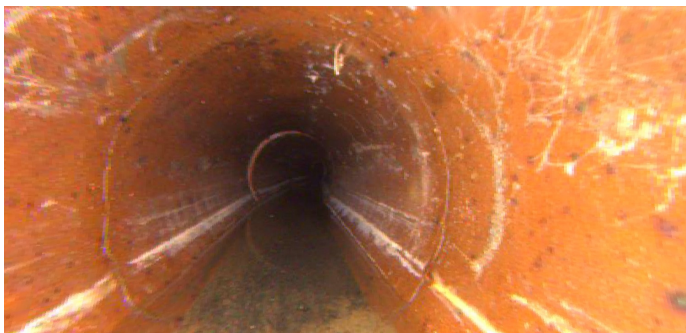
Code: **AMH**  
Description: **Manhole**

Distance (ft): **.0**  
Structural Grade: **0**  
O&M Grade: **0**  
Clock Start/From:  
Clock To:  
1st Value:  
2nd Value:  
Value Percent:  
Continuous Index:  
Within 8" of Joint: **NO**  
Remarks: **M-902-017**

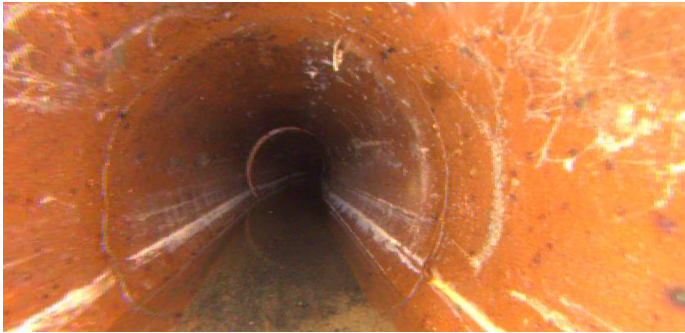
Code:	<b>MWL</b>
Description:	<b>Water Level</b>

Distance (ft):	<b>.0</b>
Structural Grade:	<b>0</b>
O&M Grade:	<b>0</b>
Clock Start/From:	
Clock To:	
1st Value:	
2nd Value:	
Value Percent:	<b>5.000</b>
Continuous Index:	
Within 8" of Joint:	<b>NO</b>
Remarks:

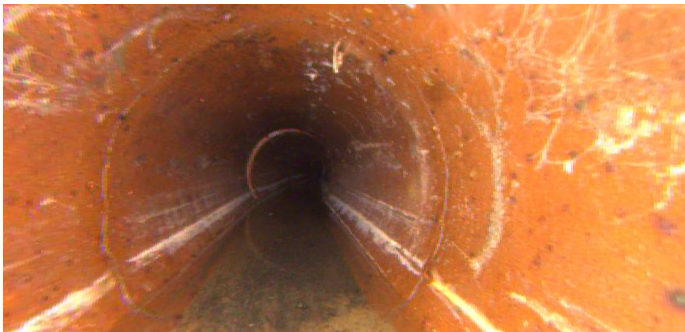
Code:	<b>CC</b>
Description:	<b>Crack Circumferential</b>

Distance (ft):	<b>.0</b>
Structural Grade:	<b>1</b>
O&M Grade:	<b>0</b>
Clock Start/From:	<b>7</b>
Clock To:	<b>5</b>
1st Value:	
2nd Value:	
Value Percent:	
Continuous Index:	
Within 8" of Joint:	
Remarks:

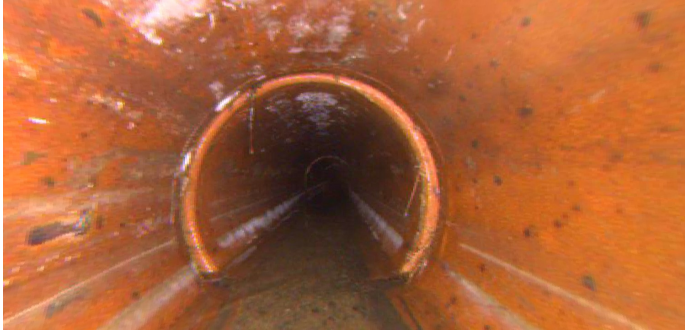
Code: **RFJ**  
Description: **Roots Fine Joint**

Distance (ft): **5.7**  
Structural Grade: **0**  
O&M Grade: **1**  
Clock Start/From: **7**  
Clock To: **5**  
1st Value:  
2nd Value:  
Value Percent:  
Continuous Index: **S01**  
Within 8" of Joint: **YES**  
Remarks: **wandering**

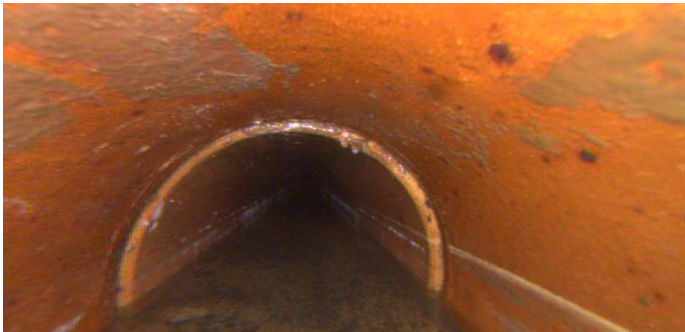
Code: **MWL**  
Description: **Water Level**

Distance (ft): **33.9**  
Structural Grade: **0**  
O&M Grade: **0**  
Clock Start/From:  
Clock To:  
1st Value:  
2nd Value:  
Value Percent: **25.000**  
Continuous Index:  
Within 8" of Joint: **NO**  
Remarks:

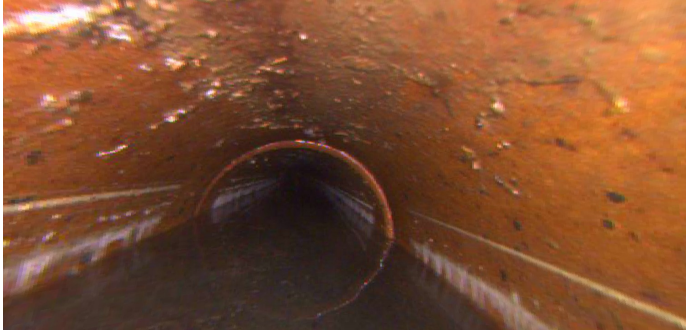
Code: **RFJ**  
Description: **Roots Fine Joint**

Distance (ft): **39.7**  
Structural Grade: **0**  
O&M Grade: **1**  
Clock Start/From: **7**  
Clock To: **5**  
1st Value:  
2nd Value:  
Value Percent:  
Continuous Index: **F01**  
Within 8" of Joint: **YES**  
Remarks: **wandering**

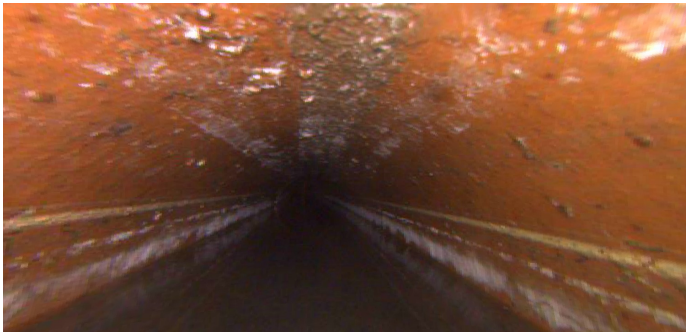
Code: **MSA**  
Description: **Abandoned Survey**

Distance (ft): **41.0**  
Structural Grade: **0**  
O&M Grade: **0**  
Clock Start/From:  
Clock To:  
1st Value:  
2nd Value:  
Value Percent:  
Continuous Index:  
Within 8" of Joint: **NO**  
Remarks: **stuck on joint/ debris**
