Profile/Photo Observation Report

Street:	E 34TH CT	Flow Control:	Not Controlled
City:	Hobart, IN	Year Renewed:	
Location:	Other	Tape/Media #:	
Purpose:	Not Known	Dia/Height:	10"
Use:	Sanitary	Material:	VCP
Drain Area:	NA	Lining:	
Category:	NA		
Comment:

Location Details:		Direction of Survey:	Downstream
US MH:	M-902-017	DS MH:	M-902-019B
		Total Length Surveyed (ft):	2.7

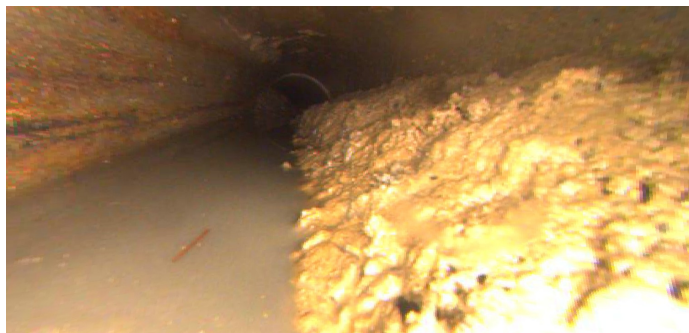
Code: **AMH**
Description: **Manhole**

Distance (ft): **.0**
Structural Grade: **0**
O&M Grade: **0**
Clock Start/From:
Clock To:
1st Value:
2nd Value:
Value Percent:
Continuous Index:
Within 8" of Joint: **NO**
Remarks: **M-902-017**

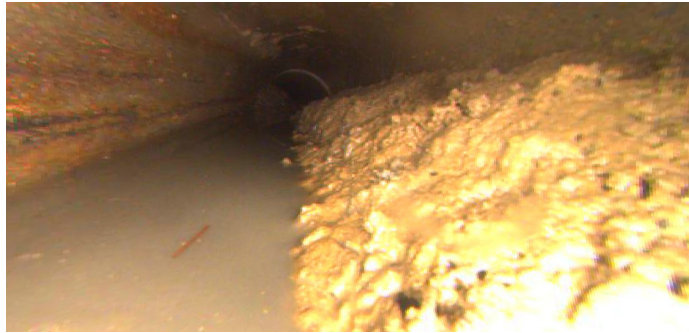
Code: **MWL**
Description: **Water Level**

Distance (ft): **.0**
Structural Grade: **0**
O&M Grade: **0**
Clock Start/From:
Clock To:
1st Value:
2nd Value:
Value Percent: **5.000**
Continuous Index:
Within 8" of Joint: **NO**
Remarks:

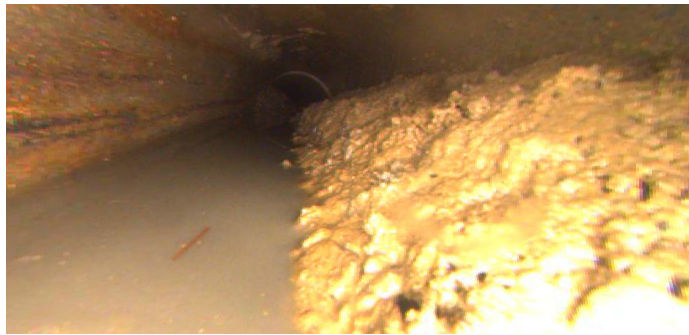
Code: **DAZ**
Description: **Deposits Attached Other**

Distance (ft): **.0**
Structural Grade: **0**
O&M Grade: **4**
Clock Start/From: **2**
Clock To: **6**
1st Value:
2nd Value:
Value Percent: **25.000**
Continuous Index:
Within 8" of Joint: **NO**
Remarks: **mud???**
