## Profile/Photo Observation Report

Street:	<b>16TH ST</b>	Flow Control:	<b>Not Controlled</b>
City:	<b>Hobart, IN</b>	Year Renewed:	
Location:	<b>Light Highway</b>	Tape/Media #:	
Purpose:	<b>Routine Assessment</b>	Dia/Height:	<b>12"</b>
Use:	<b>Sanitary</b>	Material:	<b>VCP</b>
Drain Area:	<b>NA</b>	Lining:	
Category:	<b>NA</b>		
Comment:	<b>R_M at 17 ft debris and rocks in the tracks\nFlow direction wrong</b>		
Location Details:		Direction of Survey:	<b>Upstream</b>
US MH:	<b>M-208-013</b>	DS MH:	<b>M-208-012</b>
		Total Length Surveyed (ft):	<b>18.7</b>

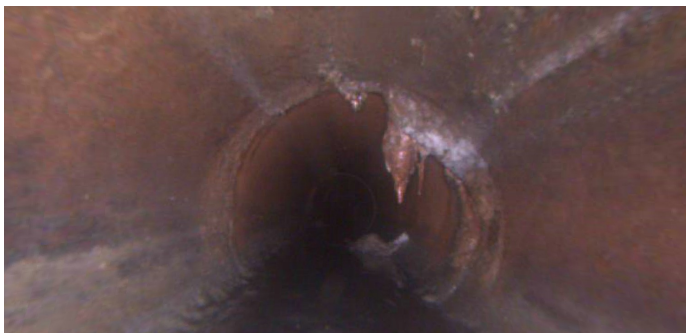
Code: **AMH**  
Description: **Manhole**

Distance (ft): **.0**  
Structural Grade: **0**  
O&M Grade: **0**  
Clock Start/From:  
Clock To:  
1st Value:  
2nd Value:  
Value Percent:  
Continuous Index:  
Within 8" of Joint: **NO**  
Remarks: **M-208-012**

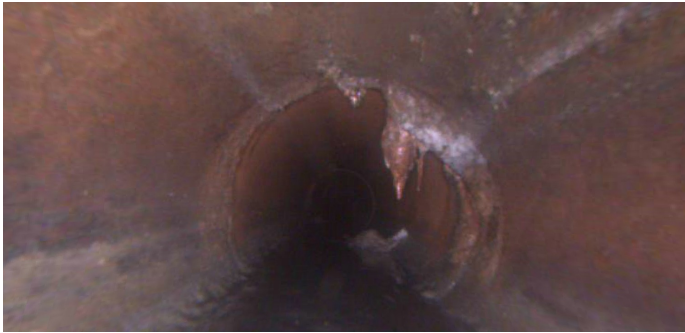
Code:	<b>MWL</b>
Description:	<b>Water Level</b>

Distance (ft):	<b>.0</b>
Structural Grade:	<b>0</b>
O&M Grade:	<b>0</b>
Clock Start/From:	
Clock To:	
1st Value:	
2nd Value:	
Value Percent:	<b>5.000</b>
Continuous Index:	
Within 8" of Joint:	<b>NO</b>
Remarks:

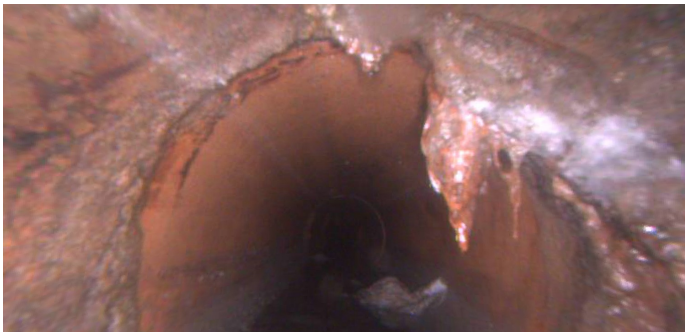
Code:	<b>ID</b>
Description:	<b>Infil Dripper</b>

Distance (ft):	<b>1.2</b>
Structural Grade:	<b>0</b>
O&M Grade:	<b>3</b>
Clock Start/From:	<b>12</b>
Clock To:	<b>1</b>
1st Value:	
2nd Value:	
Value Percent:	
Continuous Index:	
Within 8" of Joint:	<b>YES</b>
Remarks:

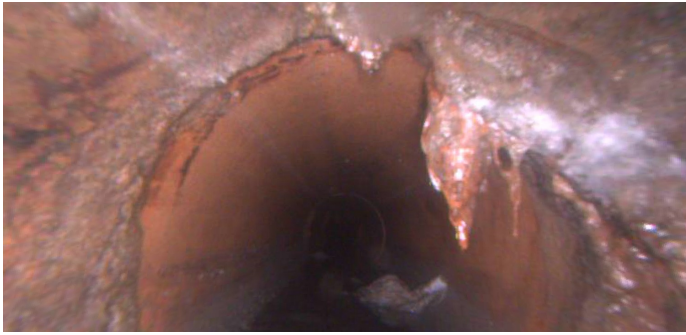
Code: **DAE**  
Description: **Deposits Attached Encrustation**

Distance (ft): **1.2**  
Structural Grade: **0**  
O&M Grade: **2**  
Clock Start/From: **8**  
Clock To: **4**  
1st Value:  
2nd Value:  
Value Percent: **10.000**  
Continuous Index: **S01**  
Within 8" of Joint: **YES**  
Remarks:

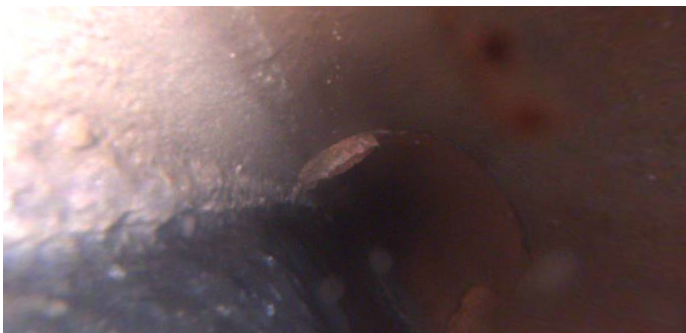
Code: **MSA**  
Description: **Abandoned Survey**

Distance (ft): **18.7**  
Structural Grade: **0**  
O&M Grade: **0**  
Clock Start/From:  
Clock To:  
1st Value:  
2nd Value:  
Value Percent:  
Continuous Index:  
Within 8" of Joint: **NO**  
Remarks: **overturned**

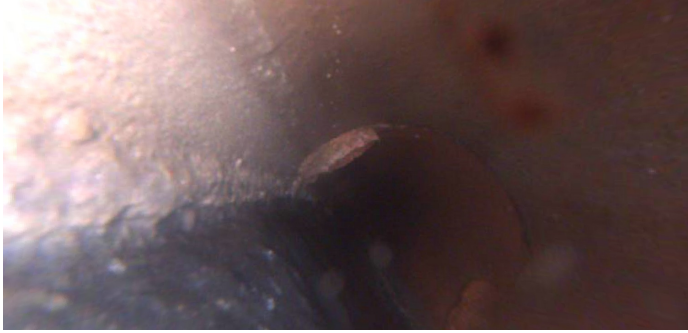
Code:	<b>DAE</b>
Description:	<b>Deposits Attached Encrustation</b>
Distance (ft):	<b>18.7</b>
Structural Grade:	<b>0</b>
O&M Grade:	<b>2</b>
Clock Start/From:	<b>8</b>
Clock To:	<b>4</b>
1st Value:	
2nd Value:	
Value Percent:	<b>10.000</b>
Continuous Index:	<b>F01</b>
Within 8" of Joint:	<b>YES</b>
Remarks:
