Profile/Photo Observation Report

Date:	03/23/2018	Weather:		Coding:	PACP 6.0
Pipe Length (ft):	182.8	Owner:	NA	Pre Clean:	No Pre-Cleaning
P.O.#:		Surveyor:	Jen Costello	PSR:	P-208-012-013
Customer:		Clean Date:	01/01/1900	Shape:	C

Street:	16TH ST	Flow Control:	Not Controlled
City:	Hobart, IN	Year Renewed:	
Location:	Light Highway	Tape/Media #:	
Purpose:	Routine Assessment	Dia/Height:	12"
Use:	Sanitary	Material:	VCP
Drain Area:	NA	Lining:	
Category:	NA		
Comment:	R_M at 33 ft nothing visible. Flow direction wrong		
Location Details:		Direction of Survey:	Downstream
US MH:	M-208-013	DS MH:	M-208-012
		Total Length Surveyed (ft):	34.7

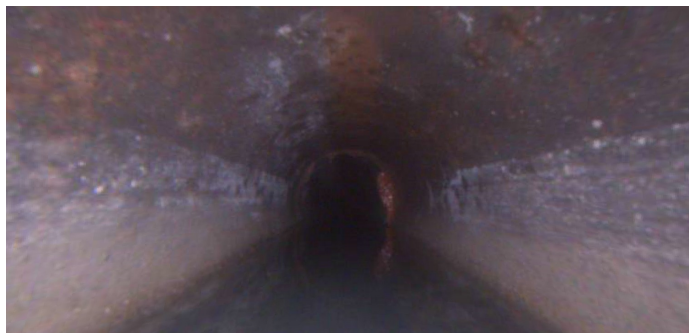
Code: **AMH**
 Description: **Manhole**
 Distance (ft): **.0**
 Structural Grade: **0**
 O&M Grade: **0**
 Clock Start/From:
 Clock To:
 1st Value:
 2nd Value:
 Value Percent:
 Continuous Index:
 Within 8" of Joint: **NO**
 Remarks: **M-208-013**

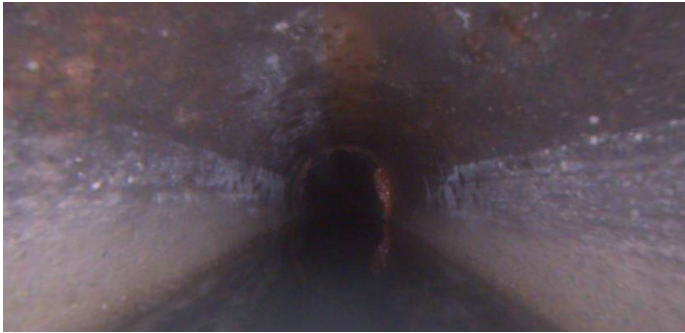
Code:	MWL
Description:	Water Level

Distance (ft):	.0
Structural Grade:	0
O&M Grade:	0
Clock Start/From:	
Clock To:	
1st Value:	
2nd Value:	
Value Percent:	10.000
Continuous Index:	
Within 8" of Joint:	NO
Remarks:

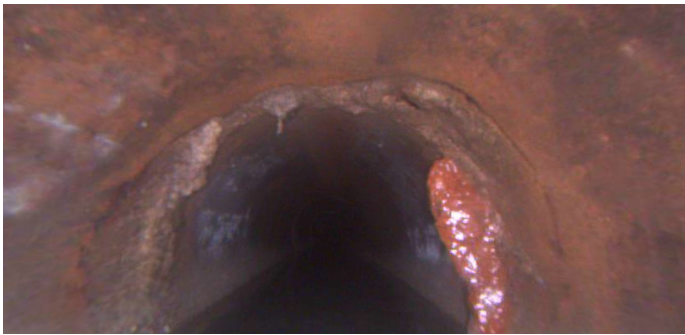
Code:	DAE
Description:	Deposits Attached Encrustation

Distance (ft):	3.2
Structural Grade:	0
O&M Grade:	2
Clock Start/From:	8
Clock To:	4
1st Value:	
2nd Value:	
Value Percent:	10.000
Continuous Index:	
Within 8" of Joint:	YES
Remarks:

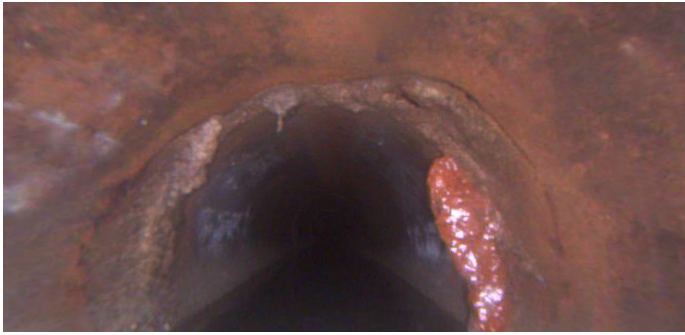
Code: **FC**
Description: **Fracture Circumferential**

Distance (ft): **3.2**
Structural Grade: **2**
O&M Grade: **0**
Clock Start/From: **12**
Clock To: **3**
1st Value:
2nd Value:
Value Percent:
Continuous Index:
Within 8" of Joint: **YES**
Remarks:

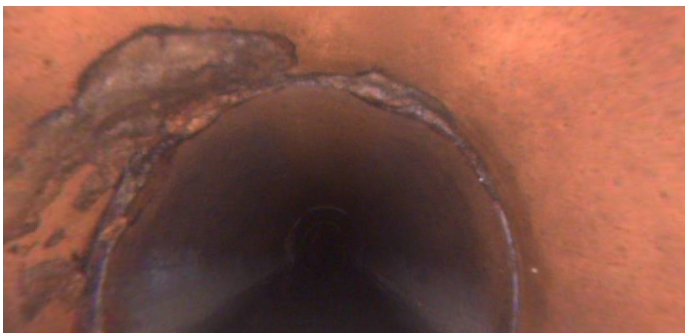
Code: **DAE**
Description: **Deposits Attached Encrustation**

Distance (ft): **6.1**
Structural Grade: **0**
O&M Grade: **2**
Clock Start/From: **8**
Clock To: **4**
1st Value:
2nd Value:
Value Percent: **5.000**
Continuous Index:
Within 8" of Joint: **YES**
Remarks:

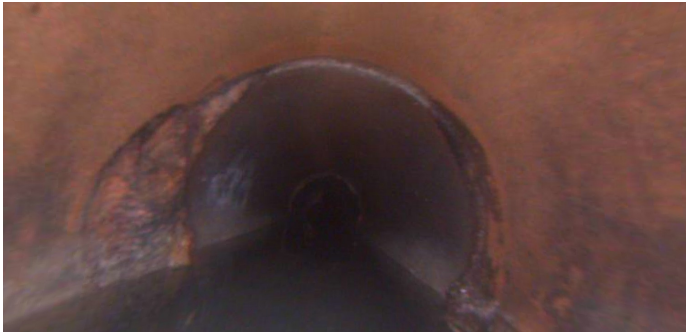
Code: **DAE**
Description: **Deposits Attached Encrustation**

Distance (ft): **8.9**
Structural Grade: **0**
O&M Grade: **2**
Clock Start/From: **8**
Clock To: **4**
1st Value:
2nd Value:
Value Percent: **10.000**
Continuous Index: **S01**
Within 8" of Joint: **YES**
Remarks:

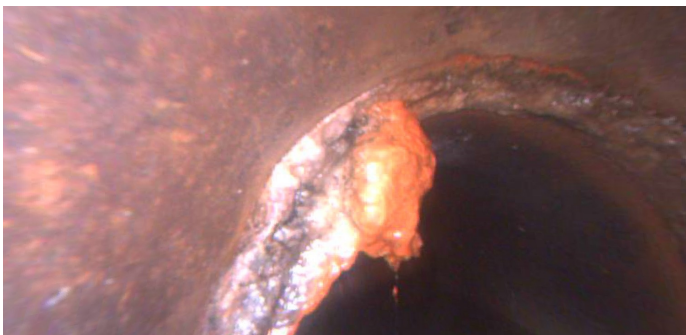
Code: **IR**
Description: **Infil Runner**

Distance (ft): **15.2**
Structural Grade: **0**
O&M Grade: **4**
Clock Start/From: **11**
Clock To:
1st Value:
2nd Value:
Value Percent:
Continuous Index:
Within 8" of Joint: **YES**
Remarks:

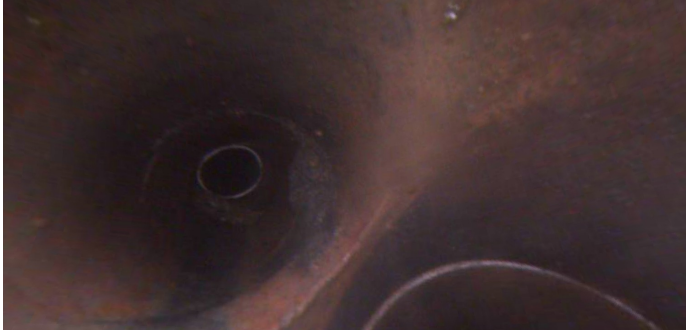
Code: **TF**
Description: **Tap Factory**

Distance (ft): **17.5**
Structural Grade: **0**
O&M Grade: **0**
Clock Start/From: **10**
Clock To:
1st Value: **4.000**
2nd Value:
Value Percent:
Continuous Index:
Within 8" of Joint:
Remarks:

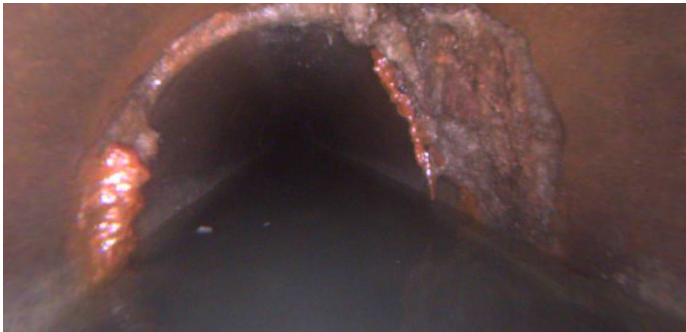
Code: **ID**
Description: **Infil Dripper**

Distance (ft): **20.9**
Structural Grade: **0**
O&M Grade: **3**
Clock Start/From: **1**
Clock To:
1st Value:
2nd Value:
Value Percent:
Continuous Index:
Within 8" of Joint: **YES**
Remarks:

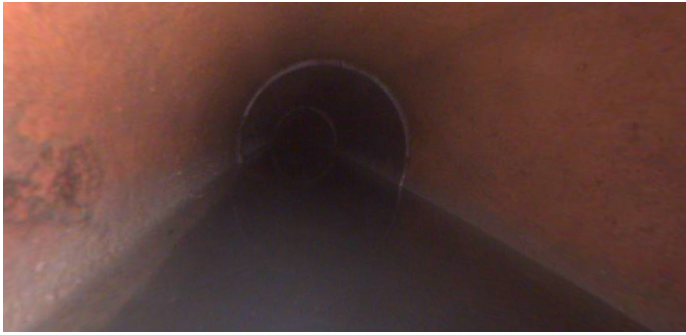
Code: **DAE**
Description: **Deposits Attached Encrustation**

Distance (ft): **34.7**
Structural Grade: **0**
O&M Grade: **2**
Clock Start/From: **8**
Clock To: **4**
1st Value:
2nd Value:
Value Percent: **10.000**
Continuous Index: **F01**
Within 8" of Joint: **YES**
Remarks:

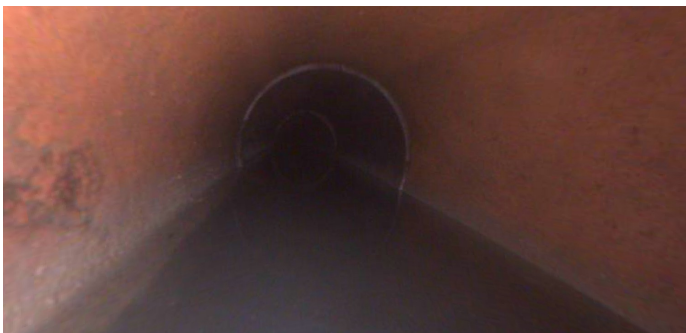
Code: **MSA**
Description: **Abandoned Survey**

Distance (ft): **34.7**
Structural Grade: **0**
O&M Grade: **0**
Clock Start/From:
Clock To:
1st Value:
2nd Value:
Value Percent:
Continuous Index:
Within 8" of Joint: **NO**
Remarks: **DEBRIS UNDER WATER**
