## Profile/Photo Observation Report

Date:	<b>03/23/2018</b>	Weather:		Coding:	<b>PACP 6.0</b>
Pipe Length (ft):	<b>182.8</b>	Owner:	<b>NA</b>	Pre Clean:	<b>No Pre-Cleaning</b>
P.O.#:		Surveyor:	<b>Jen Costello</b>	PSR:	<b>P-208-012-013</b>
Customer:		Clean Date:	<b>01/01/1900</b>	Shape:	<b>C</b>

Street:	<b>FOXCROFT STREET</b>	Flow Control:	<b>Not Controlled</b>
City:	<b>Hobart, IN</b>	Year Renewed:	
Location:	<b>Light Highway</b>	Tape/Media #:	
Purpose:	<b>Routine Assessment</b>	Dia/Height:	<b>12"</b>
Use:	<b>Sanitary</b>	Material:	<b>VCP</b>
Drain Area:	<b>NA</b>	Lining:	
Category:	<b>NA</b>		
Comment:	<b>R_M at 33 ft nothing visible. Flow direction wrong</b>		
Location Details:		Direction of Survey:	<b>Downstream</b>
US MH:	<b>M-208-013</b>	DS MH:	<b>M-208-012</b>
		Total Length Surveyed (ft):	<b>34.7</b>

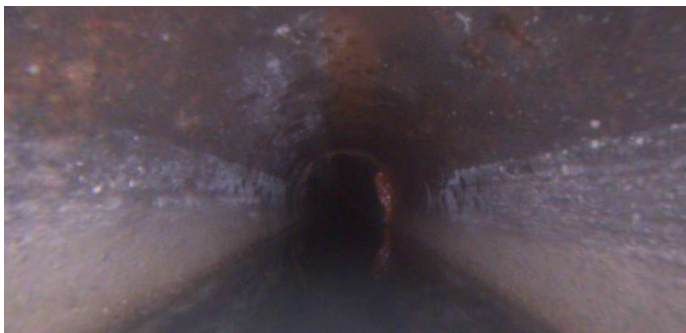
Code: **AMH**  
Description: **Manhole**

Distance (ft): **.0**  
Structural Grade: **0**  
O&M Grade: **0**  
Clock Start/From:  
Clock To:  
1st Value:  
2nd Value:  
Value Percent:  
Continuous Index:  
Within 8" of Joint: **NO**  
Remarks: **M-208-013**

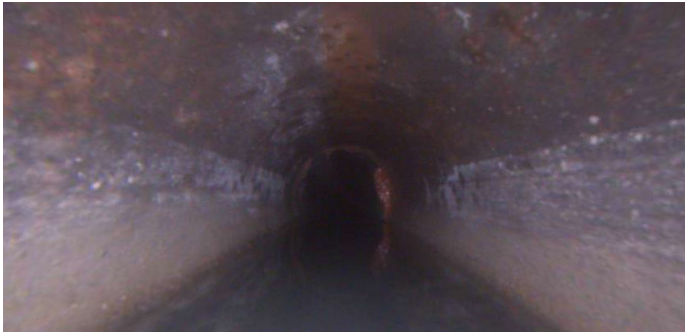
Code:	<b>MWL</b>
Description:	<b>Water Level</b>

Distance (ft):	<b>.0</b>
Structural Grade:	<b>0</b>
O&M Grade:	<b>0</b>
Clock Start/From:	
Clock To:	
1st Value:	
2nd Value:	
Value Percent:	<b>10.000</b>
Continuous Index:	
Within 8" of Joint:	<b>NO</b>
Remarks:

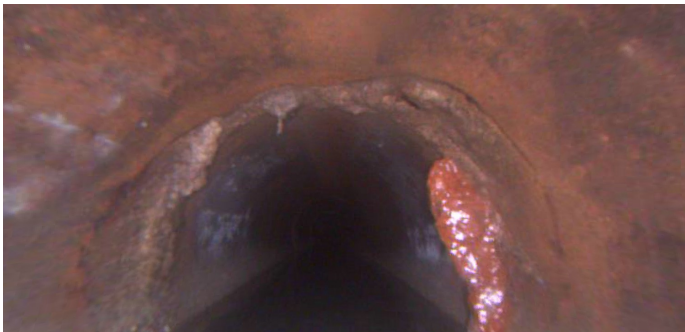
Code:	<b>DAE</b>
Description:	<b>Deposits Attached Encrustation</b>

Distance (ft):	<b>3.2</b>
Structural Grade:	<b>0</b>
O&M Grade:	<b>2</b>
Clock Start/From:	<b>8</b>
Clock To:	<b>4</b>
1st Value:	
2nd Value:	
Value Percent:	<b>10.000</b>
Continuous Index:	
Within 8" of Joint:	<b>YES</b>
Remarks:

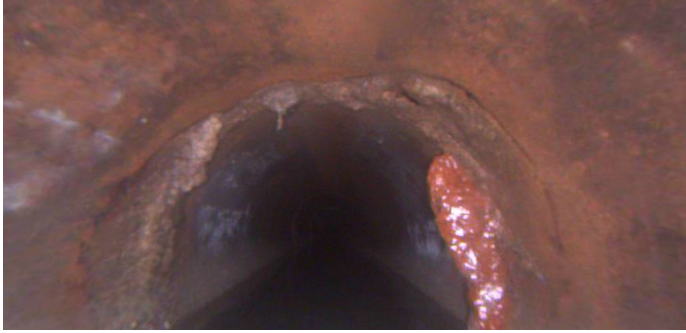
Code: **FC**  
Description: **Fracture Circumferential**

Distance (ft): **3.2**  
Structural Grade: **2**  
O&M Grade: **0**  
Clock Start/From: **12**  
Clock To: **3**  
1st Value:  
2nd Value:  
Value Percent:  
Continuous Index:  
Within 8" of Joint: **YES**  
Remarks:

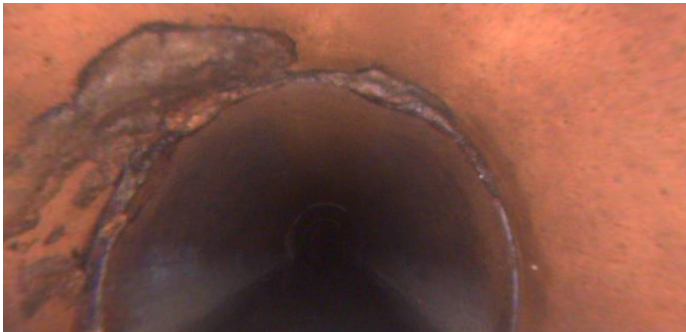
Code: **DAE**  
Description: **Deposits Attached Encrustation**

Distance (ft): **6.1**  
Structural Grade: **0**  
O&M Grade: **2**  
Clock Start/From: **8**  
Clock To: **4**  
1st Value:  
2nd Value:  
Value Percent: **5.000**  
Continuous Index:  
Within 8" of Joint: **YES**  
Remarks:

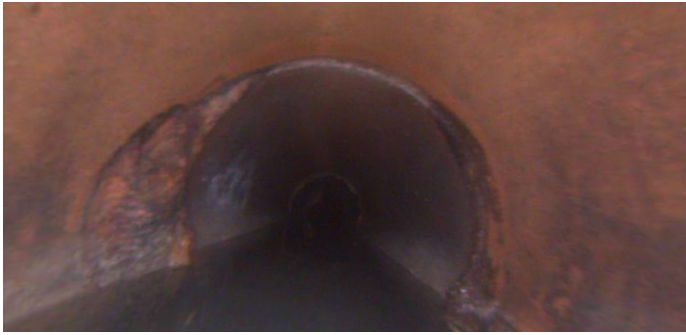
Code: **DAE**  
Description: **Deposits Attached Encrustation**

Distance (ft): **8.9**  
Structural Grade: **0**  
O&M Grade: **2**  
Clock Start/From: **8**  
Clock To: **4**  
1st Value:  
2nd Value:  
Value Percent: **10.000**  
Continuous Index: **S01**  
Within 8" of Joint: **YES**  
Remarks:

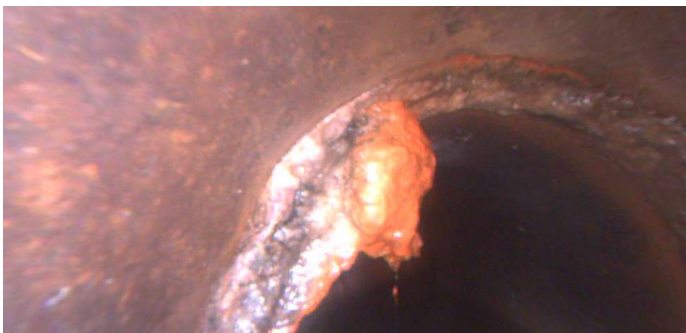
Code: **IR**  
Description: **Infil Runner**

Distance (ft): **15.2**  
Structural Grade: **0**  
O&M Grade: **4**  
Clock Start/From: **11**  
Clock To:  
1st Value:  
2nd Value:  
Value Percent:  
Continuous Index:  
Within 8" of Joint: **YES**  
Remarks:

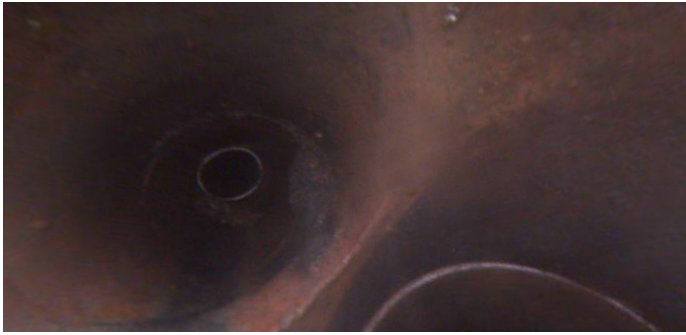
Code: **TF**  
Description: **Tap Factory**

Distance (ft): **17.5**  
Structural Grade: **0**  
O&M Grade: **0**  
Clock Start/From: **10**  
Clock To:  
1st Value: **4.000**  
2nd Value:  
Value Percent:  
Continuous Index:  
Within 8" of Joint:  
Remarks:

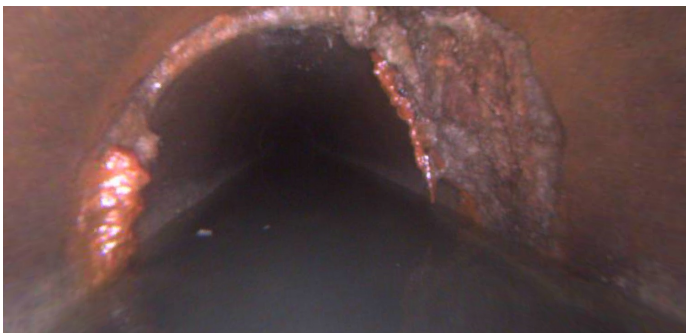
Code: **ID**  
Description: **Infil Dripper**

Distance (ft): **20.9**  
Structural Grade: **0**  
O&M Grade: **3**  
Clock Start/From: **1**  
Clock To:  
1st Value:  
2nd Value:  
Value Percent:  
Continuous Index:  
Within 8" of Joint: **YES**  
Remarks:

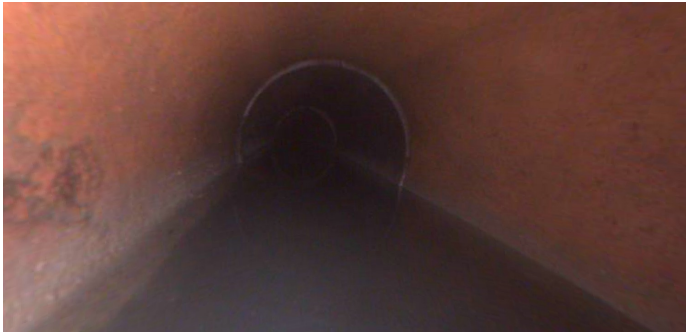
Code: **DAE**  
Description: **Deposits Attached Encrustation**

Distance (ft): **34.7**  
Structural Grade: **0**  
O&M Grade: **2**  
Clock Start/From: **8**  
Clock To: **4**  
1st Value:  
2nd Value:  
Value Percent: **10.000**  
Continuous Index: **F01**  
Within 8" of Joint: **YES**  
Remarks:

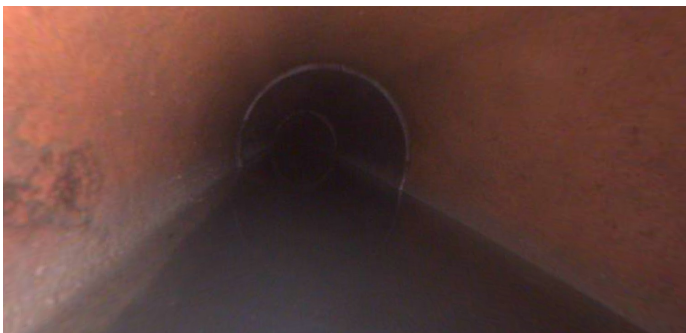
Code: **MSA**  
Description: **Abandoned Survey**

Distance (ft): **34.7**  
Structural Grade: **0**  
O&M Grade: **0**  
Clock Start/From:  
Clock To:  
1st Value:  
2nd Value:  
Value Percent:  
Continuous Index:  
Within 8" of Joint: **NO**  
Remarks: **DEBRIS UNDER WATER**
